MINERALS PROGRAM INSPECTION REPORT

MINE NAME: Sunday Mine Complex Topaz Mine Monitoring Well Construction	MINE/PROSPECTING ID#: P-2022-010	MINERAL: Vanadium and uranium	COUNTY: San Miguel
INSPECTION TYPE: Preoperation Inspection	INSPECTOR(S): Lucas West	INSP. DATE: May 19, 2022	INSP. TIME: 14:15
OPERATOR: Pinon Ridge Mining LLC	OPERATOR REPRESENTATIVE: Michael Rutter, Grant Glasier	TYPE OF OPERATION: MP - Mineral Prospecting

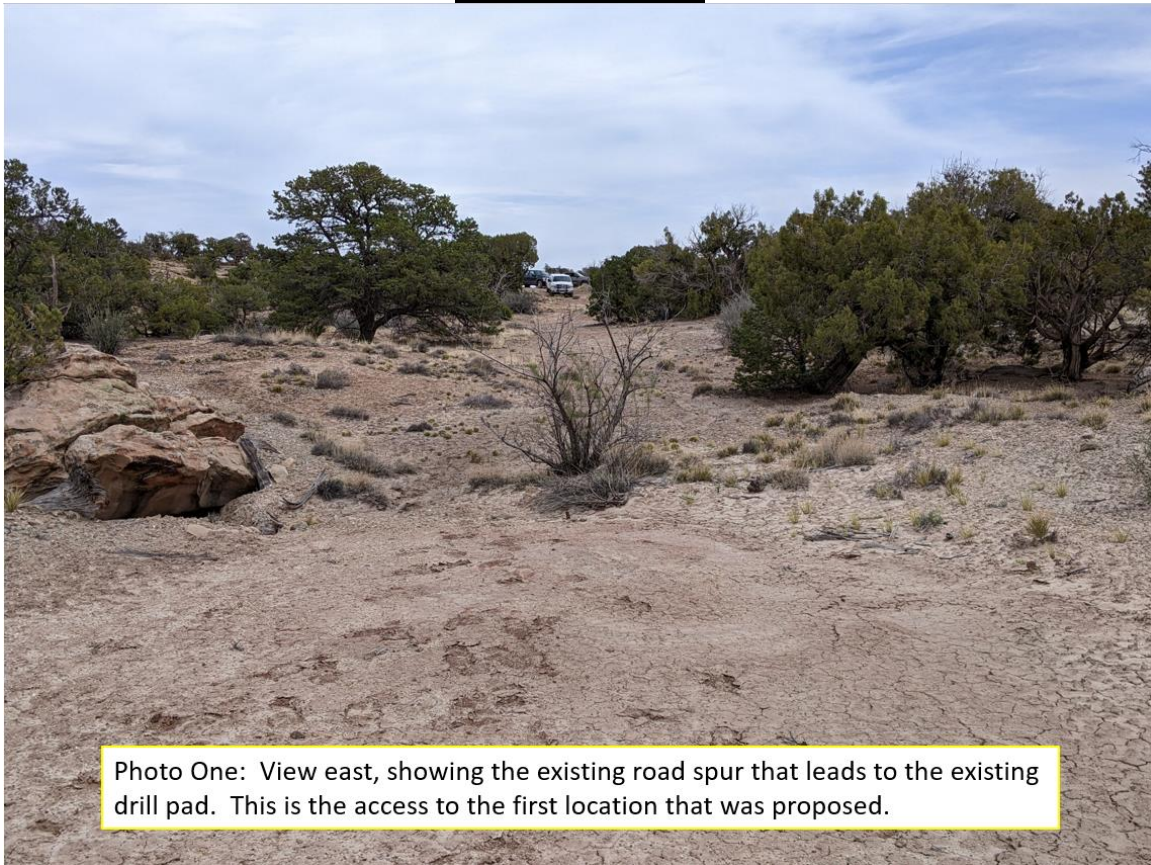
At the time of the inspection, three possible locations for the drill hole were discussed. The first location is at the end of an existing drill road spur off of the established BLM trail. The existing road spur is in good condition, and show no signs of recent use. No evidence of erosion, state listed noxious weeds or matters of concern were identified. The drill spur leads to a small pad, approximately 200 yds down gradient from the existing BLM trail. The pad was constructed at some point to support drilling operations. Historic drill core was observed indicating historic use of the pad. The pad and an example of the road can be seen in Photos One and Two.

Photo One: View east, showing the existing road spur that leads to the existing drill pad. This is the access to the first location that was proposed.

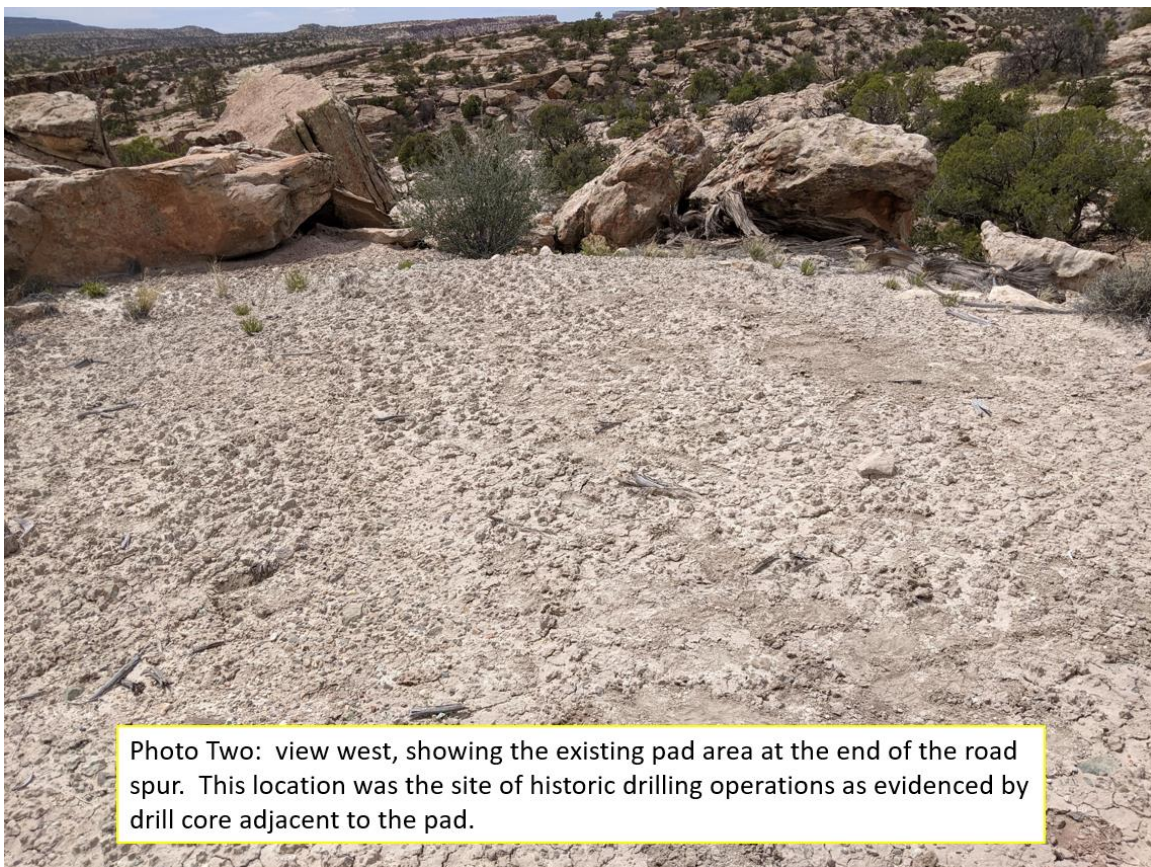
Photo Two: view west, showing the existing pad area at the end of the road spur. This location was the site of historic drilling operations as evidenced by drill core adjacent to the pad.

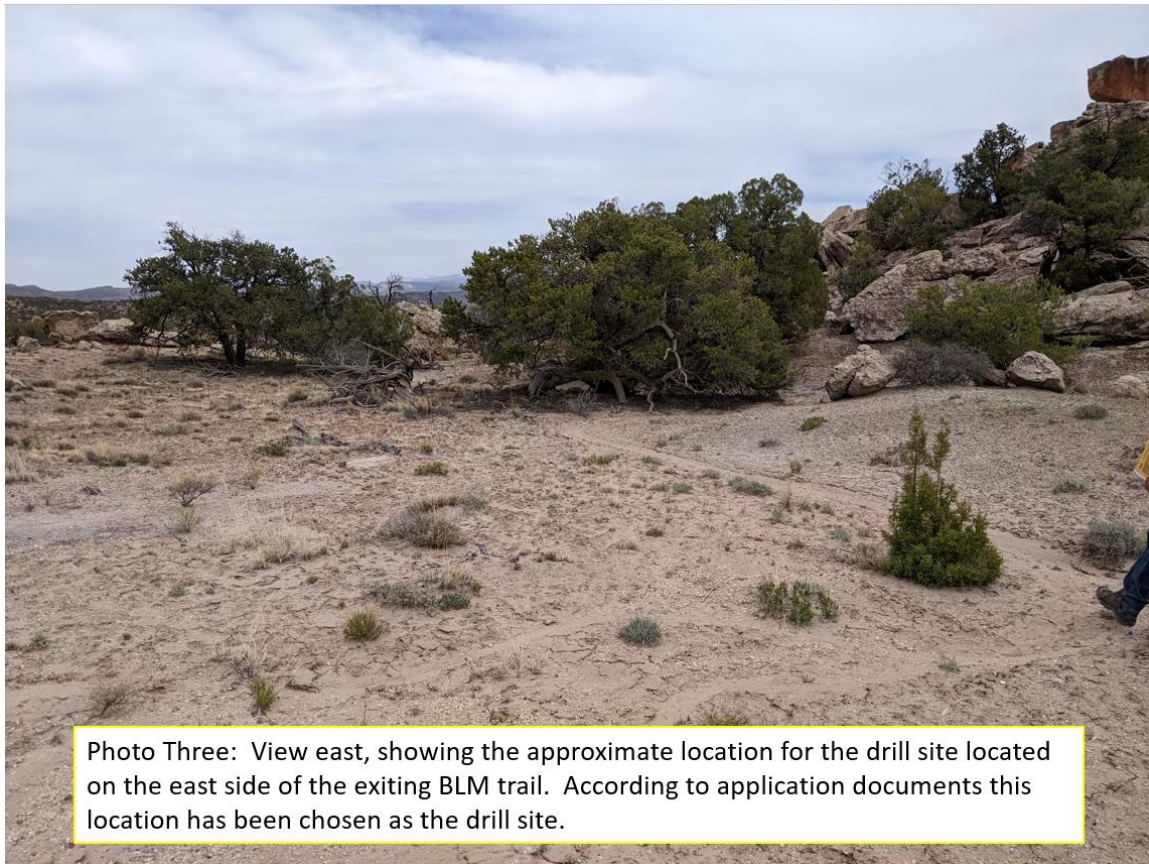
The third and final location observed was a large flat area located just adjacent to the existing BLM trail, directly east of the existing road spur on the east side of the main trail. Similar to the second proposed location the area is fairly flat and sparsely vegetated. The area shows no signs of historic use or previous disturbance and would provide ease of access for construction of the hole as well as ongoing monitoring efforts. According to the application documentation, this site has been chosen as the location for the construction of the monitoring well. The area can be seen in Photo Three.
