MINERALS PROGRAM INSPECTION REPORT

MINE NAME: Leadville Complaint	MINE/PROSPECTING ID#: M-2022-026	MINERAL: UNK	COUNTY: Lake
INSPECTION TYPE: Illegal(Unpermitted Operation)	INSPECTOR(S): Lucas West	INSP. DATE: June 1, 2022	INSP. TIME: 12:56
OPERATOR: Carol Bellhouse	OPERATOR REPRESENTATIVE: Carol Bellhouse	TYPE OF OPERATION: ILL - Illegal	
REASON FOR INSPECTION: Citizen Complaint	BOND CALCULATION TYPE: None	BOND AMOUNT: No Bond Held	
DATE OF COMPLAINT: NA	POST INSP. CONTACTS: None	JOINT INSP. AGENCY: None	
WEATHER: Clear	INSPECTOR'S SIGNATURE:

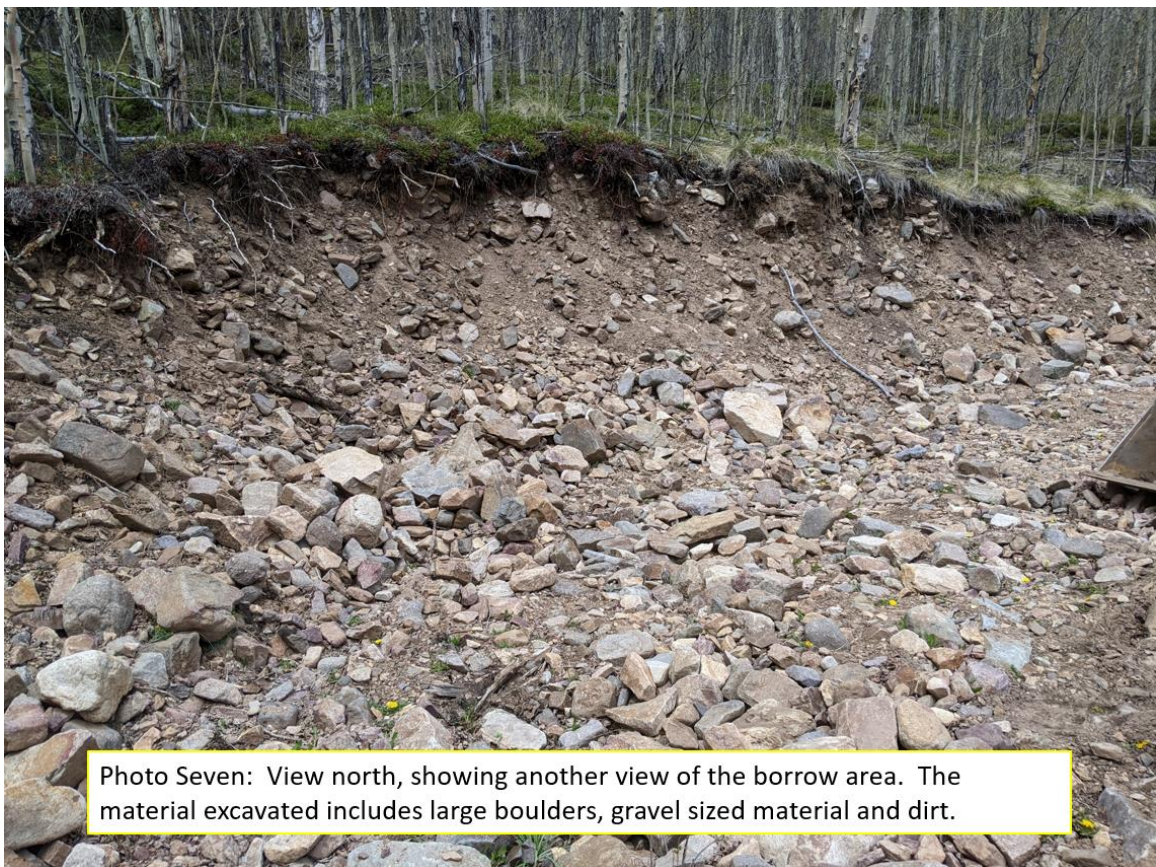
The access road continues past the three pads, to an upper fourth pad. The pad is small, and a backhoe was located in the area. This area appears to be a borrow source for materials needed to construct the pads. The area can be seen in Photos Six and Seven. The footprint of the borrow area appears to coincide with the material located on the lower pad and used in their construction. This suggests that all material for the construction of the pad was generated on site and no material appears to have left the property. No mining related items or equipment was observed in the borrow area.

Photo Six: View northeast showing the upper most pad that was identified to be used as a borrow source. The amount of material used in the lower pad approximately matches the volume of void in this area suggesting that all material was generated and used on site.
