MINERALS PROGRAM INSPECTION REPORT
PHONE: (303) 866-3567

| MINE NAME: File Pit 112 | MINE/PROSPECTING ID#: M-2004-047 | MINERAL: Sand and gravel and | COUNTY: Weld |
| INSPECTION TYPE: Monitoring | INSPECTOR(S): Eric Scott | INSP. DATE: June 14, 2022 | INSP. TIME: 12:00 |

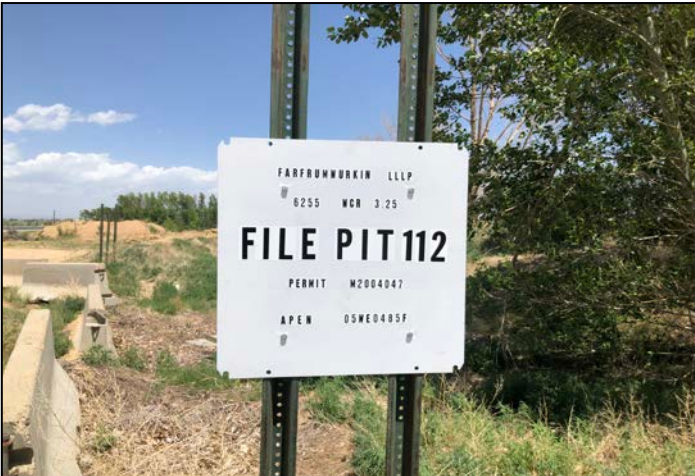
This was a routine monitoring inspection of the 112c Farfromwukin File Pit (M2004-047) conducted by Eric Scott of the Division of Reclamation Mining and Safety (Division/DRMS). This site was last inspected by the Division in March of 2017. Mr. Jon File, the permittee for this site, was present and accompanied DRMS for this inspection. The site identification sign was present at the site entrance (photo 1) and the permit boundary is defined by markers and existing fencing.

Photo 1 – Site identification sign at site entrance.

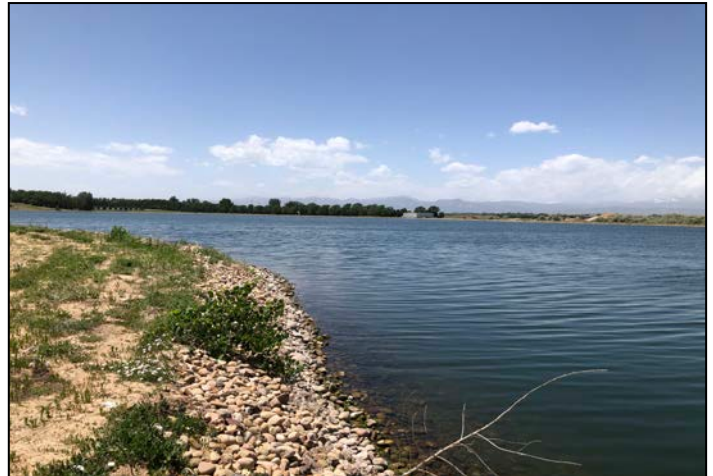
The site is permitted for 314.14 acres with the currently approved post mining land use of developed water resource. The site is divided into east and west pits by WCR 3¼. The liner of the 56 acre reservoir that makes up the majority of the west pit area was approved by the State Engineer's Office on March 7, 2016 (photo 2). There is an approximately 3.7 acre unlined pond to the north of this lined reservoir (photo 3), and an approximately 6 acre area of unlined exposed groundwater located at the northwest corner of the eastern permit area (photo 4). The majority of the eastern permit area has not been affected by mining and remains agricultural, although a significant oil and gas structure is now present in the west-central area of it.

Photo 2 – 56 acre lined reservoir in west permit area.

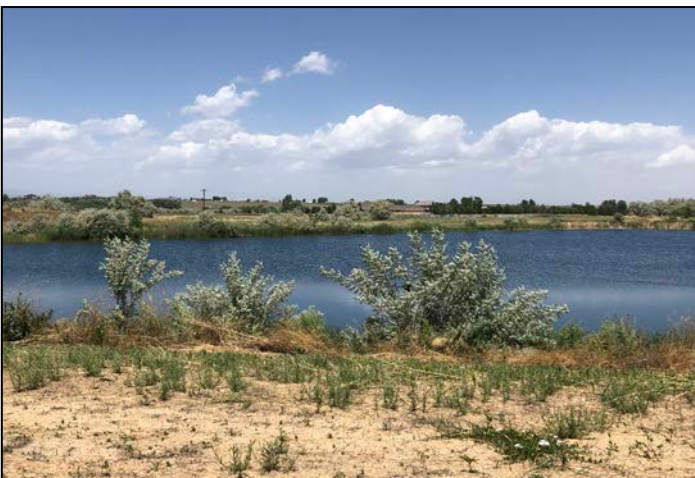
Photo 3 – 3.7 acre unlined pond on north end of west permit area.

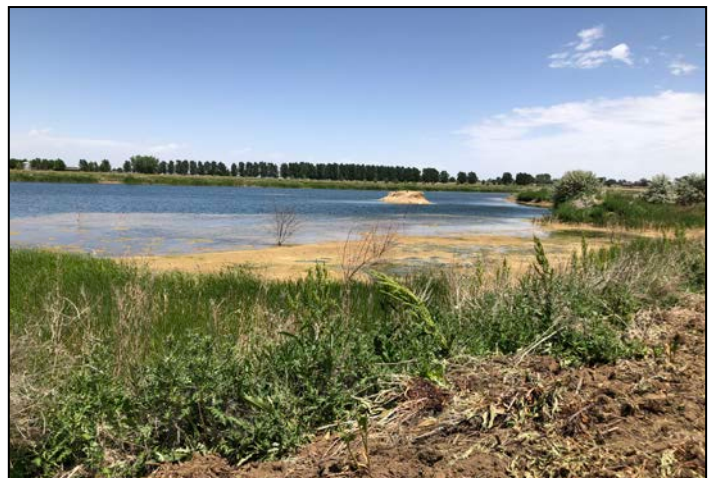
Photo 4 – Approximately 6 acre unlined pond in NW corner of east permit area.

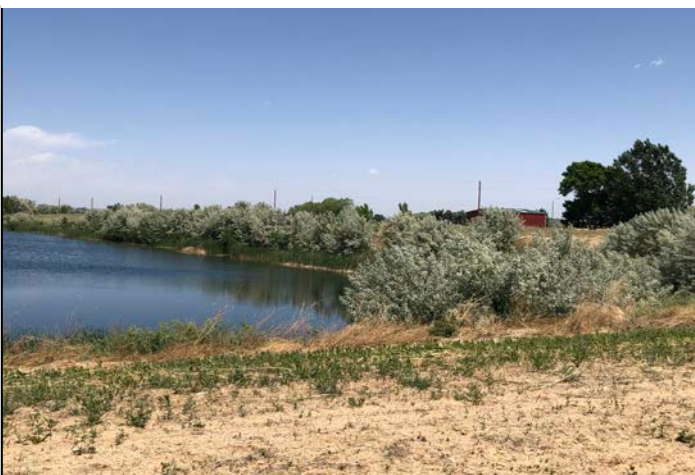
PROBLEM/POSSIBLE VIOLATION: Problem: Russian olive trees are present within or have volunteered into the permit area and are becoming established. This is a problem for failure to employ weed control methods for a state listed noxious weed species within the permitted area, and to reduce the spread of weeds to nearby areas as required by Section 3.1.10 (6) of the rule.

The Division holds a financial warranty in the amount of \$476,500.00, which should be adequate to complete the remaining reclamation based on this inspection. The long-term groundwater augmentation requirements for the site are satisfied by the bond, which includes the cost to construct a clay liner for the eastern pit. The operator has dedicated water rights to the SEO through the submitted SWSP to cover groundwater exposure at the northern unlined pond on the west side of the site until a permanent augmentation plan is approved. As noted on the first page of this report, the many Russian Olive trees that have established on site (photo 5) will need to be eliminated and proof that this has been done provided to DRMS by August 31, 2022.

Photo 5 – Representative photo of large number of Russian Olive trees that will need to be removed by corrective action date of 8/31/22.

CORRECTIVE ACTIONS: Russian Olive trees within the permit area should be removed and proof that this has been done provided to DRMS by the corrective action date.

CORRECTIVE ACTION DUE DATE: 8/31/22

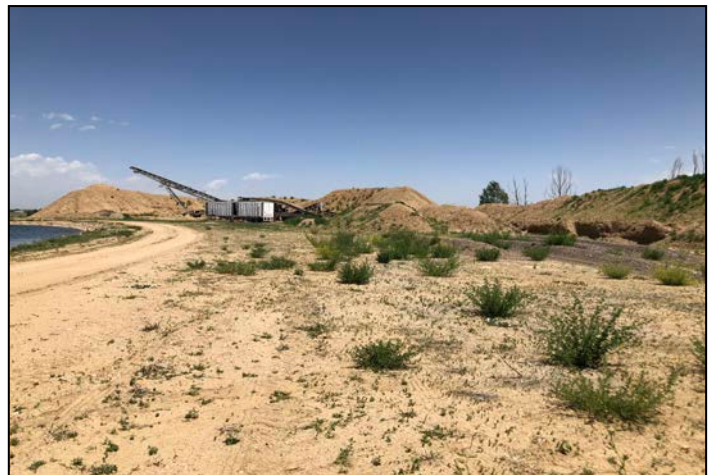
The site was inactive at the time of this inspection, however, there is a small area (approx. 4 acres) at the northeast corner of the lined reservoir where material has been processed and staged to be used in the final development/reclamation of the site (photo 6). Although DRMS acknowledges that the south pit has been successfully lined, there is still quite a significant amount of earthmoving, grading, and seeding of affected areas to be completed in order to achieve the currently approved reclamation plan and allow for the DRMS permit to be released. In addition, permanent augmentation of the unlined groundwater areas will also need to be addressed to the State Engineer's Office satisfaction prior to the release of the DMRS permit.

Photo 6 – Approximately 4 acre processing and stockpile area located near NE corner of lined reservoir.
