**MINERALS PROGRAM INSPECTION REPORT**  
**PHONE: (303) 866-3567**

| <b>MINE NAME:</b><br>Climax Mine | <b>MINE/PROSPECTING ID#:</b><br>M-1977-493 | <b>MINERAL:</b><br>Molybdenum | <b>COUNTY:</b><br>Lake, Summit |
| <b>INSPECTION TYPE:</b><br>Multi Person Inspection | <b>INSPECTOR(S):</b><br>Amy Yeldell | <b>INSP. DATE:</b><br>June 16, 2022 | <b>INSP. TIME:</b><br>10:30 |

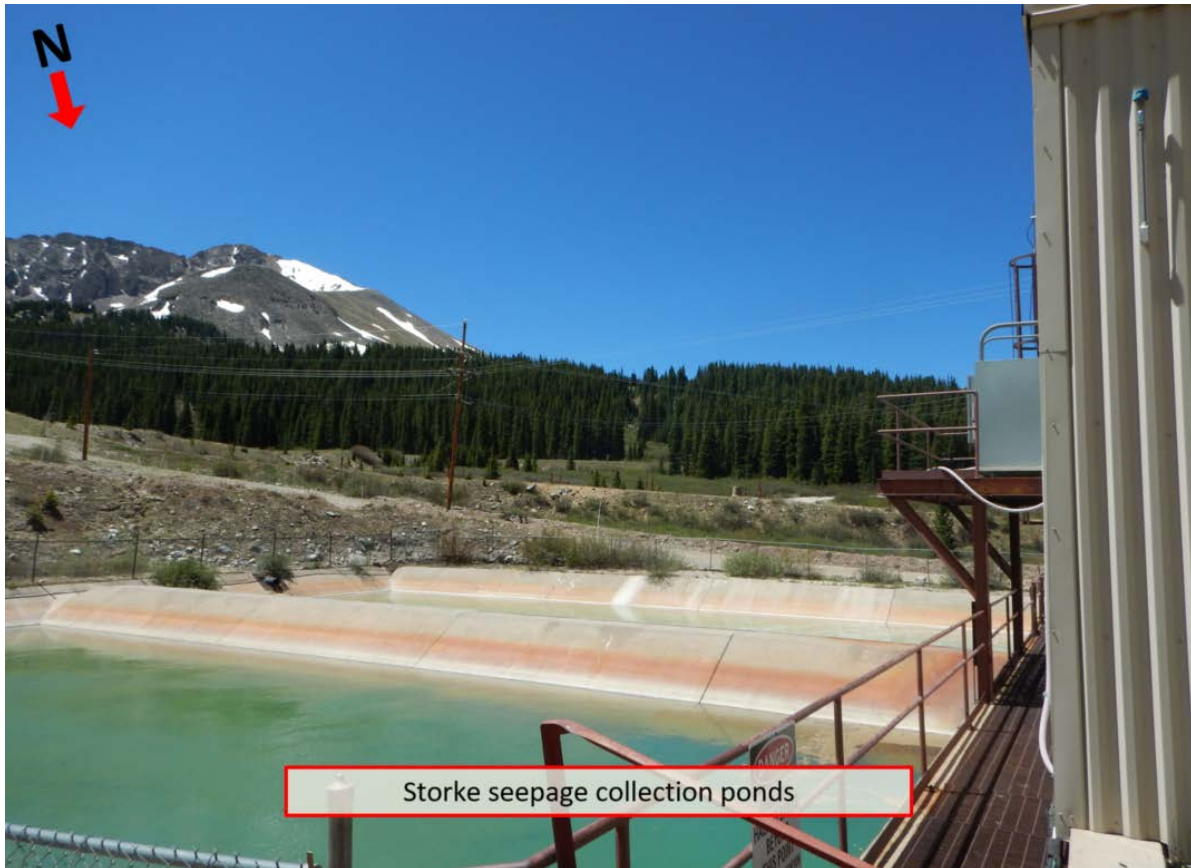
The storke wastewater pump system is an EPF that works alongside the 5-shaft Pump system to protect the Arkansas watershed. Seepage water and stormwater collected from the 5-Shaft next reports to the Storke Wastewater Pump System where it is pumped to the Tenmile basin for treatment and discharge. There are also two concrete lined ponds that collect the seepage and stormwater from the Storke Yard. These ponds are completely fenced and concrete was in good shape. Water was observed entering the ponds through discharge pipe to the pond at a low rate. That water is then pumped to the ETDL where it mixed with other mine collected water prior to treatment in the Tenmile Basin. The floor within the building was wet during the inspection but no apparent source of a leak was identified. One of the four pump pedestals was empty, so potentially there was a repair in progress. All water reports to the in floor sumps which appeared to be effectively managing the water.

Storke seepage collection ponds

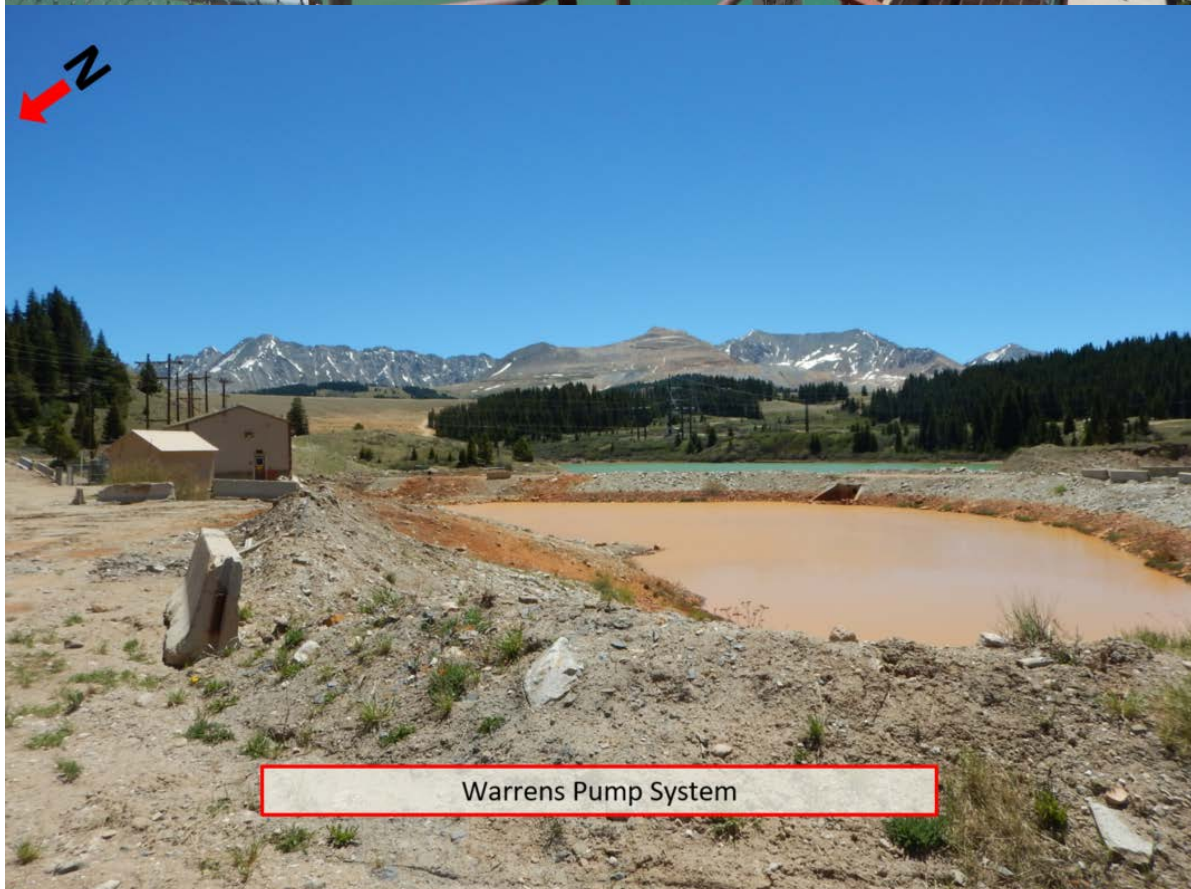
Warrens Pump System (Warrens Station) is located adjacent to Robinson Lake. It collects water from Tim's pond and 1 Dam seepage water where it is to be settled and then pumped into the SDP located within the Tenmile basin. The overall condition of the pond is good, water was below the outlet height and banks appear stable.

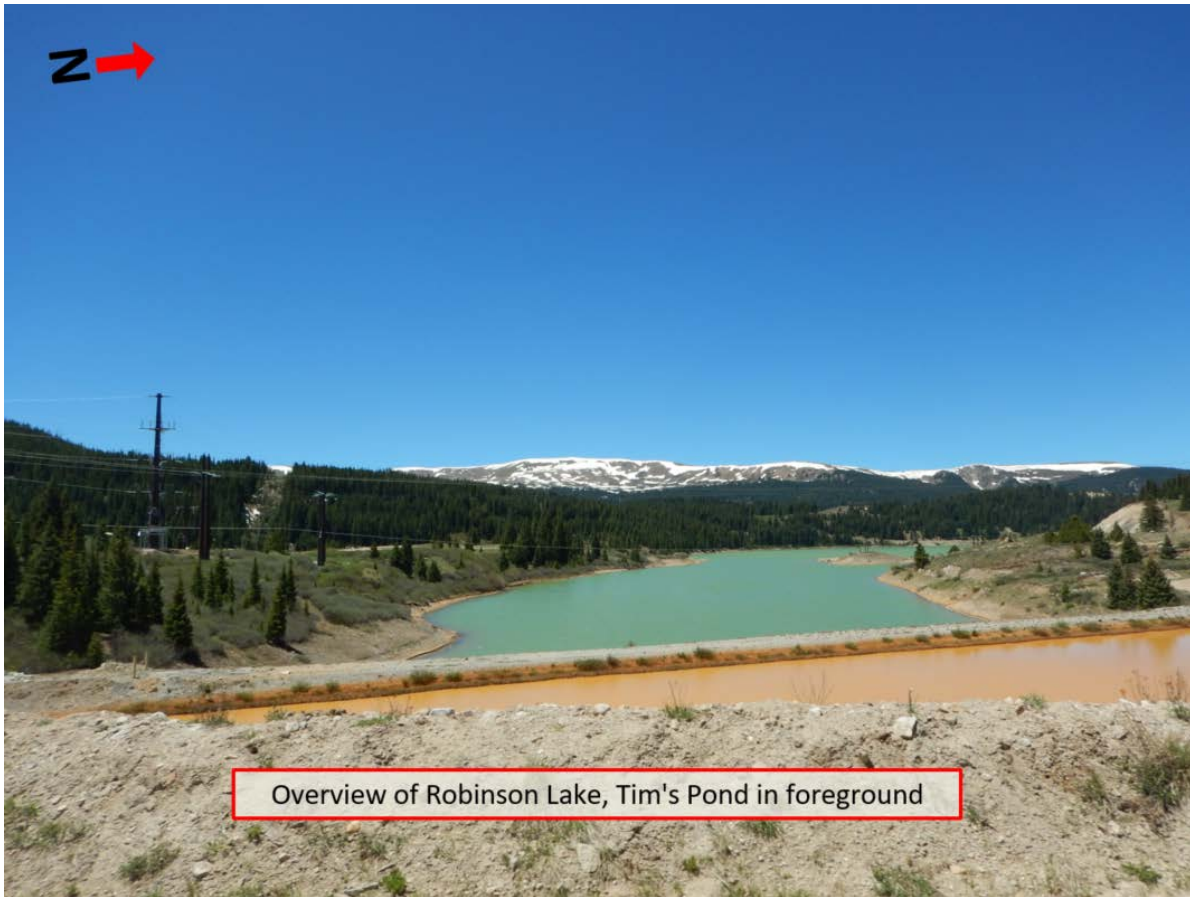
Robinson Lake is located within the Eagle watershed. Robinson Lake is used as the primary water storage facility. Water collected in the lake is pumped back to the mill to be used as process water and re-circulated throughout the mill. Lime is added to the pond to pretreat the water prior to it reaching the mill. There is a noticeable color difference between Tim's pond, Warren's pond and Robinson Lake based on differences in water chemistry. Overall the lake appears functional with no signs of excessive bank erosion or sluffing.

Overview of Robinson Lake, Tim's Pond in foreground

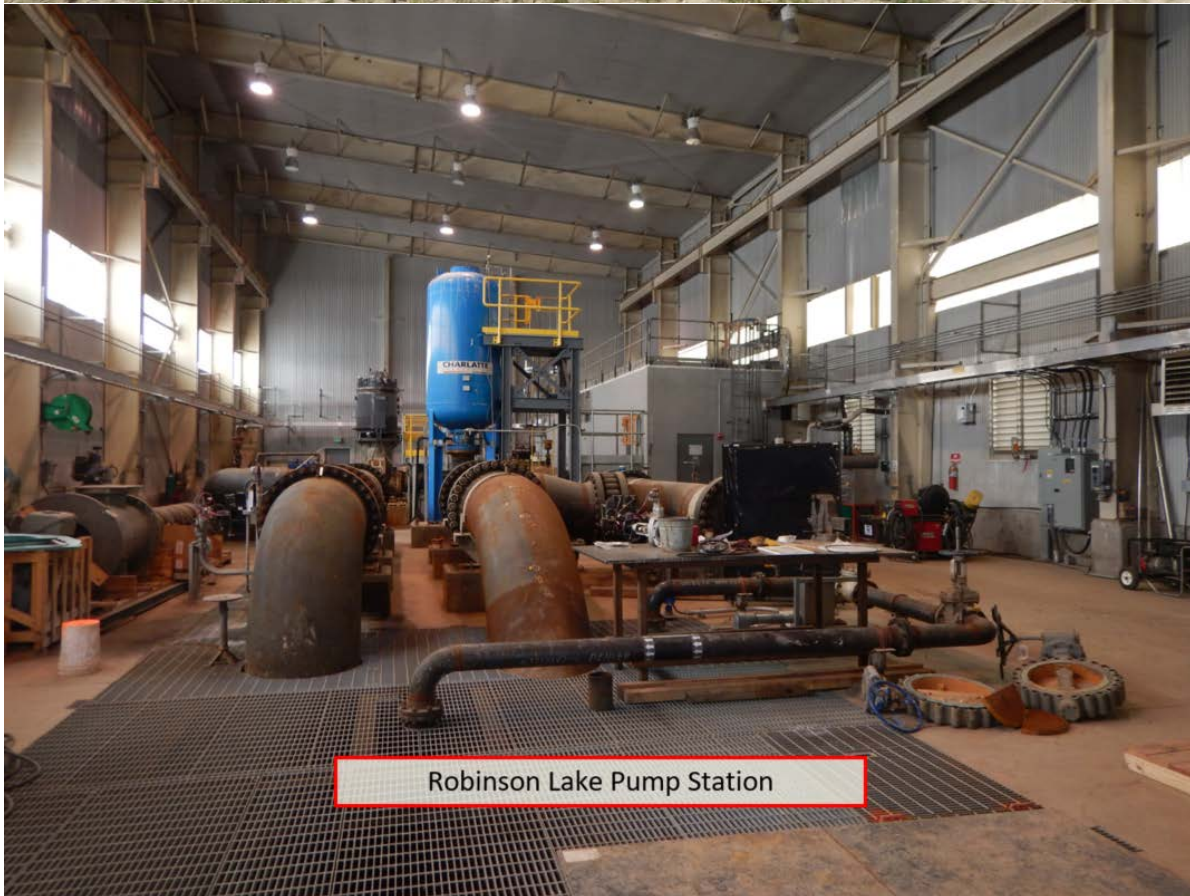
Robinson Lake Pump Station

At the base of Robinson Dam is a seepage collection system. The dam face appeared to be in good shape with no evidence of settling, slumping or erosion. Any water is collected in the small pond at the base of the dam then pumped back into Robinson Lake for future use. The pump station pond was dry, well vegetated and stable. The pump station building itself was only briefly inspected due to noise inside the buildings. Pumps were actively operating providing water to the mill. No leaks were identified and good housekeeping practices were in place.
