## MINERALS PROGRAM INSPECTION REPORT

<b>MINE NAME:</b> West Side Placer	<b>MINE/PROSPECTING ID#:</b> M-2016-081	<b>MINERAL:</b> Gold, niobium (colorado), rare earths	<b>COUNTY:</b> Moffat
<b>INSPECTION TYPE:</b> Monitoring	<b>INSPECTOR(S):</b> Zach Trujillo	<b>INSP. DATE:</b> June 8, 2022	<b>INSP. TIME:</b> 14:00
<b>OPERATOR:</b> AuPt Industries LLC	<b>OPERATOR REPRESENTATIVE:</b> Peter Freedman	<b>TYPE OF OPERATION:</b> 110(2) - Hard Rock Limited Impact	
<b>REASON FOR INSPECTION:</b> Normal I&E Program	<b>BOND CALCULATION TYPE:</b>	<b>BOND AMOUNT:</b> \$46,110.00	
<b>DATE OF COMPLAINT:</b> NA	<b>POST INSP. CONTACTS:</b> None	<b>JOINT INSP. AGENCY:</b> None	
<b>WEATHER:</b> Clear	<b>INSPECTOR'S SIGNATURE:</b>

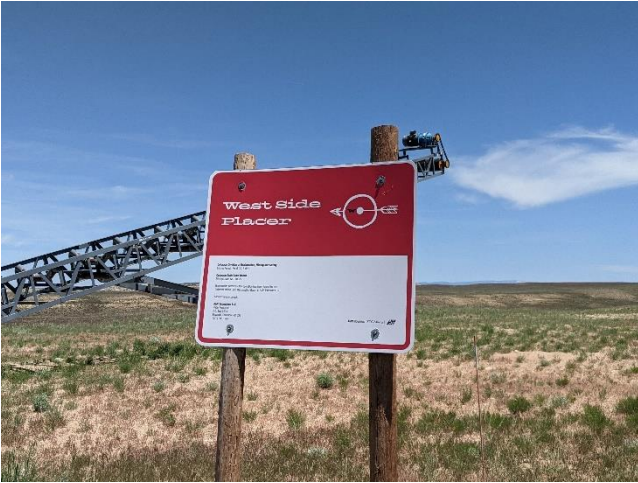
The mine identification sign remains in place in compliance with Rule 3.1.12 and is located at the northern part of the permit boundary along County Road 88. Affected area boundary markers were observed throughout the boundary of the site.

Mine identification sign.

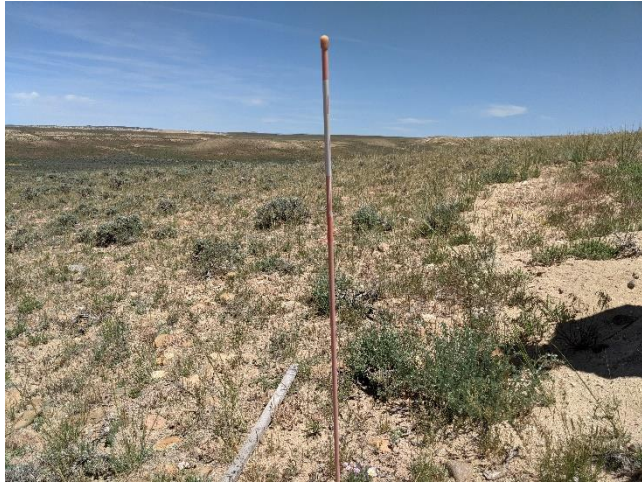
Affected boundary marker.

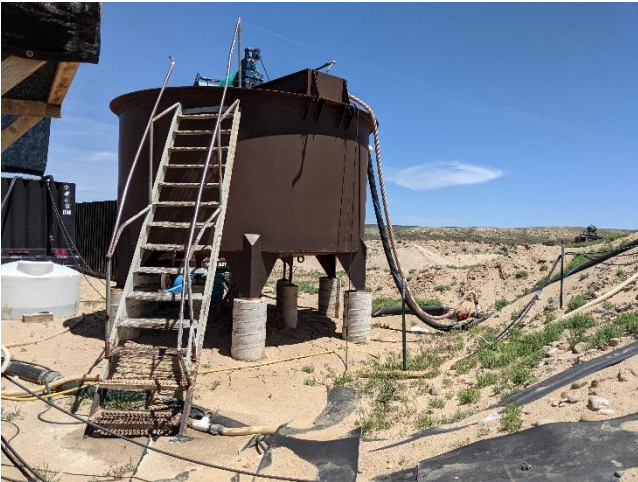
Flocculant mixing tank.

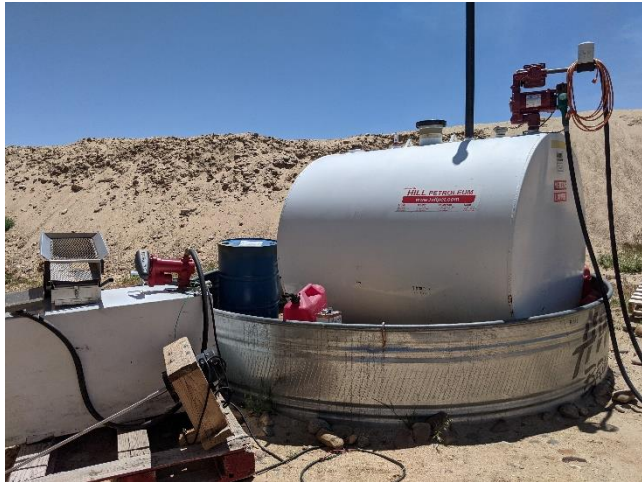
Fuel storage.

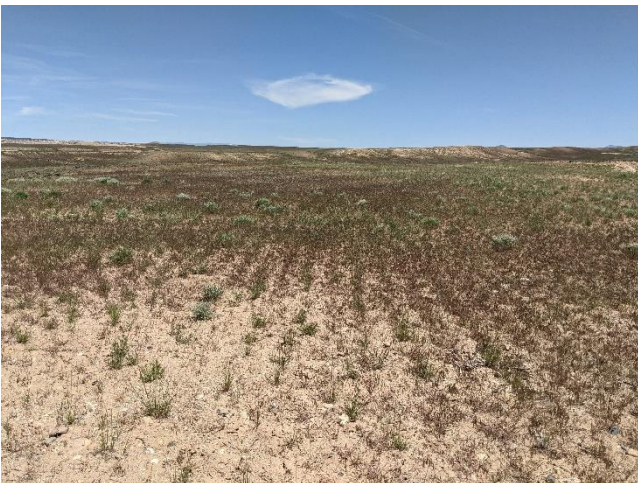
The northern part of the mine area has received reclamation. Vegetation establishment was observed. The northern portion of the permit which has not received reclamation is being used for equipment storage and processing facilities. There is a storage container used for tool and flocculant storage. A flocculant mixing tank is adjacent to the storage container and a larger tank is used to store the excess mixed flocculent that is added to the system. Additional tanks are used for water storage and circulation to feed the plant. There is also a permitted well on site for access to additional water. Processing equipment includes a hopper, elevated trommel, riffles and a sand screw in addition to a few small conveyors, water circulation equipment and shaker tables. The fuel located on site is stored in secondary containment and no issues were observed.

Reclamation along northern end of permit.

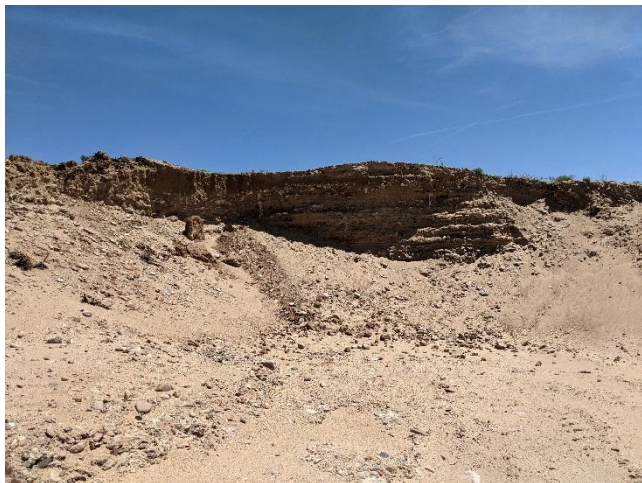
Active mining is occurring in the southern most portion of the permit boundary. The current excavated cut is approximately 20 feet deep. The area adjacent and to the east of the current active mining area has been reclaimed and reseeded. Visible vegetation was observed but sparse. The operator stated that additional seeding is planned in the area however it may be re-mined as processing onsite has become more refined since the original excavation of this area. The existing settling pond located on the east side of the mine remains in place and in use. No noxious weeds or erosional features of note were observed on site during the inspection.

Current pit excavation.
