MINERALS PROGRAM INSPECTION REPORT
PHONE: (303) 866-3567

MINE NAME: Hertzog Pit	MINE/PROSPECTING ID#: M-1981-276	MINERAL: Sand and gravel	COUNTY: Moffat
INSPECTION TYPE: Preoperation Inspection	INSPECTOR(S): Zach Trujillo	INSP. DATE: June 8, 2022	INSP. TIME: 09:00
OPERATOR: Bower Brothers Construction, Inc.	OPERATOR REPRESENTATIVE: Steve Baker	TYPE OF OPERATION: 112c - Construction Regular Operation	
REASON FOR INSPECTION: Preoperation Inspection	BOND CALCULATION TYPE:	BOND AMOUNT: \$52,054.00	
DATE OF COMPLAINT: NA	POST INSP. CONTACTS: None	JOINT INSP. AGENCY: None	
WEATHER: Clear	INSPECTOR'S SIGNATURE:

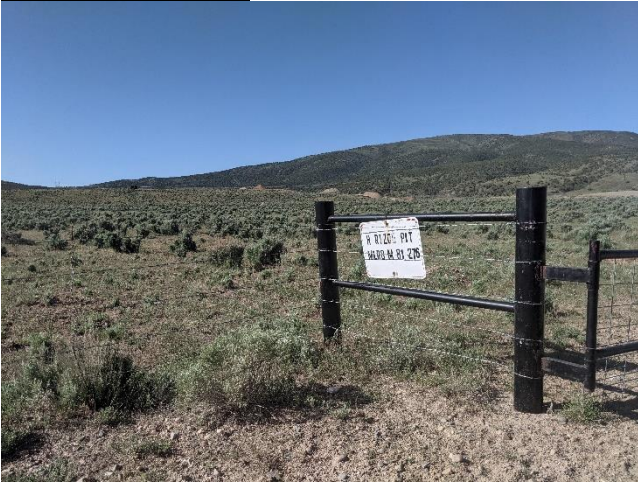
The mine identification sign and affected area boundary markers are in place and in compliance with Rule 3.1.12. The sign is located at the entrance to the permit boundary from County Road 74. The scale and scale house along the entrance remain on site.

Hertzog Pit identification sign.

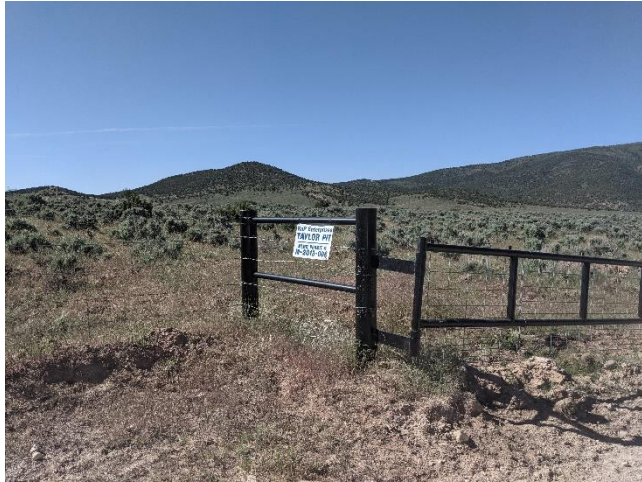
Taylor Pit identification sign.

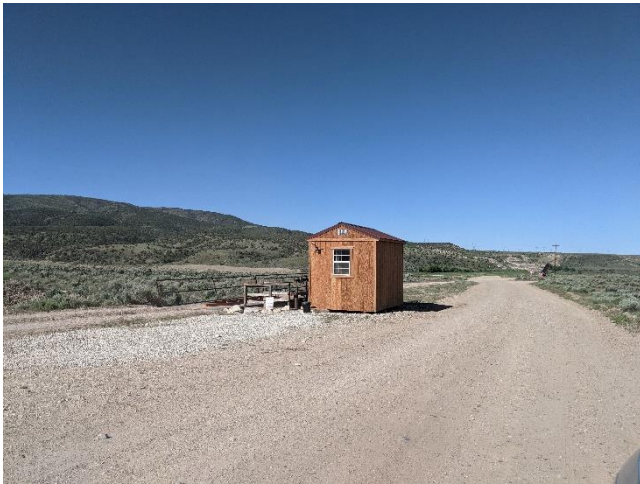
Scale and weigh station.

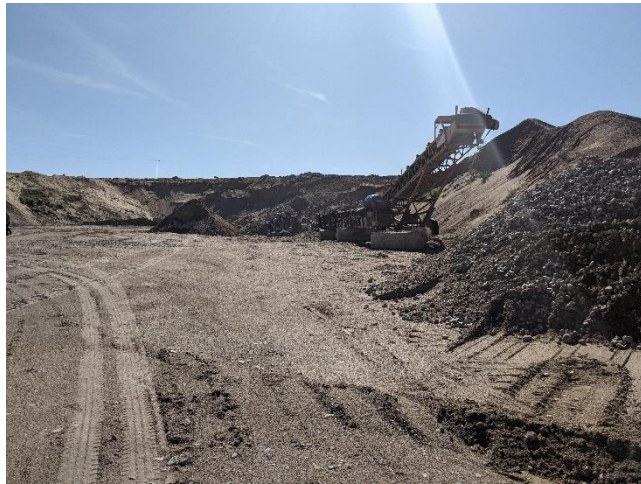
Equipment and current gravel stockpile area is located at the entrance of the excavated pit and neatly organized. Conveyor and skidsteer were located in this area. Current operations were occurring in the southeastern portion of the approved affected area. No activating mining was occurring during the inspection.

Stockpile area.

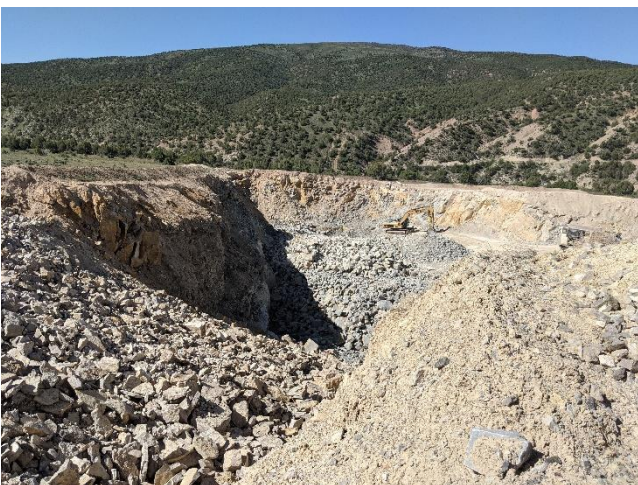
As noted earlier, the Taylor Pit was inspected as part of the pre-operation inspection. The Taylor Pit was also inspected as part of the Division's normal frequency requirement. Since no additional affected area is being proposed with AM-01 in relation to the Taylor Pit, additional details regarding the Taylor Pit is documented in Division's June 8, 2022 inspection report. No issues were noted at the Taylor Pit.

Taylor Pit.
