**MINERALS PROGRAM INSPECTION REPORT**  
**PHONE: (303) 866-3567**

<b>MINE NAME:</b> Taylor Pit	<b>MINE/PROSPECTING ID#:</b> M-2013-006	<b>MINERAL:</b> Limestone (general)	<b>COUNTY:</b> Moffat
<b>INSPECTION TYPE:</b> Monitoring	<b>INSPECTOR(S):</b> Zach Trujillo	<b>INSP. DATE:</b> June 8, 2022	<b>INSP. TIME:</b> 09:30
<b>OPERATOR:</b> Bower Brothers Construction, Inc.	<b>OPERATOR REPRESENTATIVE:</b> Steve Baker	<b>TYPE OF OPERATION:</b> 110c - Construction Limited Impact	
<b>REASON FOR INSPECTION:</b> Normal I&E Program	<b>BOND CALCULATION TYPE:</b> None	<b>BOND AMOUNT:</b> \$33,279.00	
<b>DATE OF COMPLAINT:</b> NA	<b>POST INSP. CONTACTS:</b> None	<b>JOINT INSP. AGENCY:</b> None	
<b>WEATHER:</b> Clear	<b>INSPECTOR'S SIGNATURE:</b>

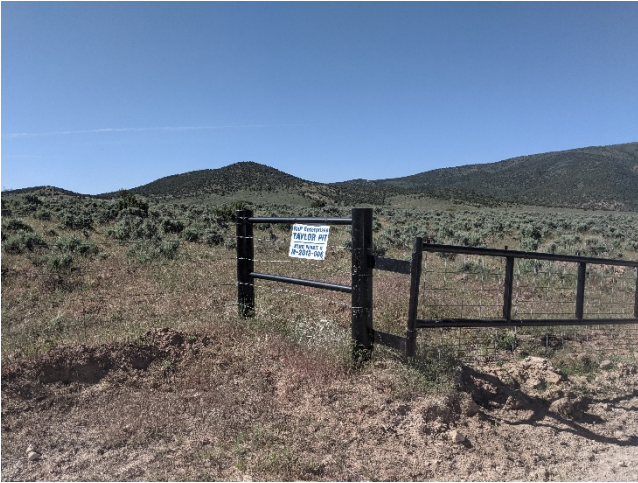
The mine identification sign and affected area boundary markers are in place and in compliance with Rule 3.1.12. The sign is located at the entrance to the permit boundary.

Mine identification sign.

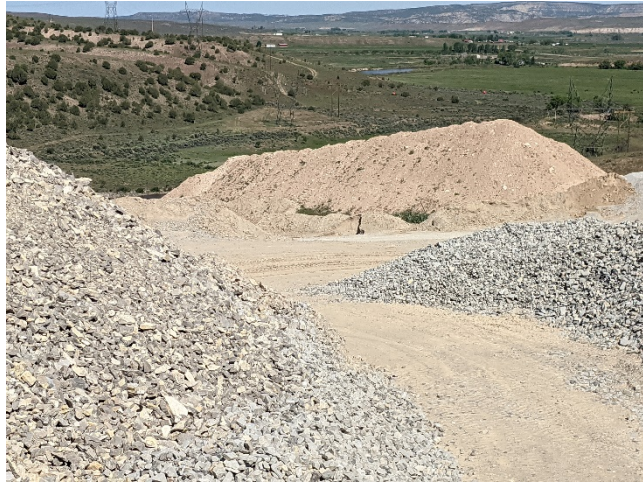
The site was not active at the time of the inspection. Crusher and support equipment were on site near the stockpile area. Stockpiles are located just north of the active pit area. Topsoil piles were inspected and located just adjacent to the stockpile area. Topsoil was lightly vegetated however piles were stable and contained. Fuel storage onsite was also inspected. The fuel is contained in a double walled secondary containment tank.

Stockpile area.

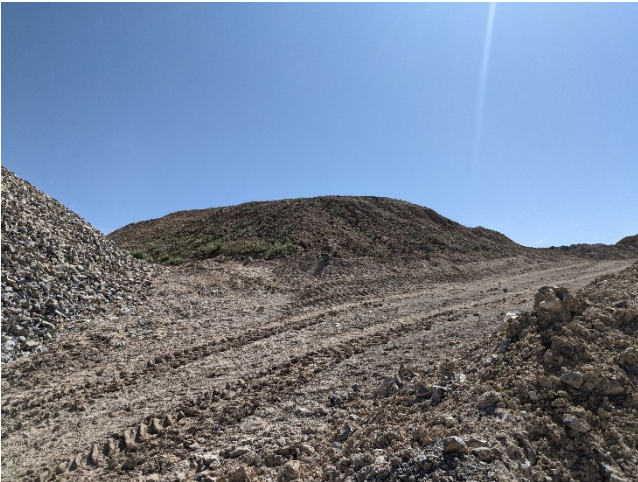
Topsoil pile.

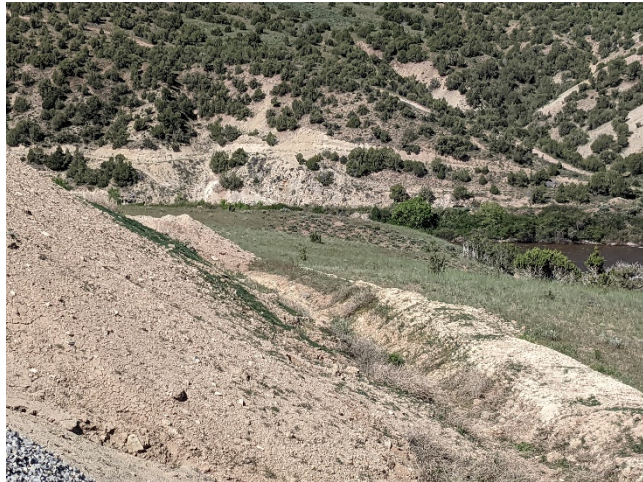
Containment berm.

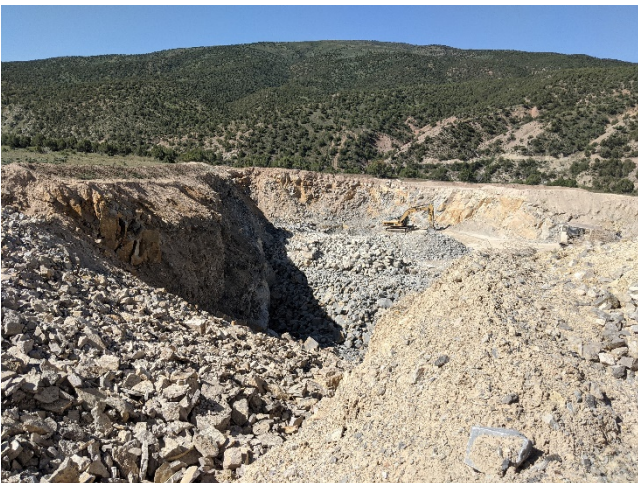
The affected area is encompassed downslope by containment berms. No erosion was observed throughout the site and no issues were observed with the containment berm. Mining is currently progressing in a northeasterly direction in multiple benches. Recent mining has occurred along the upper bench and is expected to continue until reaching the current pit floor elevation. The pit floor is currently approximately 40-50 feet deep. An excavator was observed at the pit floor but was idle during the inspection. No active mining was occurring.

Pit area.
