MINERALS PROGRAM INSPECTION REPORT

MINE NAME: Vermillion Creek Borrow Area	MINE/PROSPECTING ID#: M-2015-027	MINERAL: Borrow material for and reclamation only	COUNTY: Moffat
INSPECTION TYPE: Monitoring	INSPECTOR(S): Zach Trujillo	INSP. DATE: June 8, 2022	INSP. TIME: 12:00
OPERATOR: Rancho Greco Limited	OPERATOR REPRESENTATIVE: None	TYPE OF OPERATION: 110c - Construction Limited Impact	
REASON FOR INSPECTION: Normal I&E Program	BOND CALCULATION TYPE: Complete Bond	BOND AMOUNT: \$29,206.00	
DATE OF COMPLAINT: NA	POST INSP. CONTACTS: None	JOINT INSP. AGENCY: None	
WEATHER: Clear	INSPECTOR'S SIGNATURE:

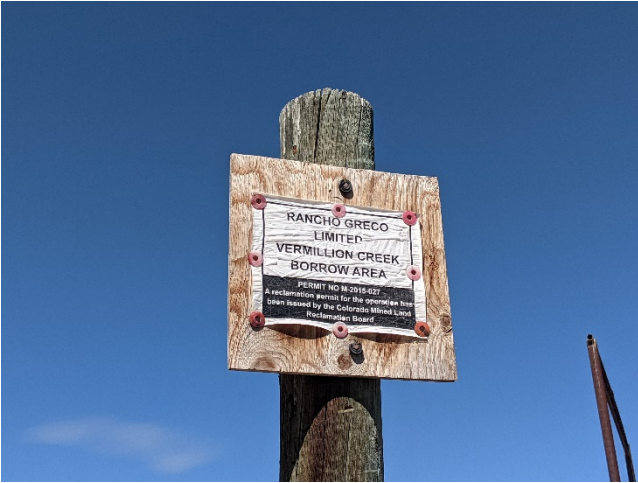
The mine identification sign and affected area boundary markers are in place and in compliance with Rule 3.1.12. The sign is located along a wooden post at the entrance to the permit boundary from County Road 74.

Mine identification sign.

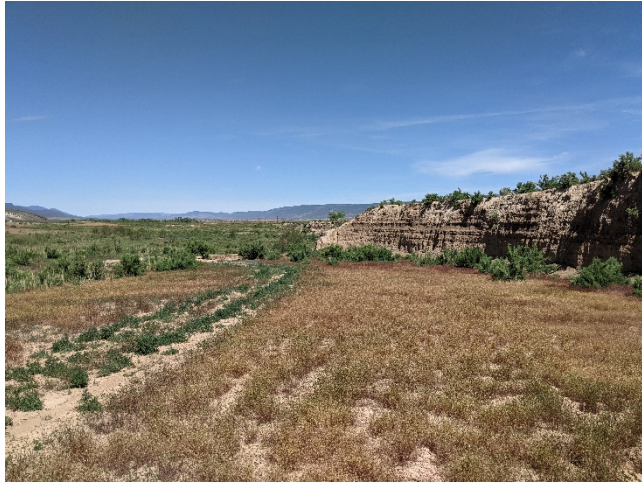
Highwall in eastern region.

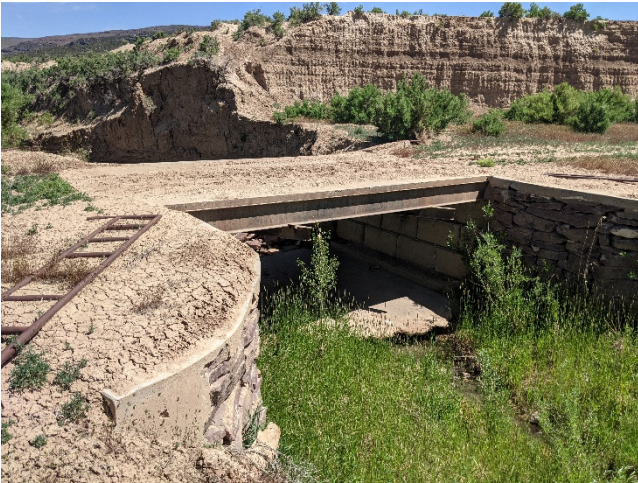
No additional reclamation has been conducted from the previous inspection report performed by the Division dated July 17, 2018 based on the annual reports for the Vermillion Creek Borrow Area. The affected area is split into two regions by a creek. A concrete pad supported by beams acts as a bridge crossing to access one region to another. The highwall cut, which is located in the eastern region within the permit boundary, remains stable with no slumping or erosion observed. The western region is relatively flat and no erosional features were observed as well. Vegetation from native encroachment has begun to establish itself along the entire affected area. The land adjacent to the creek is well vegetated with cat tails and other riparian vegetation. No stockpiles or equipment were observed on site. Overall, the site remains stable with no issues observed.

Bridge crossing.

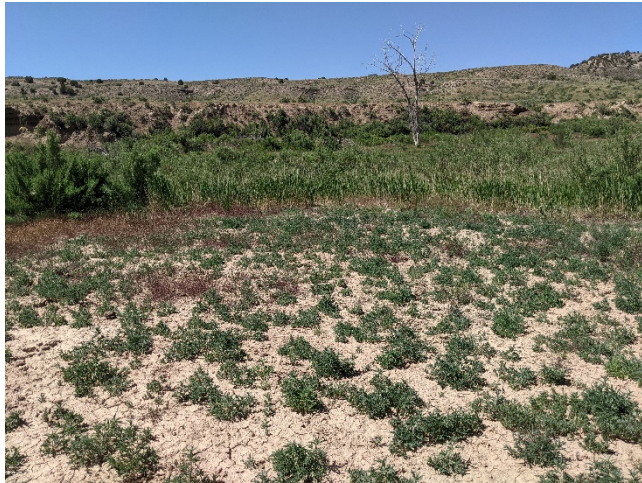
Western region.
