**MINERALS PROGRAM INSPECTION REPORT**  
**PHONE: (303) 866-3567**

<b>MINE NAME:</b> Tucker Aggregate Pit	<b>MINE/PROSPECTING ID#:</b> M-1980-002	<b>MINERAL:</b> Sand and gravel	<b>COUNTY:</b> Weld
<b>INSPECTION TYPE:</b> Monitoring	<b>INSPECTOR(S):</b> Peter Hays	<b>INSP. DATE:</b> April 5, 2022	<b>INSP. TIME:</b> 10:00
<b>OPERATOR:</b> Connell Resources, Inc.	<b>OPERATOR REPRESENTATIVE:</b> Kevin Anderson	<b>TYPE OF OPERATION:</b> 112c - Construction Regular Operation	
<b>REASON FOR INSPECTION:</b> Normal I&E Program	<b>BOND CALCULATION TYPE:</b> Partial Bond	<b>BOND AMOUNT:</b> \$131,400.00	
<b>DATE OF COMPLAINT:</b> NA	<b>POST INSP. CONTACTS:</b> None	<b>JOINT INSP. AGENCY:</b> None	
<b>WEATHER:</b> Windy	<b>INSPECTOR'S SIGNATURE:</b>

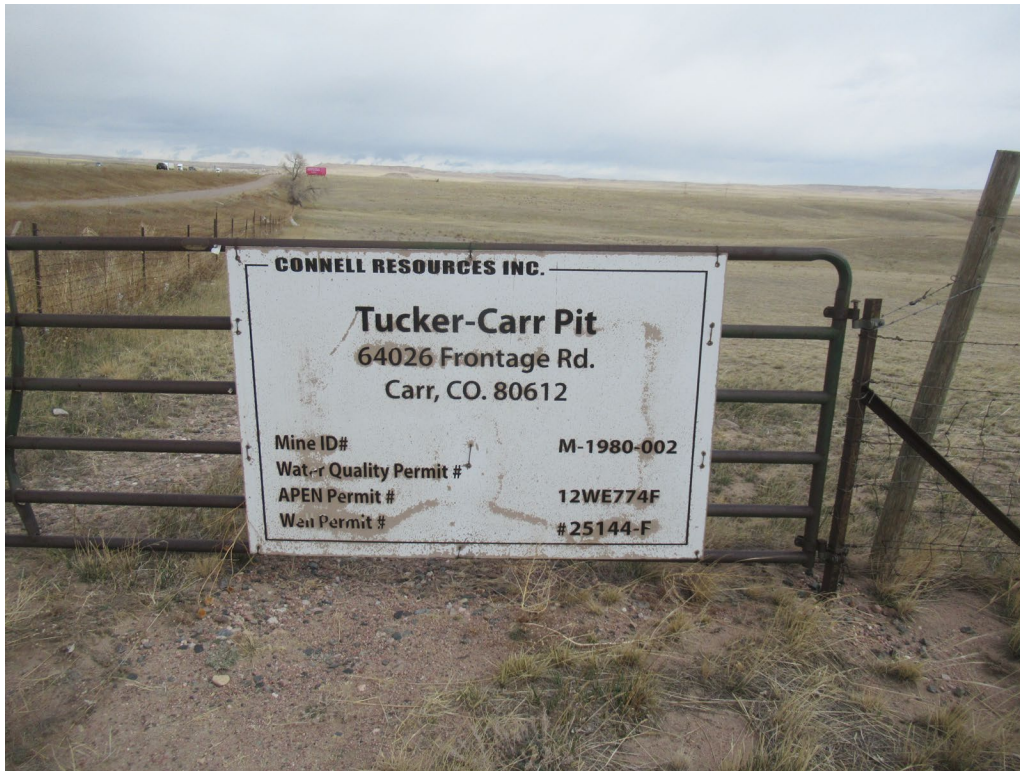
The site is an 112c operation permitted for 215.08 acres. The site was inactive during the inspection. Stockpiles of material were observed in the northern, middle and southern portions of the site. The size and number of stockpiles have been reduced since the last inspection. No processing equipment was observed at the site. There are no mining excavation areas remaining at the site. The existing stockpiles will be removed based on market demands. As the stockpiles are removed, the site will be reclaimed and released to reduce the size of the permitted area. The water well and storage tanks were observed in the middle of the site along the east side of the site. The required mine sign and boundary markers were observed as required by Rule 3.1.12.

Tucker Pit mine sign

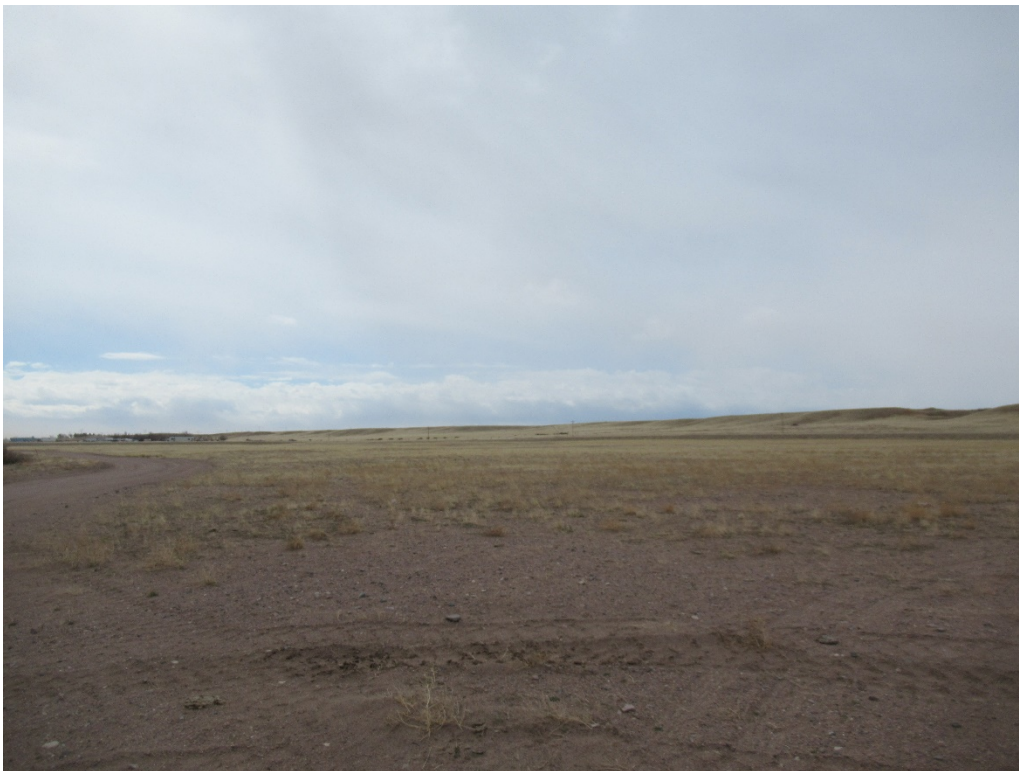
View of the southern portion of the site looking south

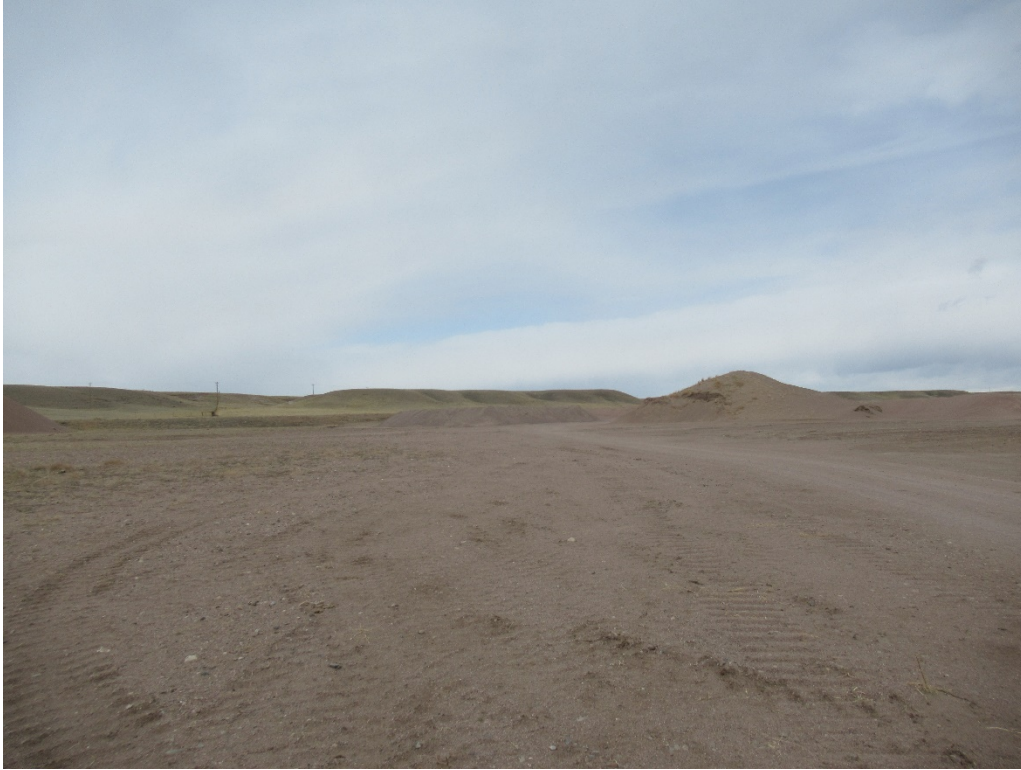
View of the stockpiles located in the middle of the site

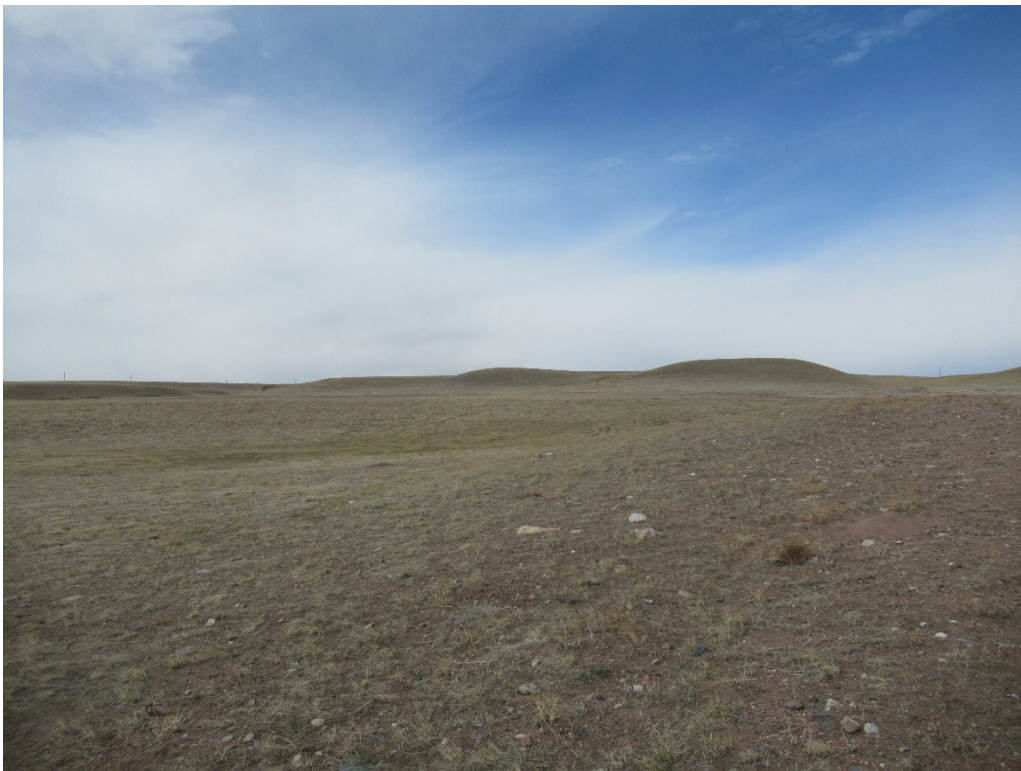
View of the northern portion of the site looking west

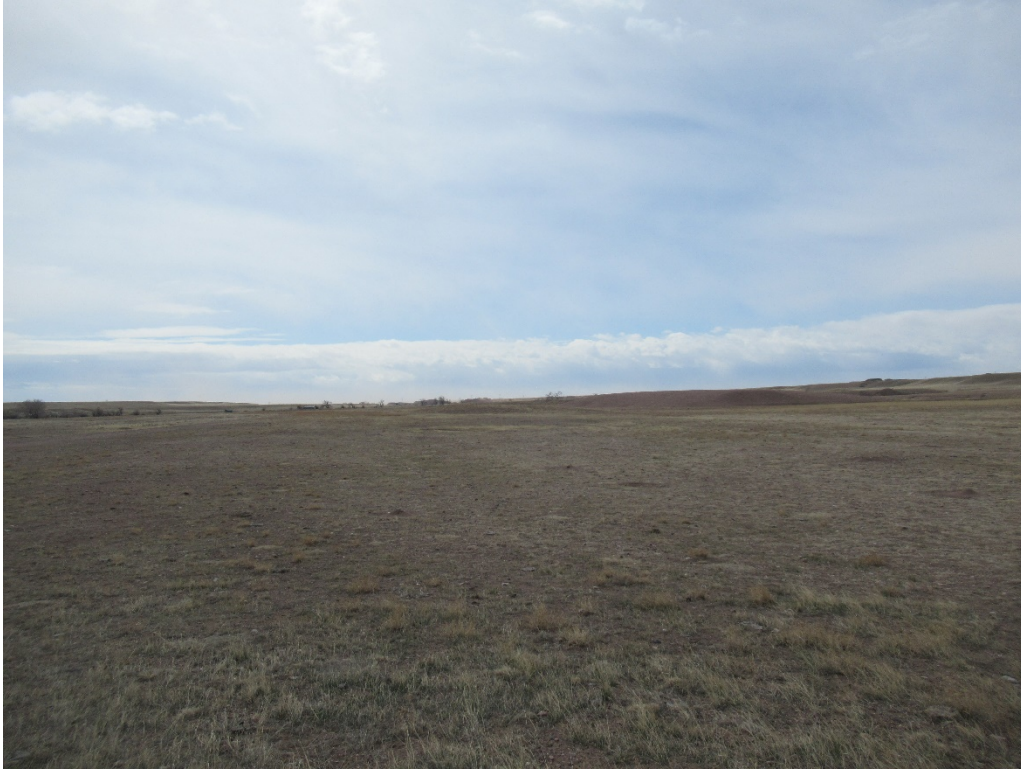
View of the northern portion of the site looking south
