MINERALS PROGRAM INSPECTION REPORT

MINE NAME: Howe Pit	MINE/PROSPECTING ID#: M-1978-052	MINERAL: Sand and gravel	COUNTY: Adams
INSPECTION TYPE: Monitoring	INSPECTOR(S): Nikie Gagnon	INSP. DATE: June 15, 2022	INSP. TIME: 09:00
OPERATOR: City & County of Denver, Board of Water Commissioners	OPERATOR REPRESENTATIVE: Brad Piede	TYPE OF OPERATION: 112c - Construction Regular Operation

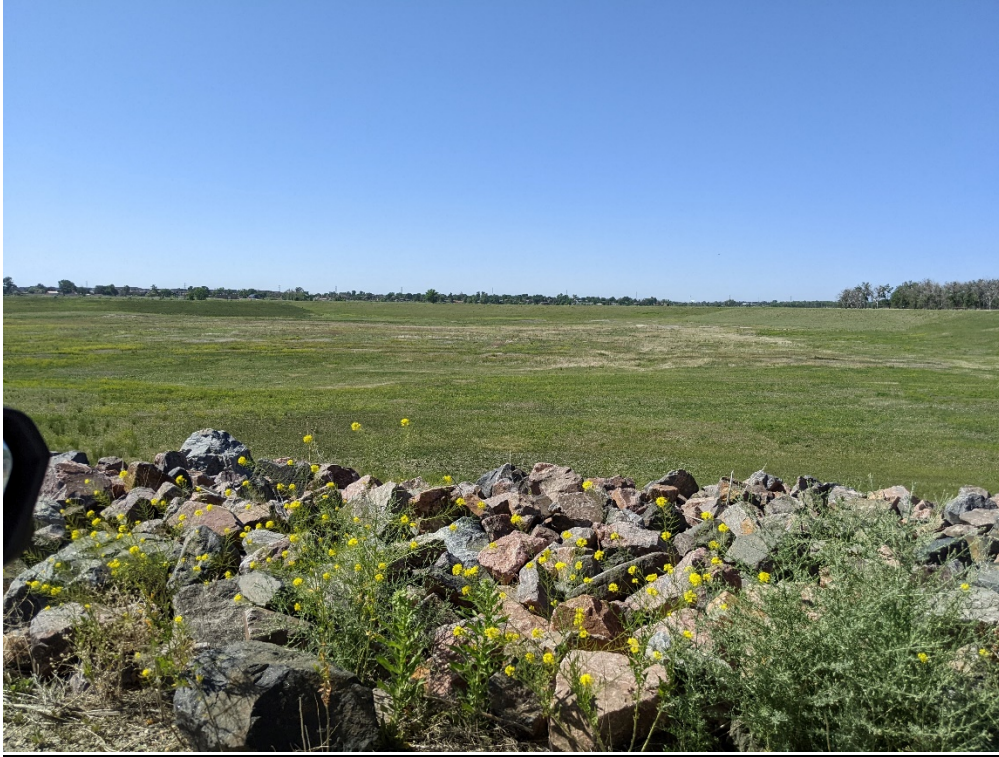
Looking southeast across Reservoir B

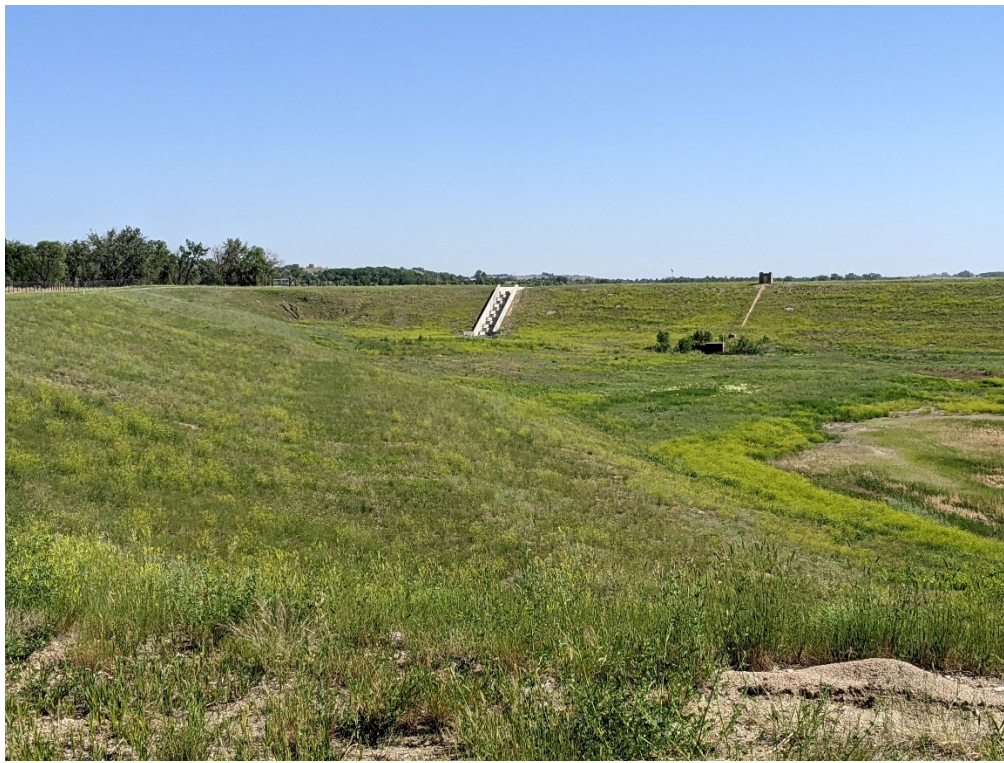
The slopes of Reservoir A and B vary in steepness, graded to a 3:1 or less, which is consistent with the grading requirements of Rule 3.1.5 (7) of the Construction Materials Rules and Regulations. The South Platte flooded in 2013 and damaged the western pit slopes of both reservoirs. These slopes have been regraded and drill seeded.

Looking north at overflow drain between Reservoir A & B. Flood repair occurred on western slopes.

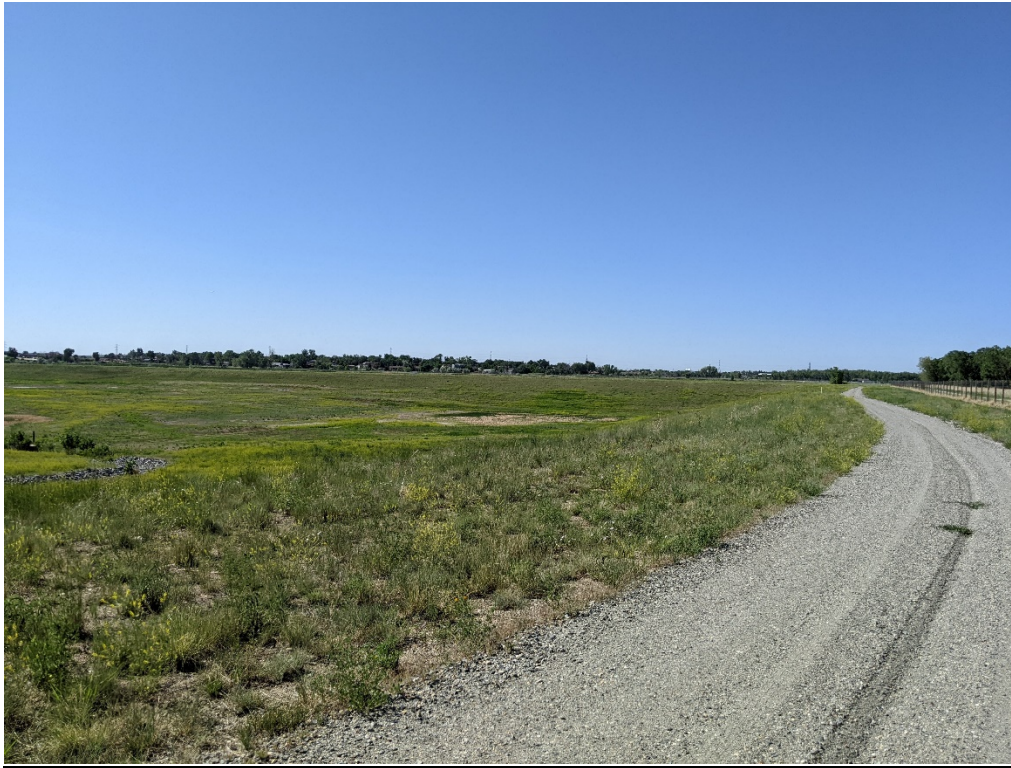
There is a gravel access road around the two reservoirs that will remain on site when reclamation is complete.

Access Road along the western edge of Reservoir B. Fenced, public bike path is on the right.

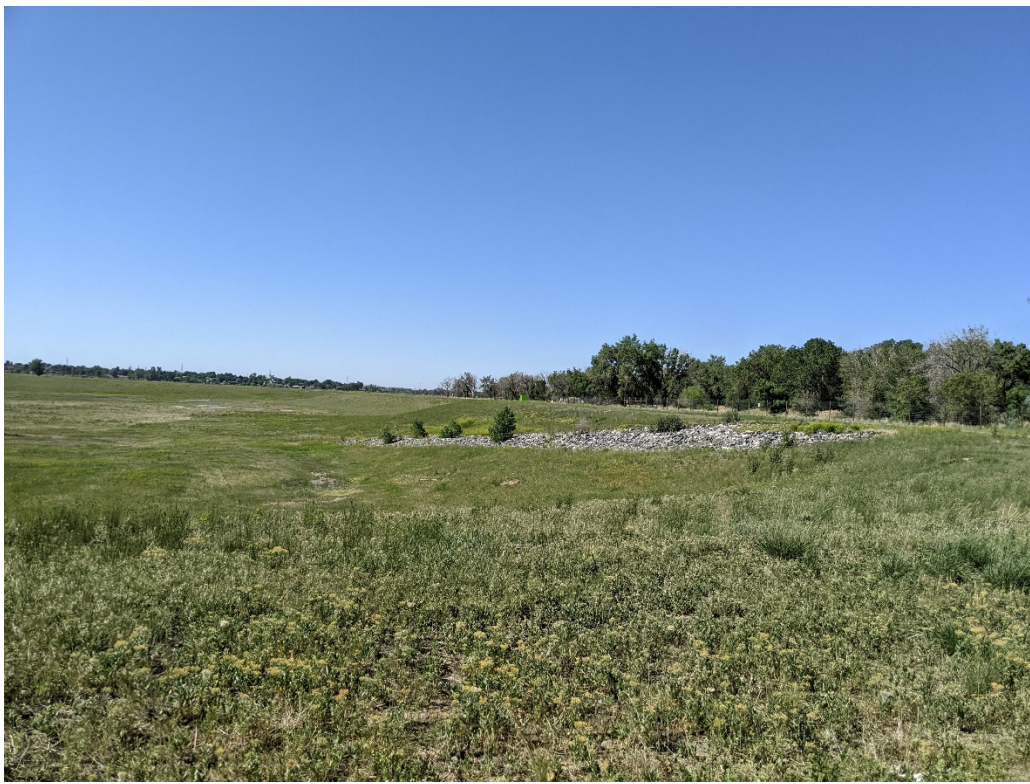
Looking southwest at Emergency Spillway of Reservoir B.

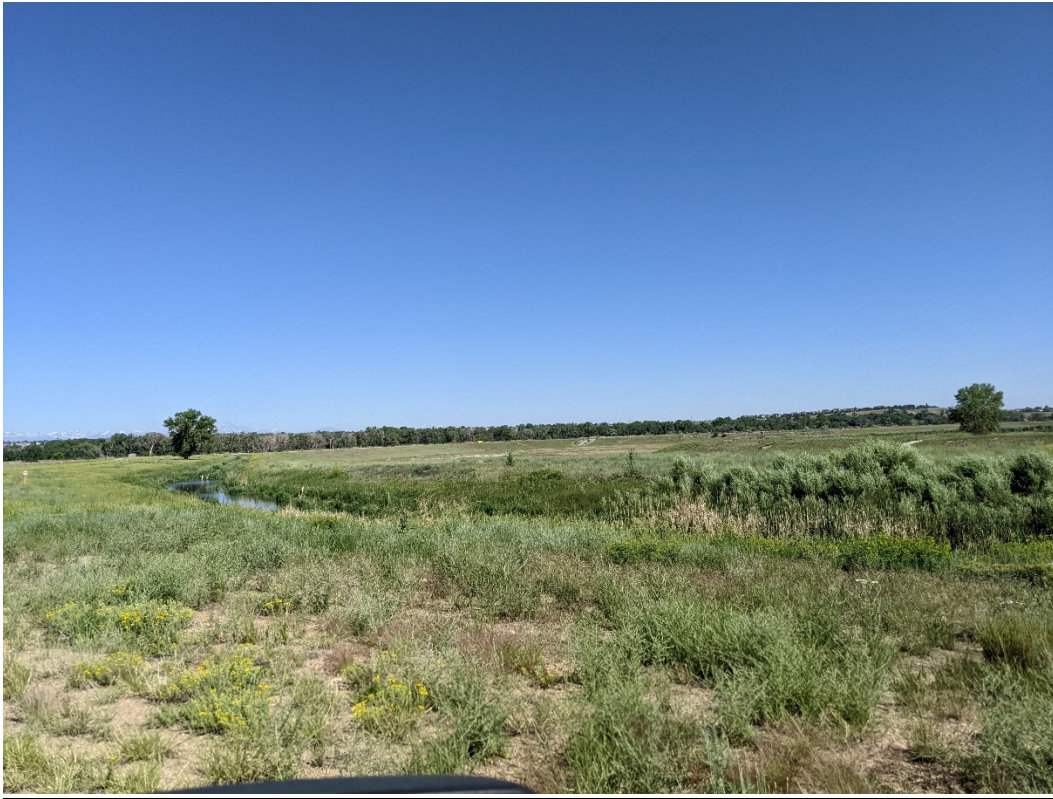
Looking northwest at the Bull Seep on the western side of Reservoir A.

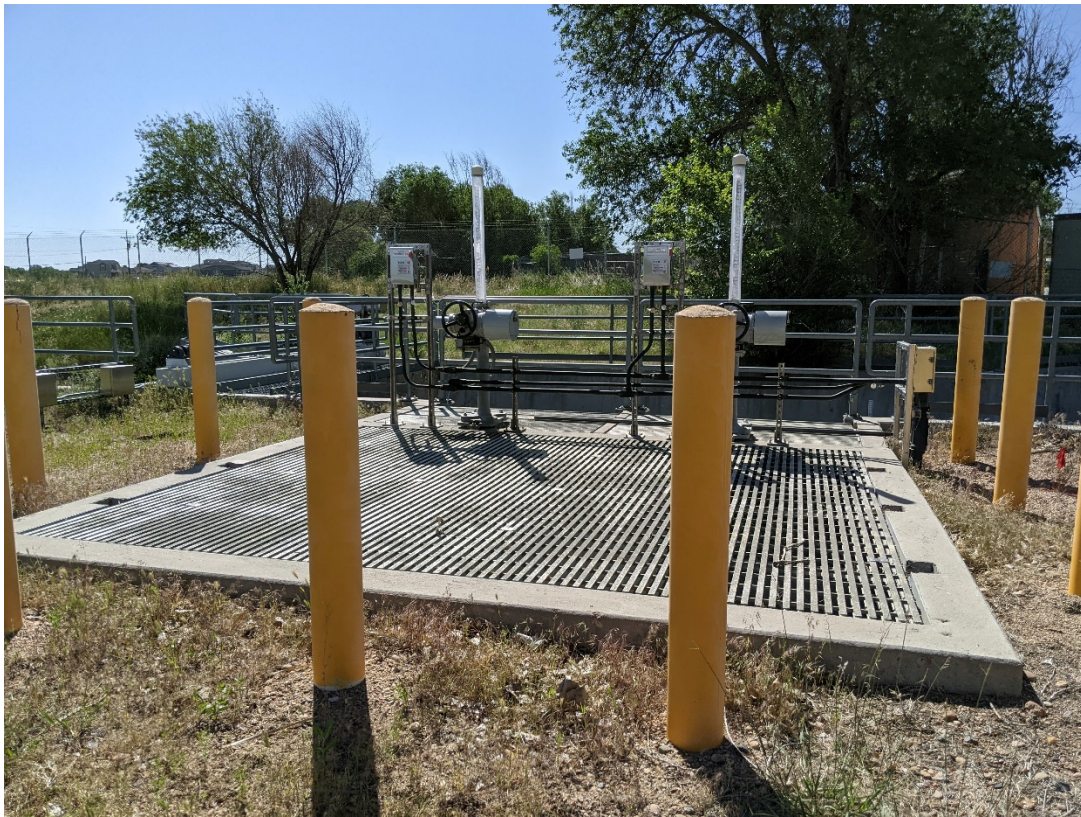
Headgate and monitoring station on irrigation canal east of Reservoir A.

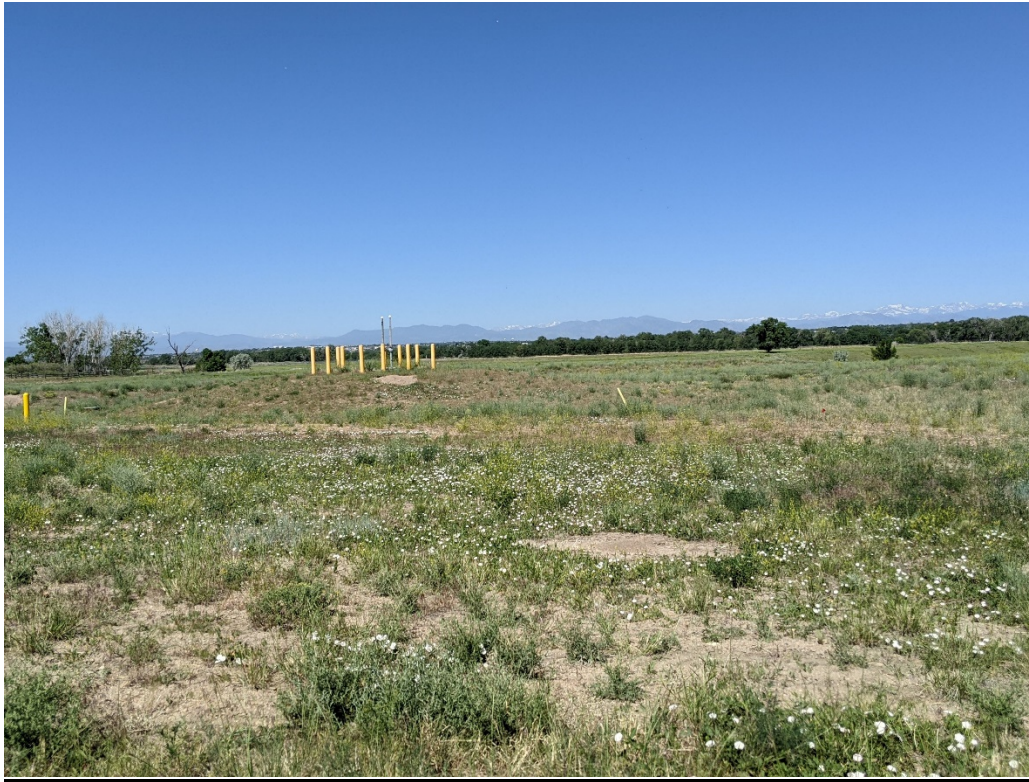
Monitoring station on the eastern side of the reservoirs.

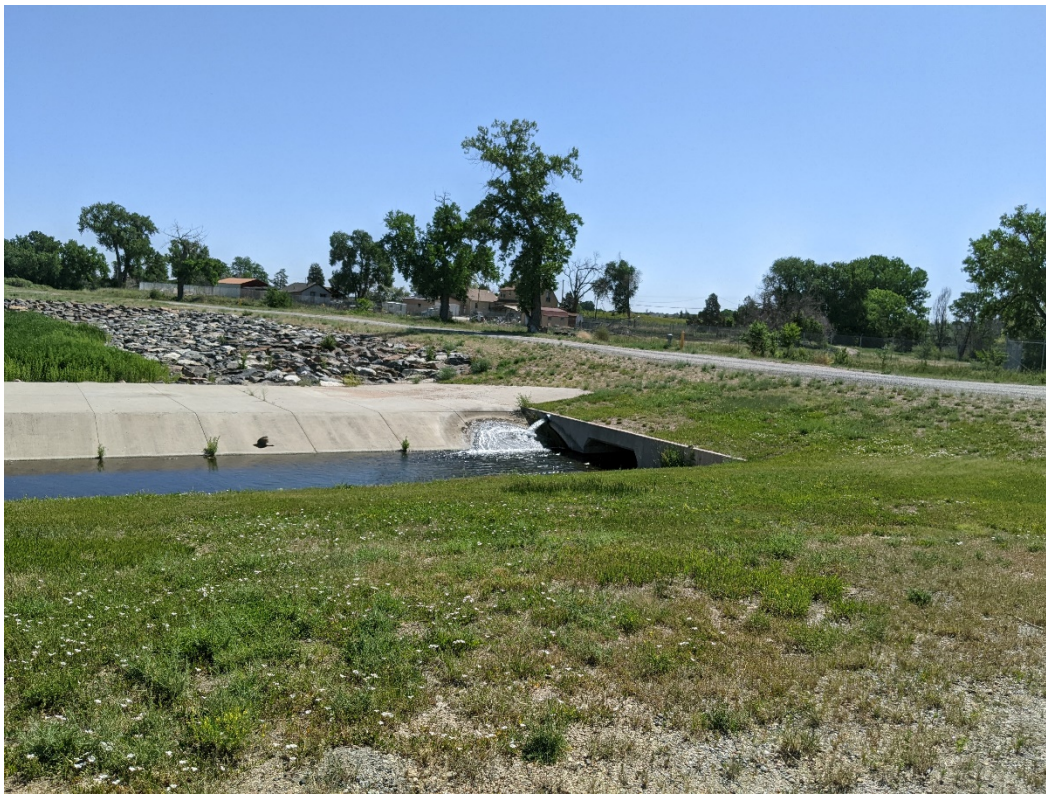
Reservoirs A and B are clay lined reservoirs. A leak test was conducted and the slurry wall was reapproved by the State Engineer in 2017 after the flood repairs were complete. No water was observed during the inspection in the two lined storage reservoirs. A mounding drain was installed west of Reservoir B. The outlet to the drain is located adjacent to the site's main office. Water was flowing during the time of inspection through the discharge pipe into the First Creek channel.

Water discharging from mounding drain into the First Creek channel north of the site office.

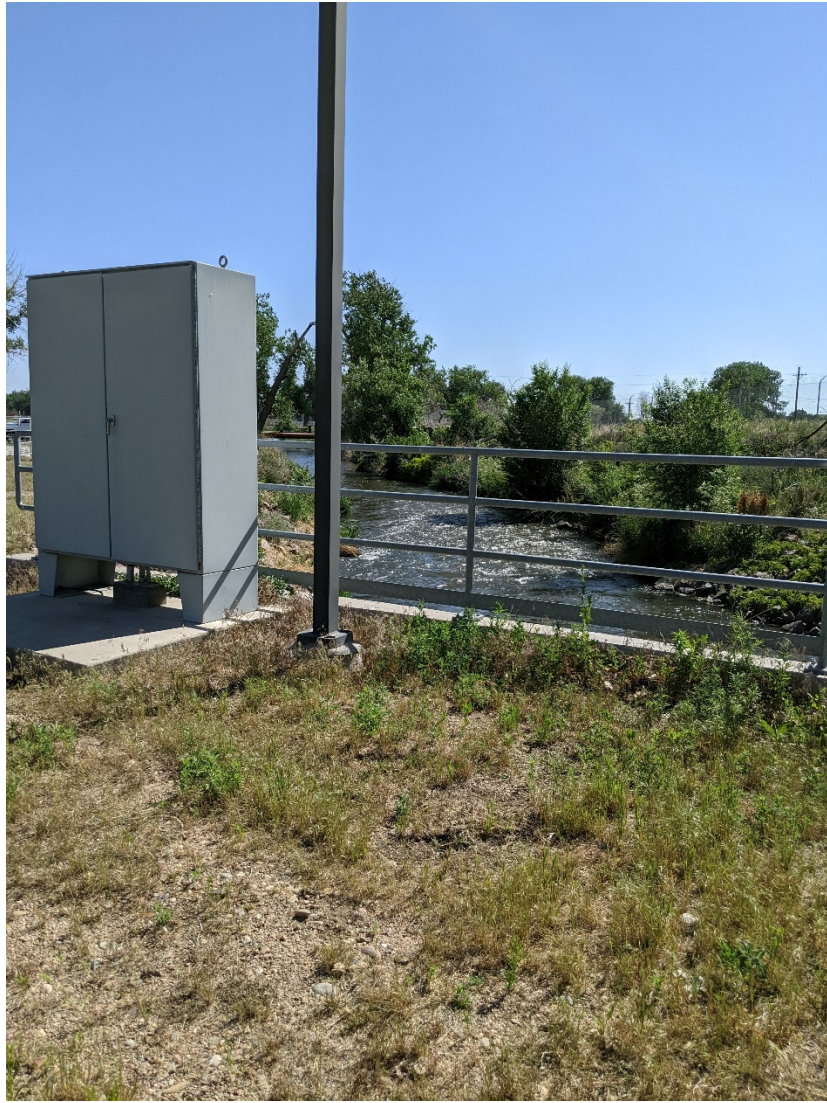
First Creek south of Reservoir A. Water control facility in the foreground.
