MINERALS PROGRAM INSPECTION REPORT

MINE NAME: Reclamation Pit No 1	MINE/PROSPECTING ID#: M-1977-153 & M-1979-195	MINERAL: Sand and gravel	COUNTY: Adams
INSPECTION TYPE: Monitoring	INSPECTOR(S): Nikie Gagnon	INSP. DATE: June 15, 2022	INSP. TIME: 09:00
OPERATOR: Denver Water Department	OPERATOR REPRESENTATIVE: Brad Piede	TYPE OF OPERATION: 112c - Construction Regular Operation

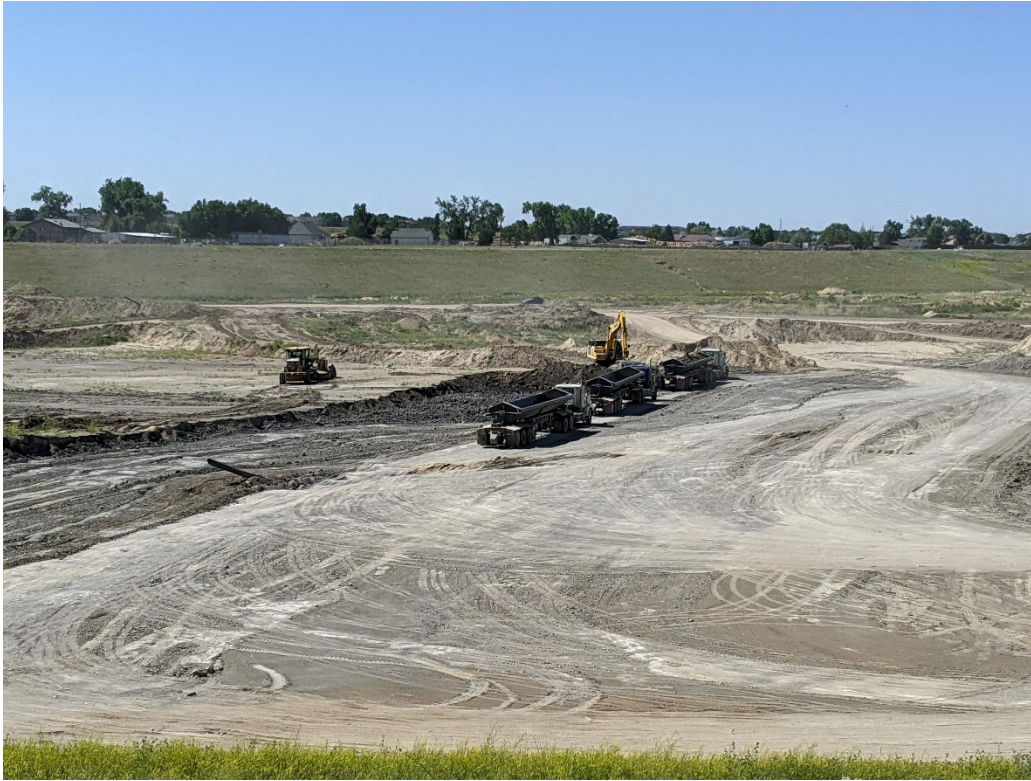
During the inspection, active mining was observed in the bottom of the Road Runner Rest Pit in the northeastern section of the Reservoir. One excavator and one grader were on site stripping material from the bottom of the reservoir and loading the material into trucks. Several trucks were observed entering and exiting the site. Mr. Piede indicated mining will occur through 2024. Afterwards, Denver Water plans to build a pump house in the northeastern corner of the permit area. Construction of the pump house is anticipated to begin after mining is complete in 2024. Additionally, Denver Water plans to install a spillway along the northern boundary of the reservoir. Older stockpiles of sand/gravel were noted in the bottom of the southwest corner of the Reservoir. According to Mr. Piede, these will be removed during reclamation to increase capacity of the reservoir.

Looking west at active mining in northeast section of Road Runners Rest II Pit.

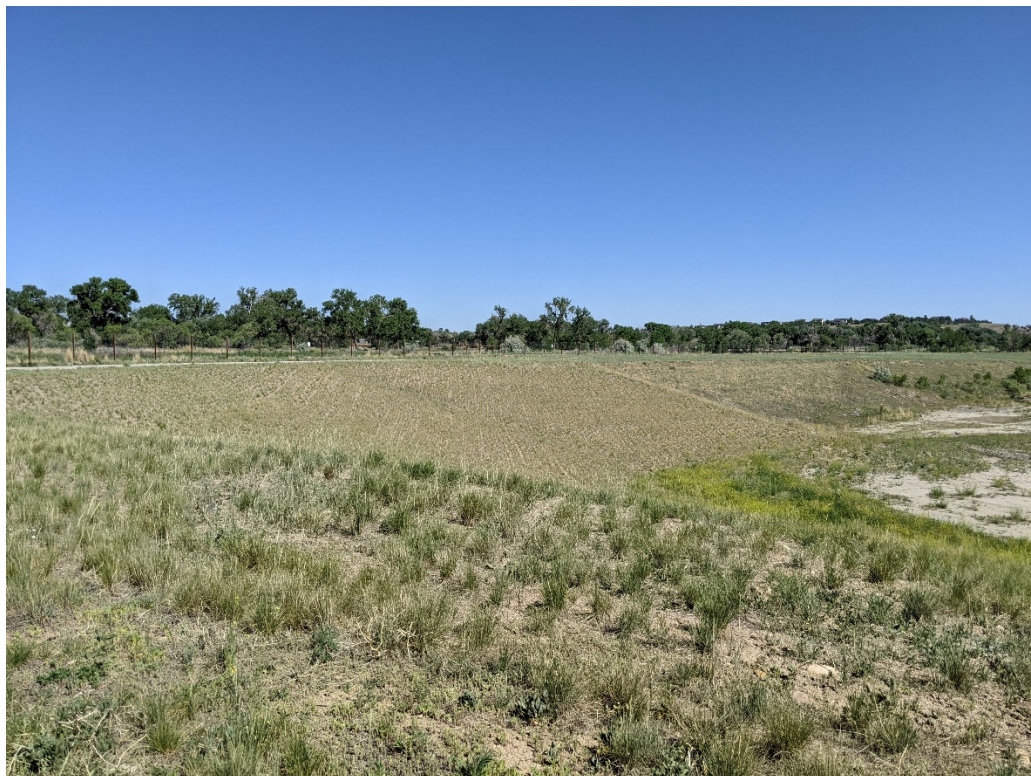
The Reservoir is lined with a soil bentonite slurry wall on the north, west and east sides and ties into the Howe-Haller Reservoir B (M-1978-052) on the south side. The South Platte flooded in 2013 and damaged the southwestern corner of the Reservoir/Reclamation Pit No. 1. A leak test was conducted and the slurry wall was approved by the State Engineer in 2017. Mr. Piede stated that a groundwater mounding drain was installed on the west side of the Reclamation Pit. During the inspection, the Reservoir was holding water in two basins, one in the northeast corner of the Road Runners Rest II Pit and one in the southeast corner of the Reclamation Pit No. 1.

Looking northwest at slurry wall repair in Reclamation Pit No. 1.

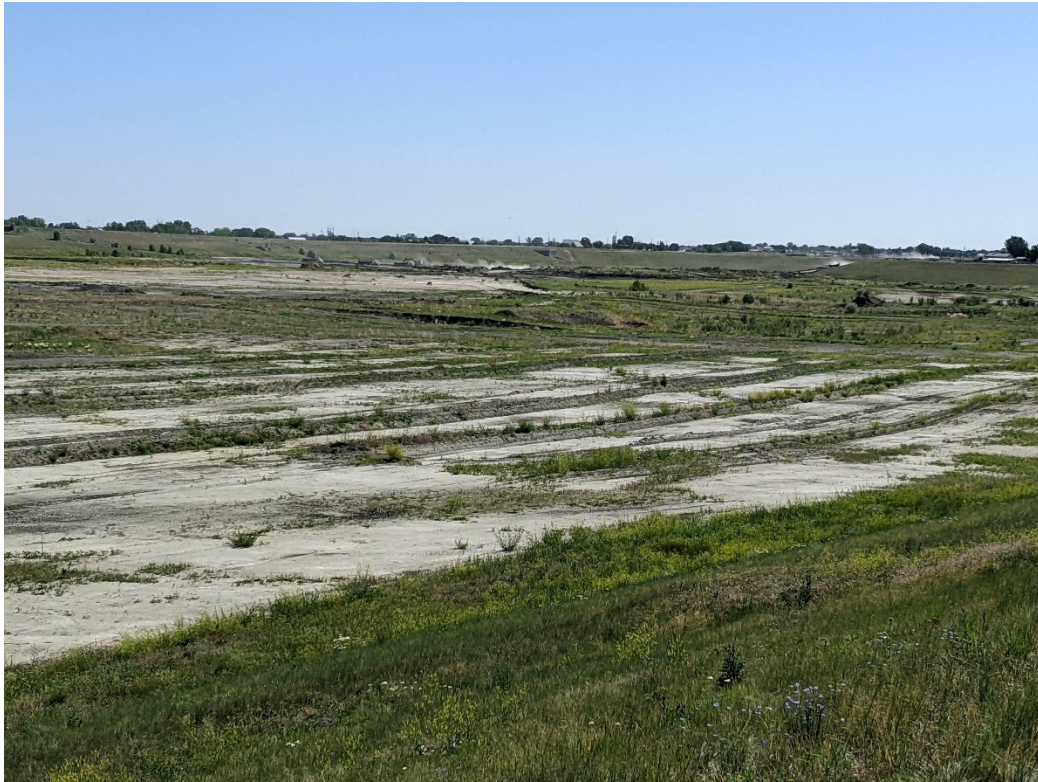
Looking northeast across the Reservoir.

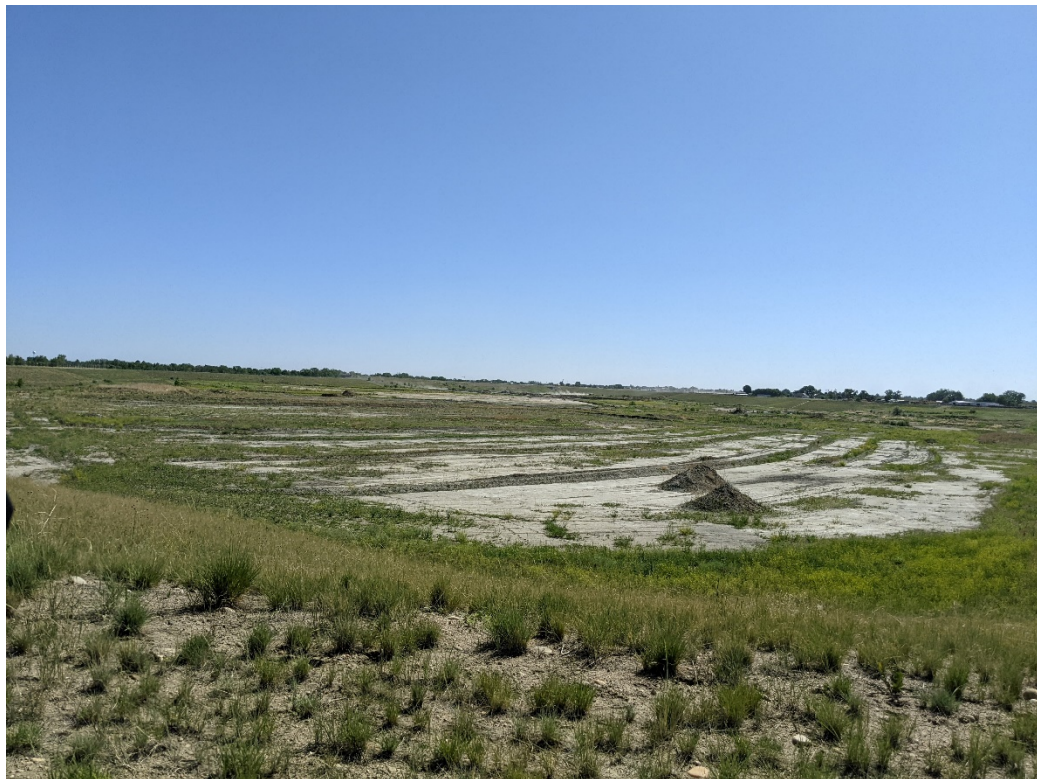
Stockpiles in southwest corner of Reclamation Pit. Slurry wall repair slope in the foreground.

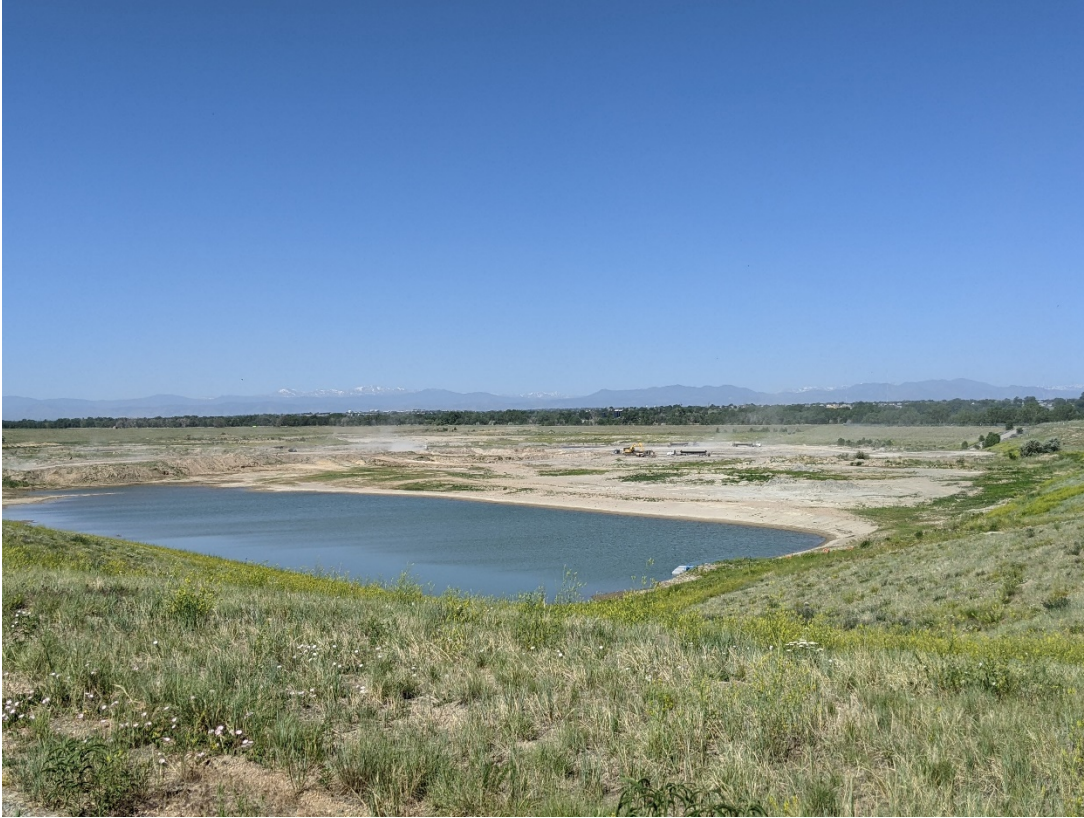
Looking west at basin in northeast corner of Reservoir. Future pumphouse will be constructed in this area.

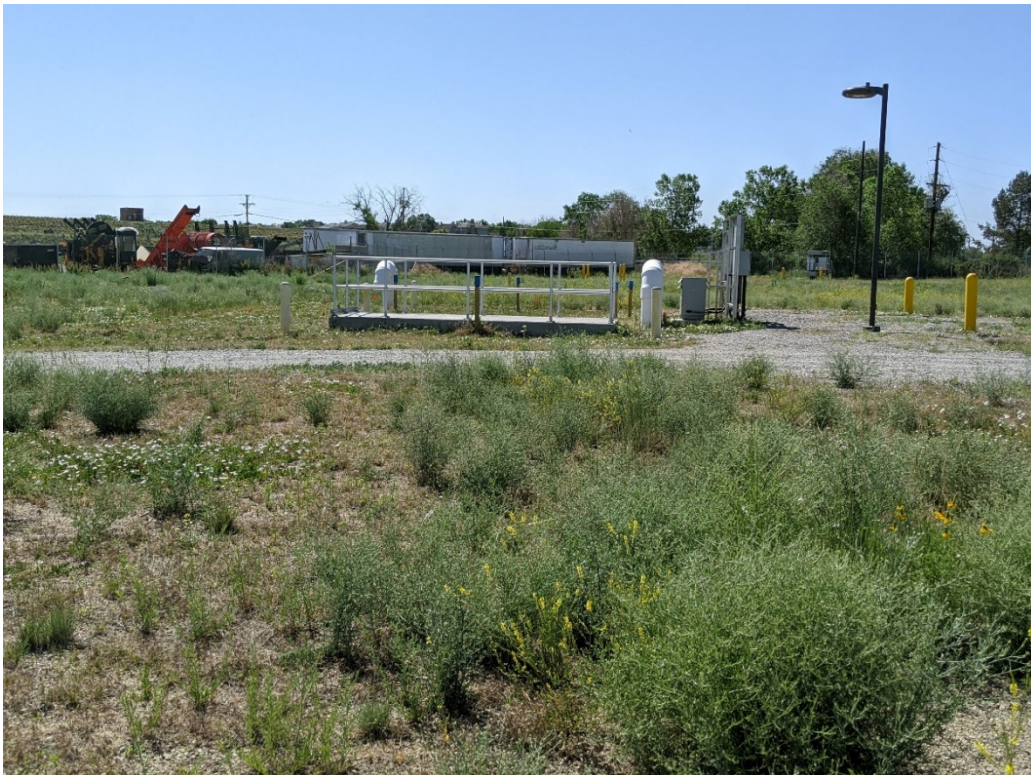
Access road east of Reclamation Pit No. 1. Discharge point to First Creek.

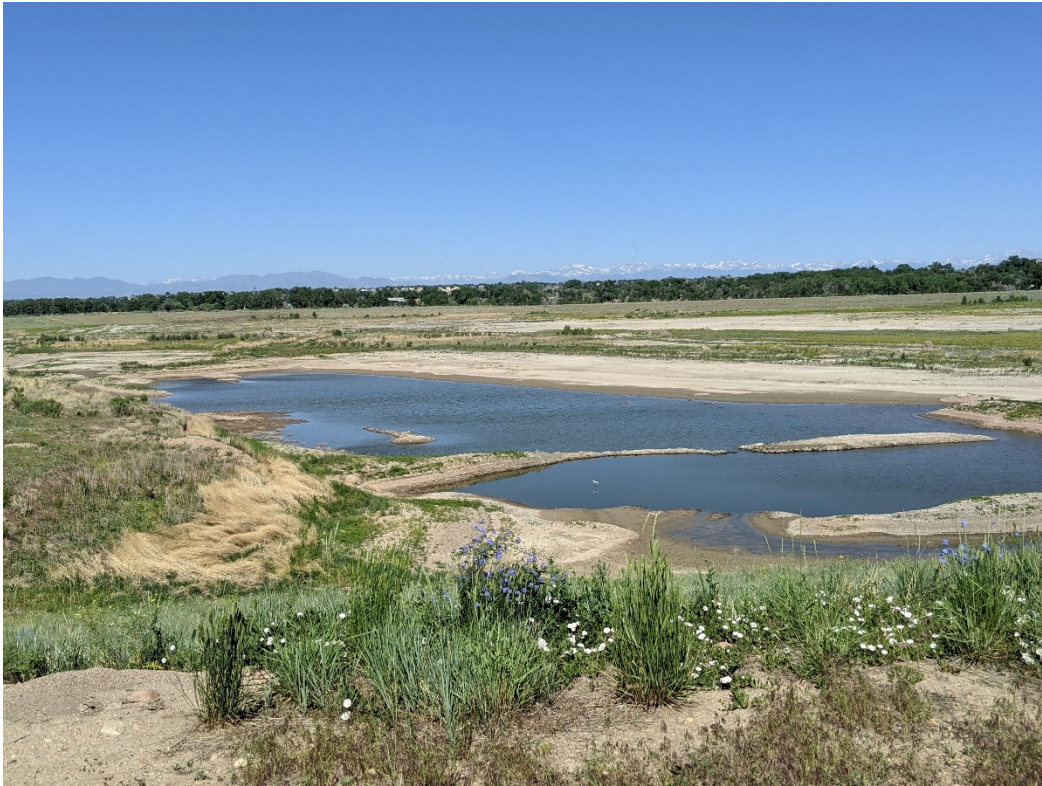
Basin in the Southeast corner of Reclamation Pit No. 1.

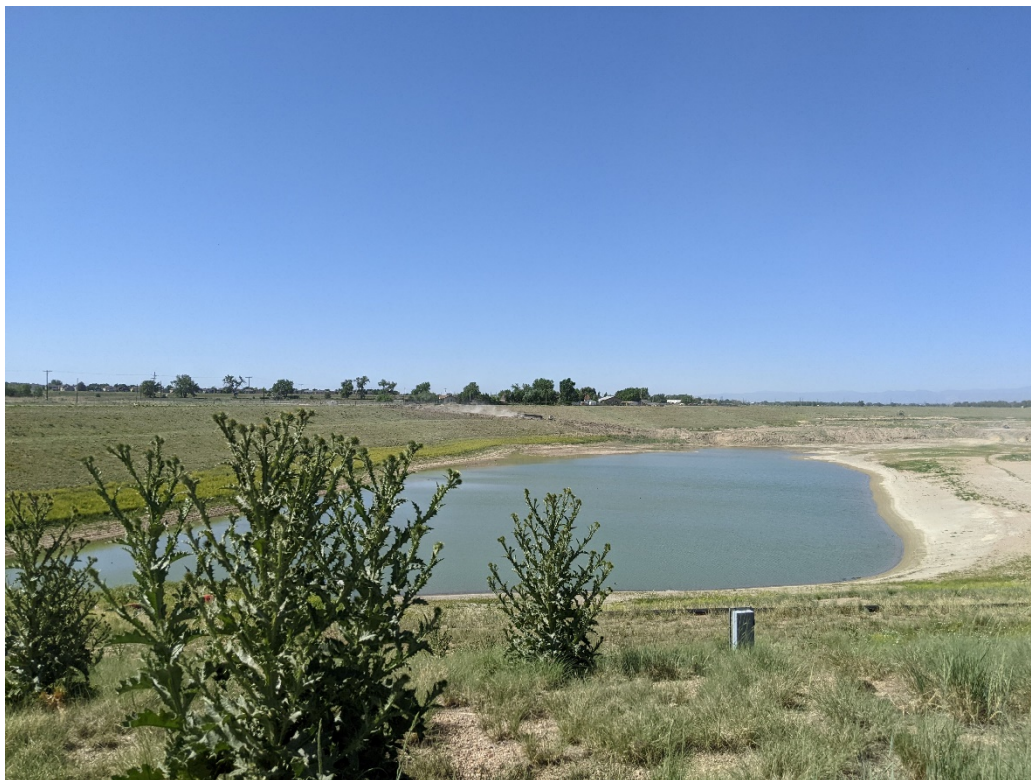
The reservoir sides are sloped at 3H:1V or flatter along the majority of the reservoir. All slopes were structurally stable with no evidence of instability noted at the time of the inspection. Dense grass is established throughout the site. During the inspection, no large patches of weeds were observed, although some thistle was noted along the northeastern side of the Reservoir. The southwestern corner of Reclamation Pit No. 1 was regraded and reseeded after the repair to the slurry wall in 2017. While not as densely vegetated as the rest of the site, the grasses have reestablished on the slopes of the repair and weeds are well

Thistle plants on slopes around pit basin in northeast corner of the Reservoir.

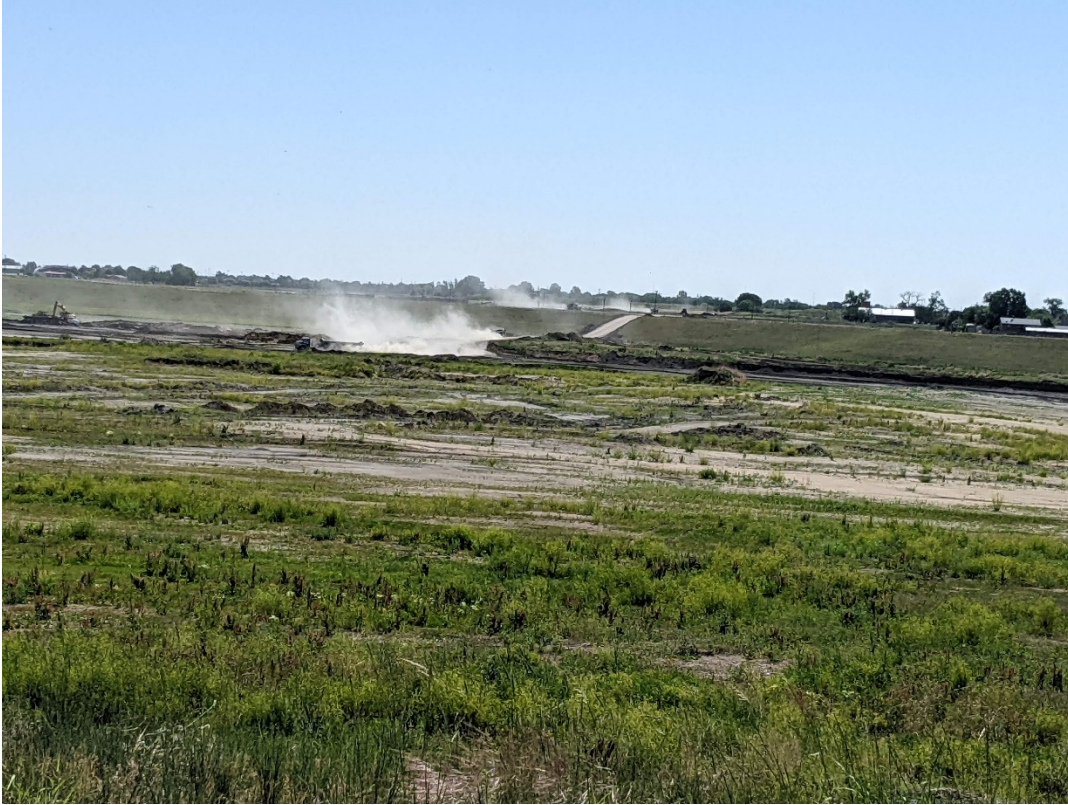
Fugitive dust was observed in the area of active mining during the inspection. The Division recommends applying water to reduce the dust during mining operations.

Fugitive dust in area of active mining.

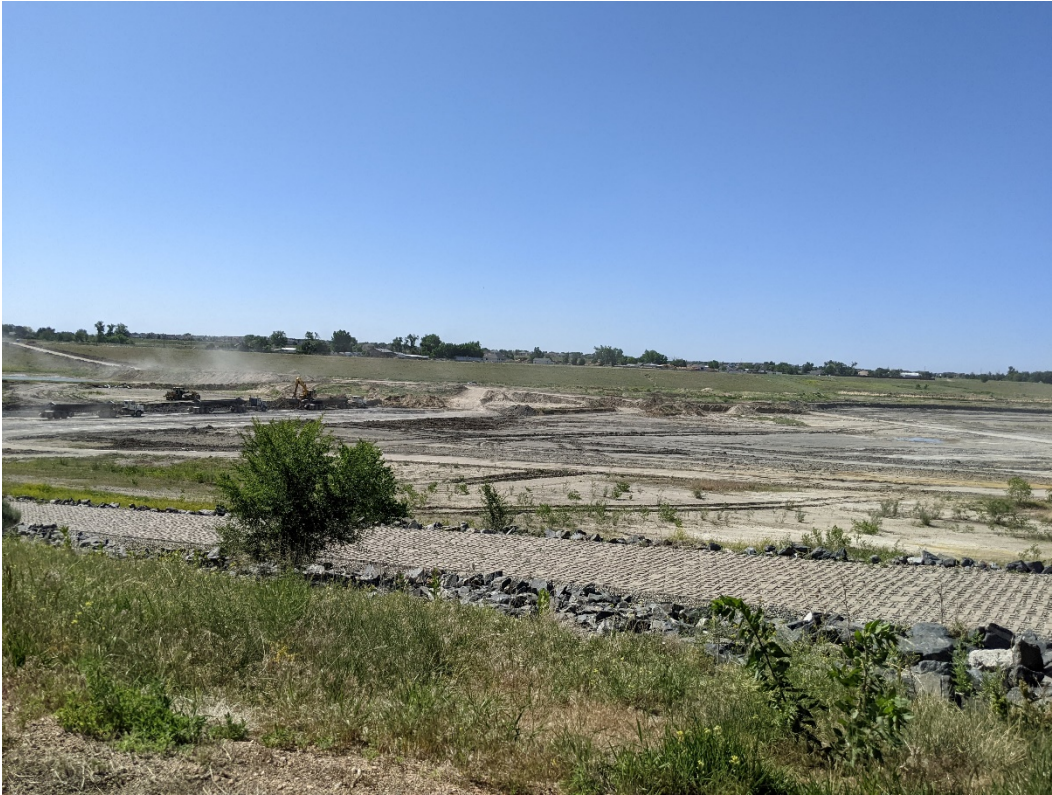
Looking south. Future location of spillway along the northern edge of the Reservoir in foreground.
