MINERALS PROGRAM INSPECTION REPORT
PHONE: (303) 866-3567

MINE NAME: Connell Carr Pit	MINE/PROSPECTING ID#: M-2014-001	MINERAL: Sand and gravel	COUNTY: Weld
INSPECTION TYPE: Monitoring	INSPECTOR(S): Peter Hays	INSP. DATE: April 5, 2022	INSP. TIME: 11:00
OPERATOR: Connell Resources, Inc.	OPERATOR REPRESENTATIVE: Kevin Anderson	TYPE OF OPERATION: 112c - Construction Regular Operation	
REASON FOR INSPECTION: Normal I&E Program	BOND CALCULATION TYPE: Partial Bond	BOND AMOUNT: \$146,495.00	
DATE OF COMPLAINT: NA	POST INSP. CONTACTS: None	JOINT INSP. AGENCY: None	
WEATHER: Windy	INSPECTOR'S SIGNATURE:

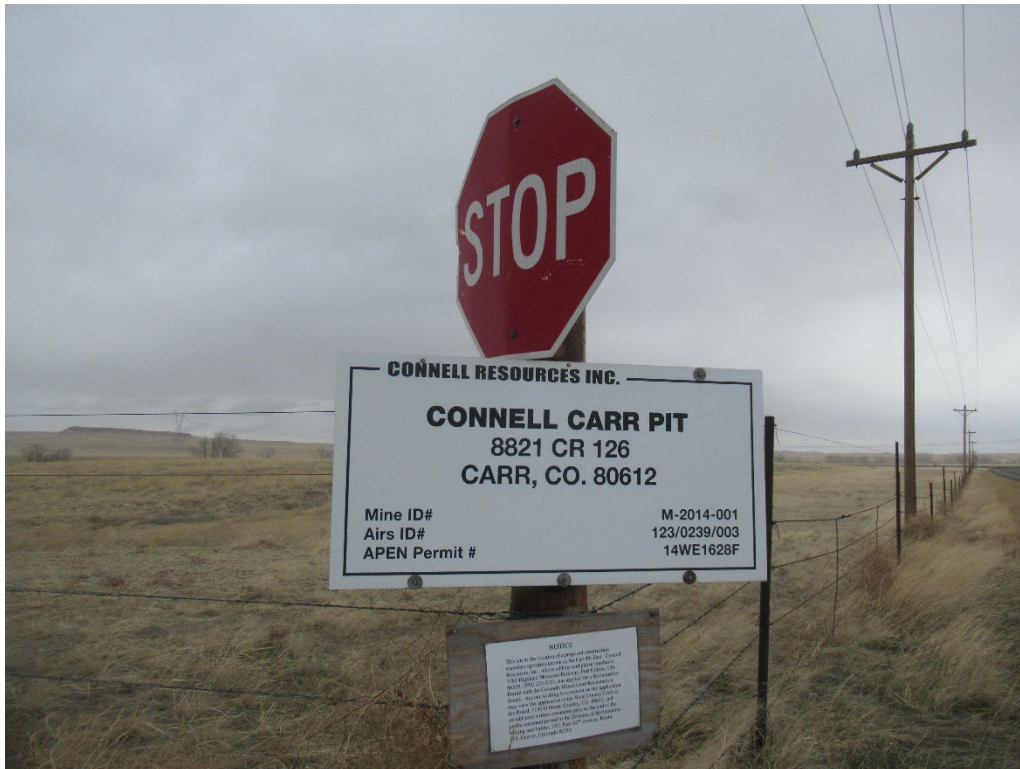
The required mine sign and boundary markers were observed as required by Rule 3.1.12.

Connell Car Pit mine sign

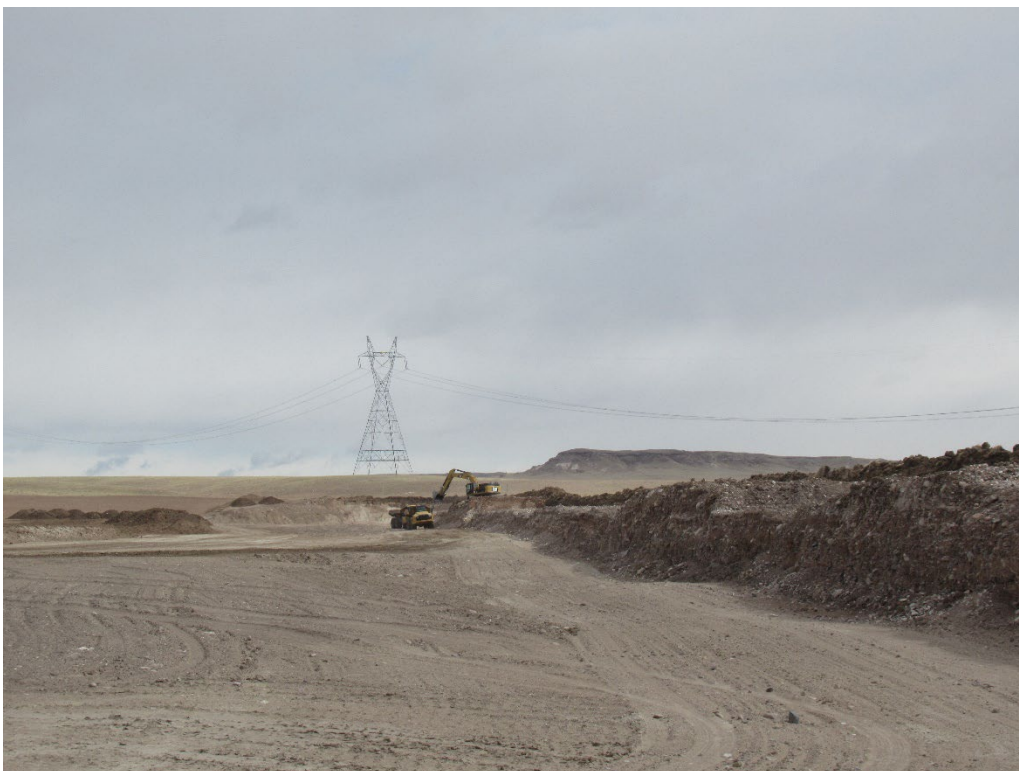
View of the mining excavation in the northeast corner of Phase 2

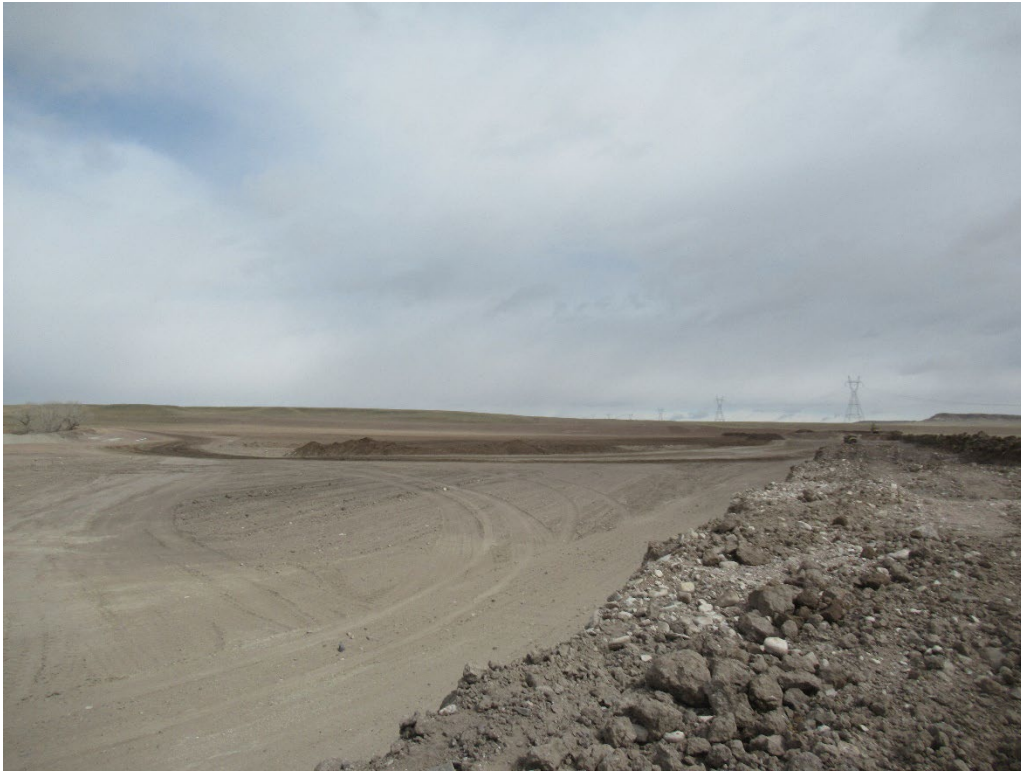
View of Phase 2 from the southwest highwall looking northeast

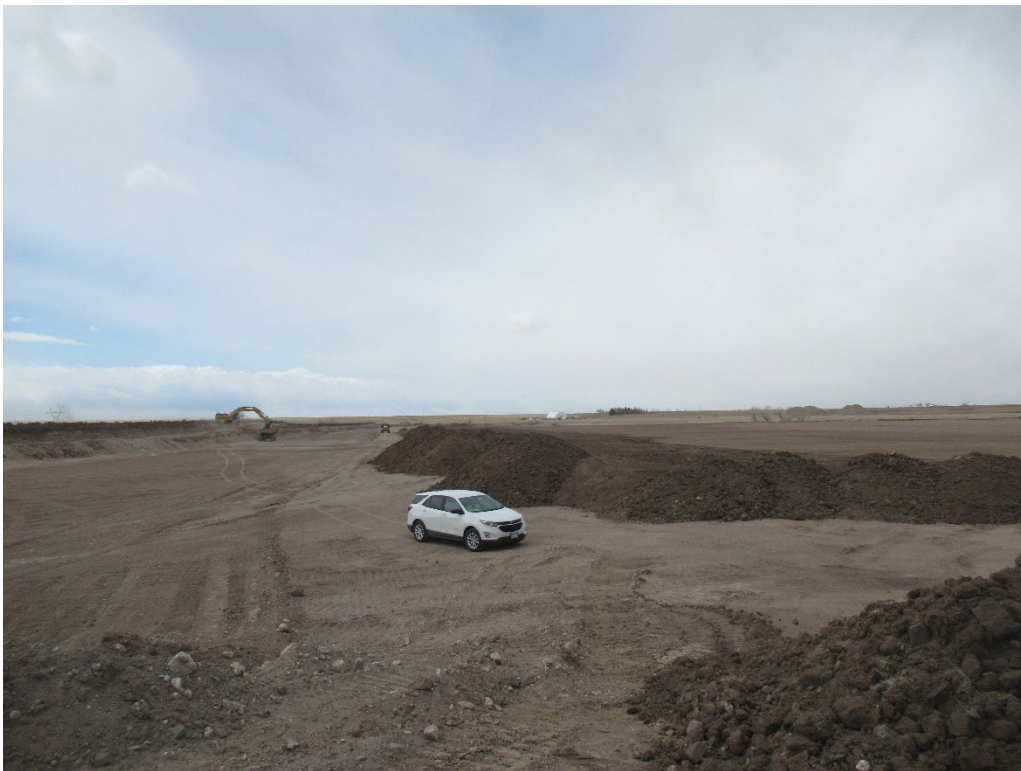
View of Phase 2 from the northeast highwall looking west
