Reference: May 2022 Geotechnical Monitoring Summary Pikeview Quarry

CONTINENTAL MATERIALS
CORP.
PIKEVIEW QUARRY SLOPE
MONITORING

SITE MAP

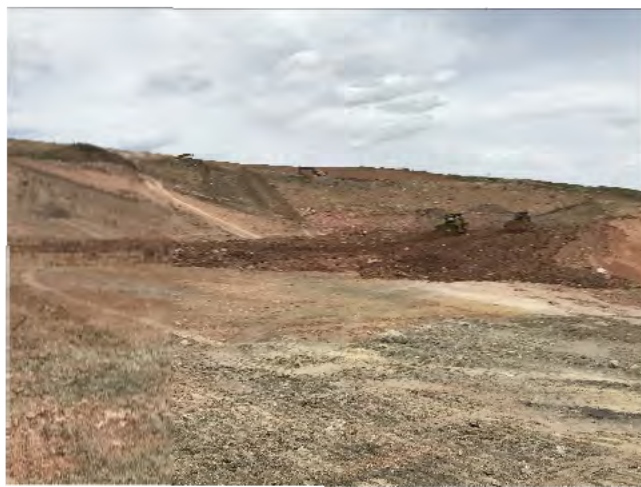
- Offsite fill was placed near the reclamation benches. The material was spread by dozers and compacted in one-foot lifts in accordance with the project specifications. (Photo 5 and 6)

6. Compacted area in the pit looking north.

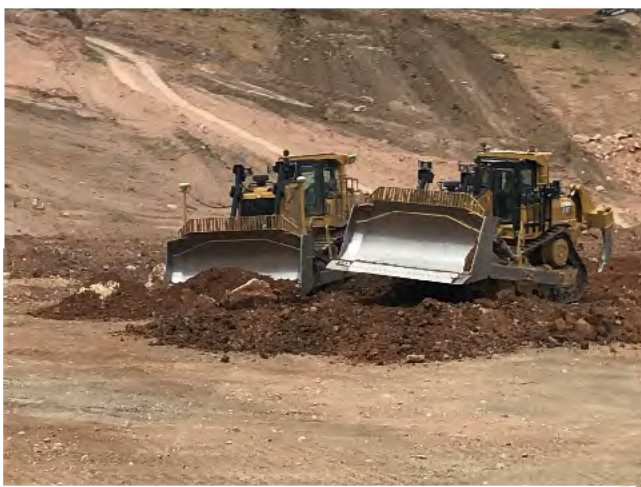
5. Dozers spreading material placed in the pit area.

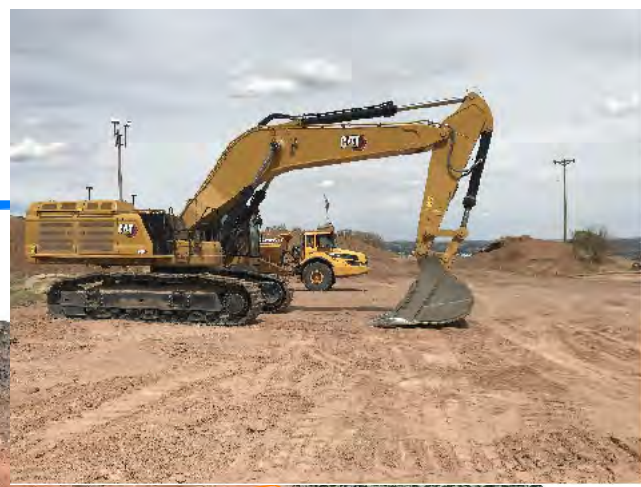
4. Excavator and haul truck used on site.

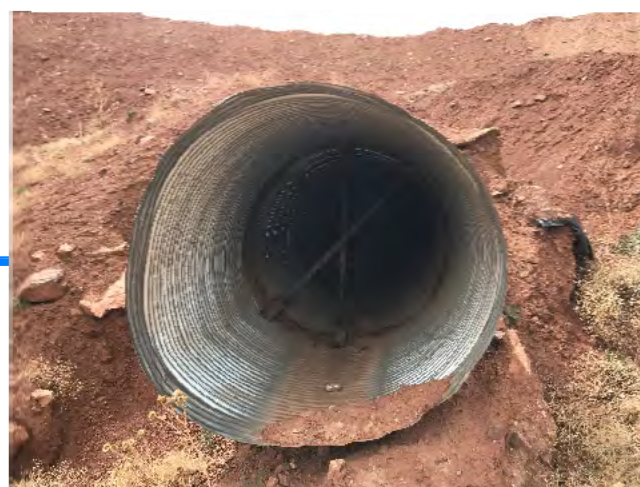
- The culvert remains cleared but mostly blocked inside. CMC has partially cleared the debris, but access limitations and supports within the culvert inhibit clearing all the debris. CMC has procured a pump and will begin pumping operations if any water collects behind the culvert. CMC inspects the culvert for ponded water following rain events, and should any water be observed, it will be removed using pumps. To date, no ponding has been observed. (Photo 3)

3. Outlet of culvert on north-end of the site.

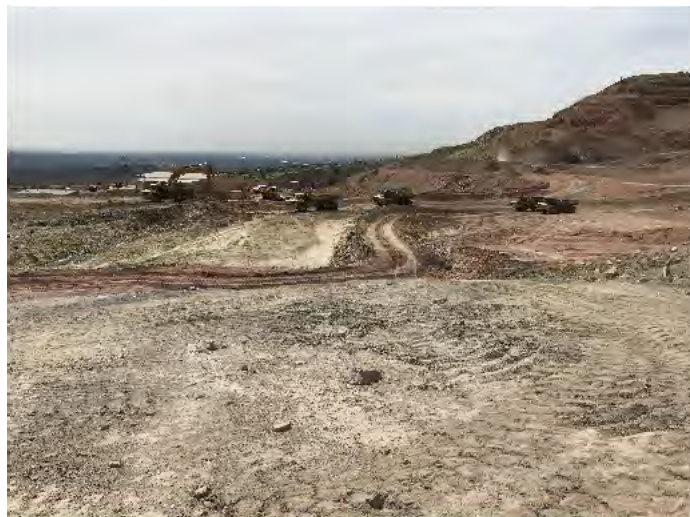
- Reclamation grading began in February 2022 and continued throughout May.
- Operators are moving material from the North Borrow Area to the pit floor for compaction in one-foot lifts. Note that the North Borrow Area is a separate project associated with the City's plans for the property; this grading was permitted by El Paso County. (Photos 1, 2 and 7)

7. Haul trucks moving material in the pit.

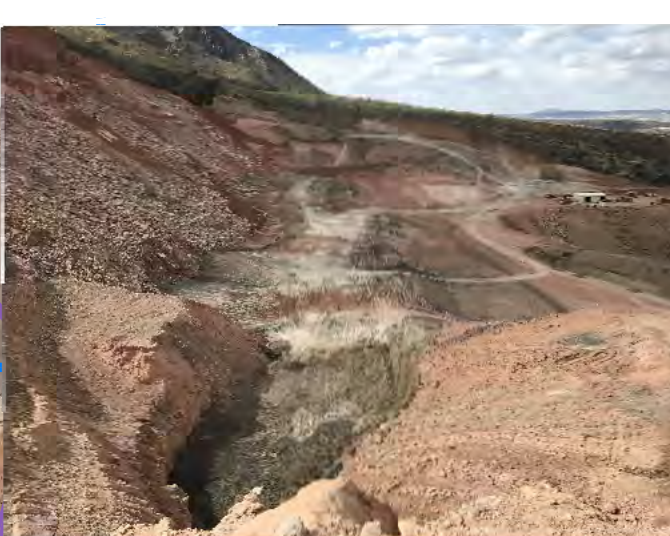
2. View to the north of the pit area.

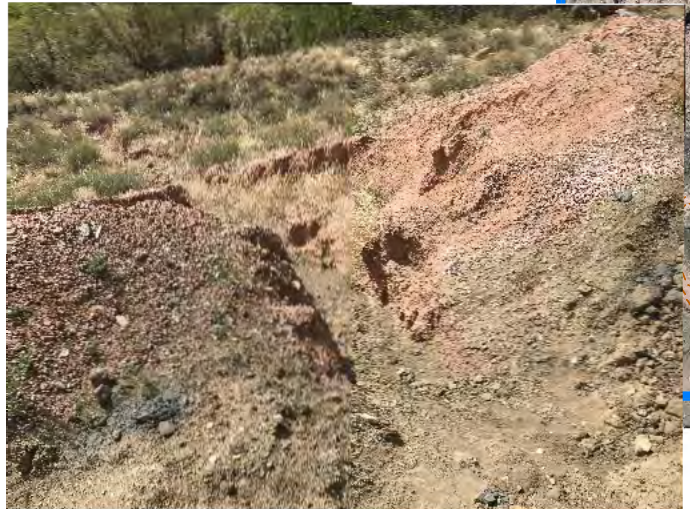
8. Erosion gully on the south end of the site.

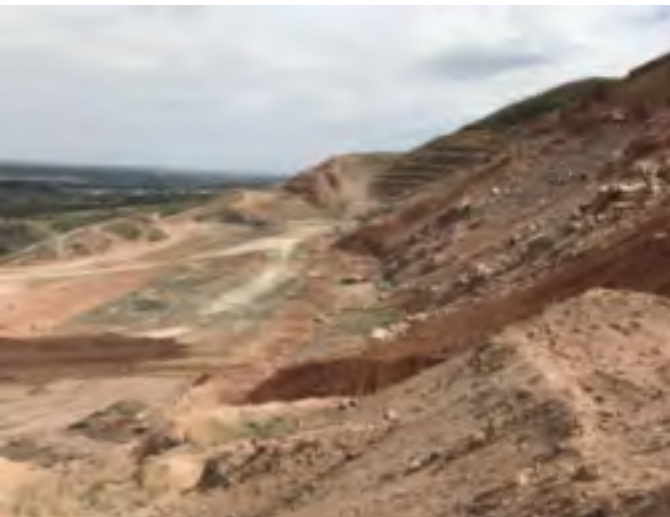
1. View to the south of the pit area.

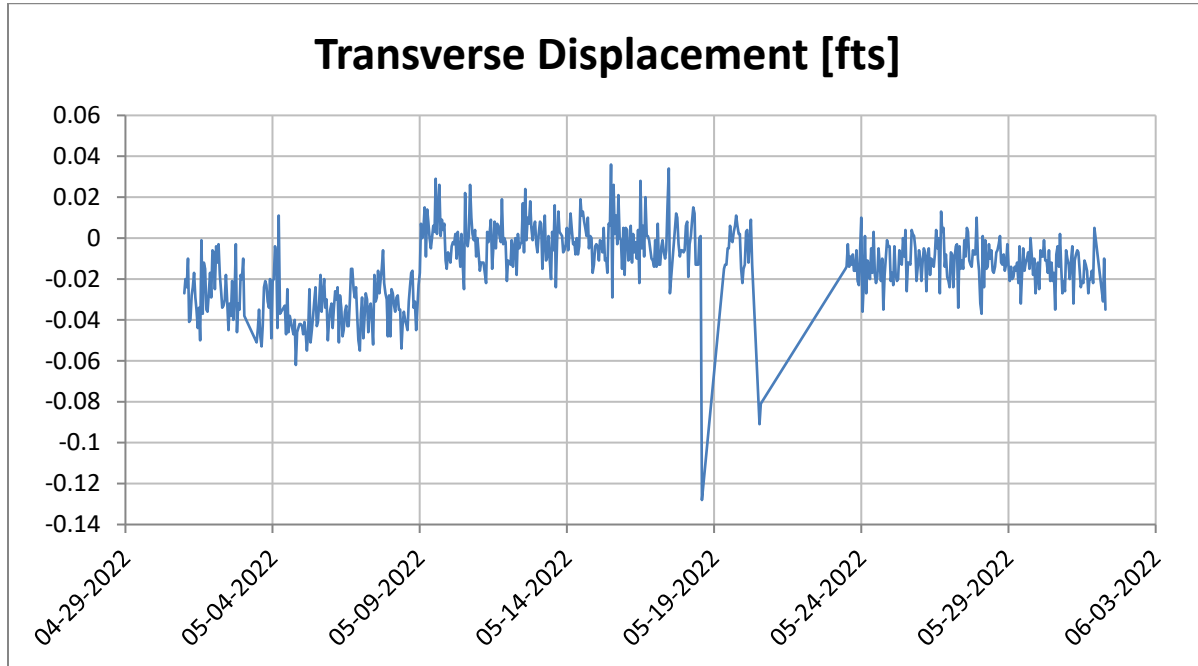
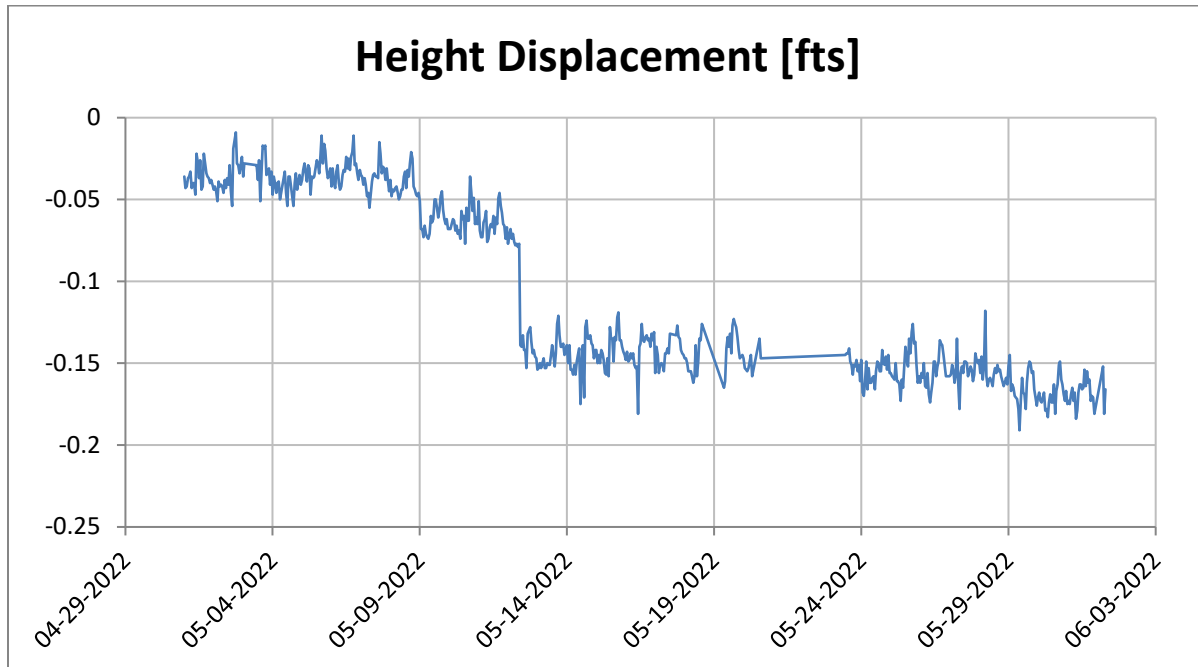
Prism BR2

1. Survey accuracy is ± 0.016 feet.
2. Alarm threshold is ± 0.35 feet.
3. Transverse displacement is in the horizontal direction. Positive direction means closer to the robotic station.
4. Height displacement is in the vertical direction. Positive direction means higher in elevation.
5. Prism is located in an area where ongoing movements are expected. The prism records slope creep movements with slow velocity. The prism shifted downwards approximately 0.06' on May 12.

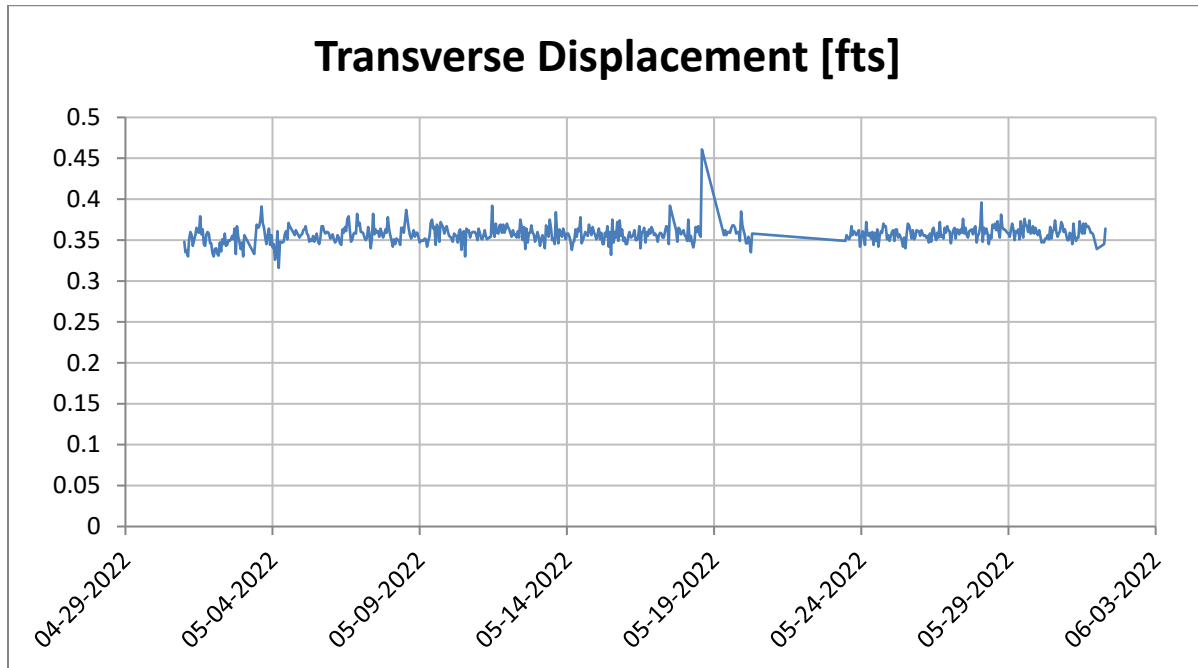
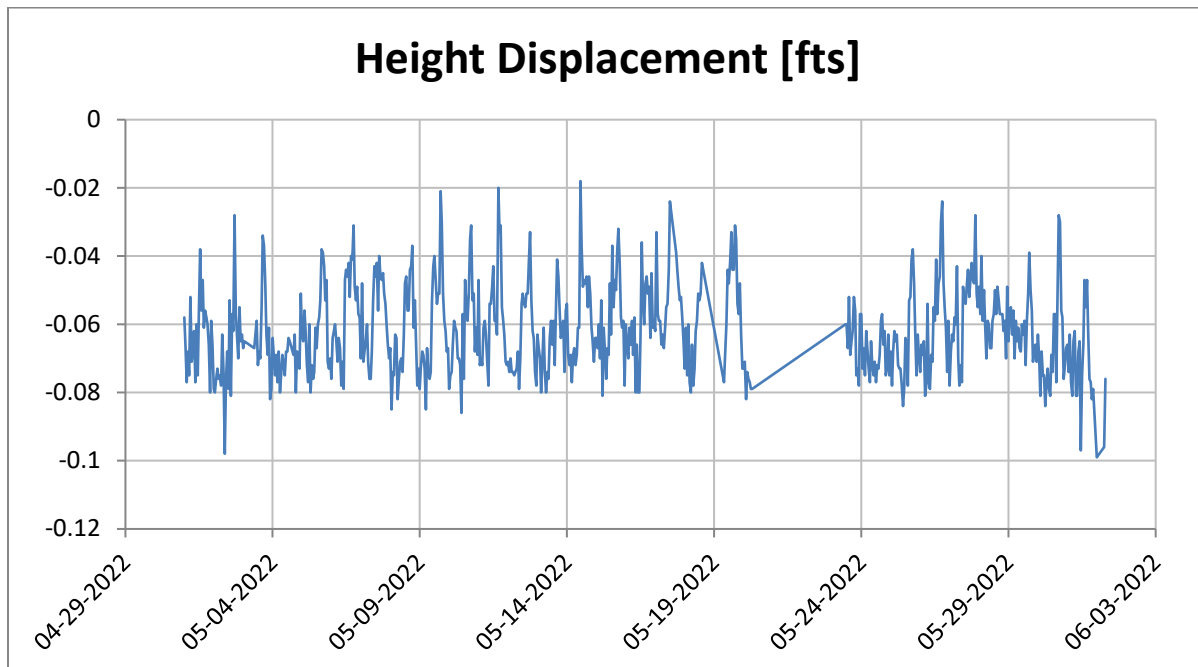
Prism P1

1. Survey accuracy is ± 0.016 feet.
2. Alarm threshold is ± 0.35 feet.
3. Transverse displacement is in the horizontal direction. Positive direction means closer to the robotic station.
4. Height displacement is in the vertical direction. Positive direction means higher in elevation.
5. Regression limit alarm was received on May 18.

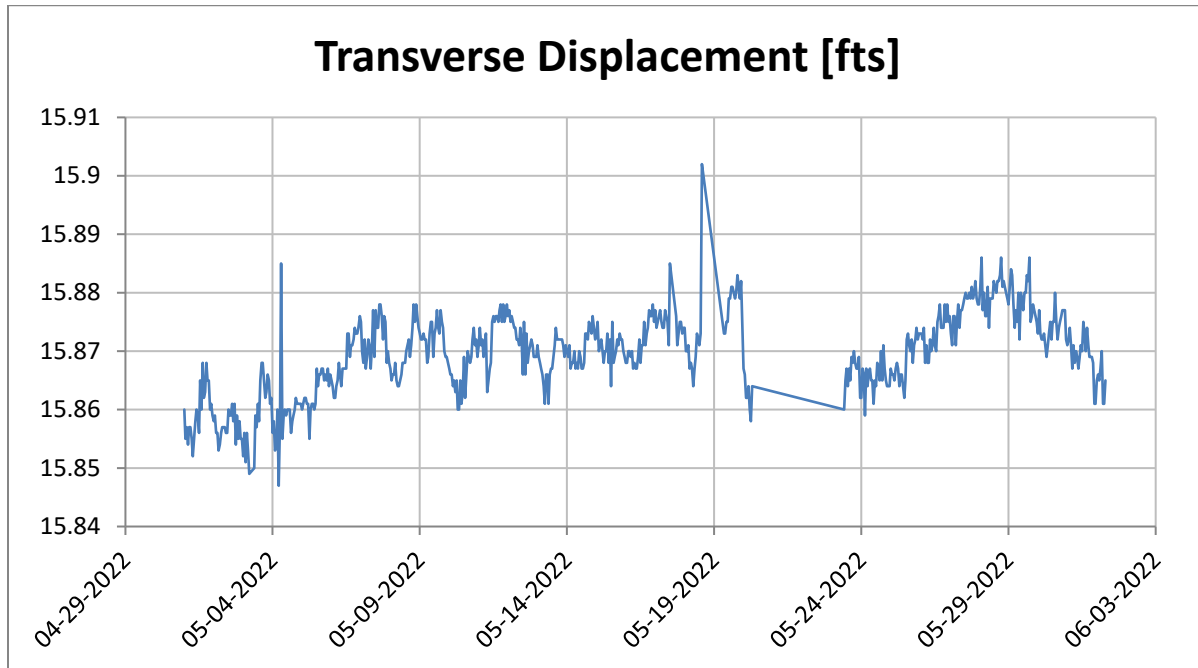
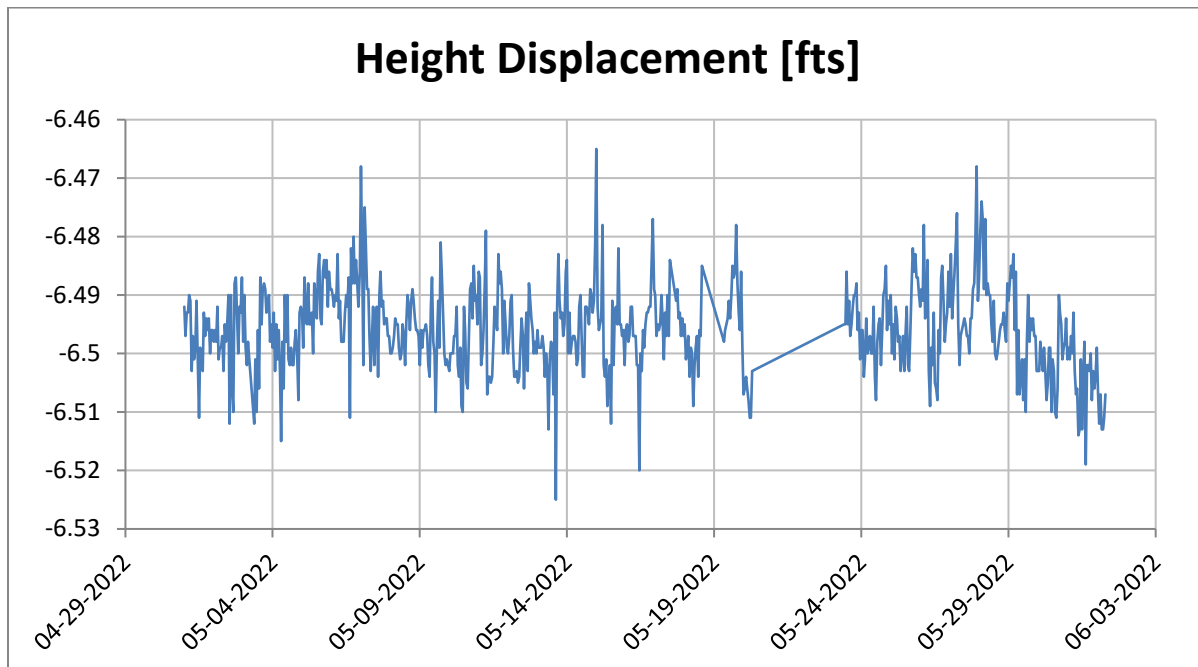
Prism P63

The data show stable conditions with no movement for 16 of 23 prisms with recorded displacements limited to data scatter and not actual movements. Prisms P63, TOE4, and TOE5 are located at the toe of the landslide, and these locations showed slope creep movements at slow velocities. Prisms BR1, BR2, NP66, and TS1 are located above the landslide, and these prisms also recorded slope creep movements at slow velocity. This settlement is likely related to the landslide material consolidating under its own weight. New prisms are placed in areas where slope creep movements are likely to be recorded; therefore, slope creep movements being recorded at more locations is expected to occur. Prism BR2 also recorded a downwards movement of approximately 0.06' on May 12; this did not meet the threshold for an alarm. Plots of the transverse and height displacements for each prism are included in Appendix B.

1. Survey accuracy is ± 0.016 feet.
2. Alarm threshold is ± 0.35 feet.
3. Transverse displacement is in the horizontal direction. Positive direction means closer to the robotic station.
4. Height displacement is in the vertical direction. Positive direction means higher in elevation.
5. Prism records slope creep movements with slow velocity.

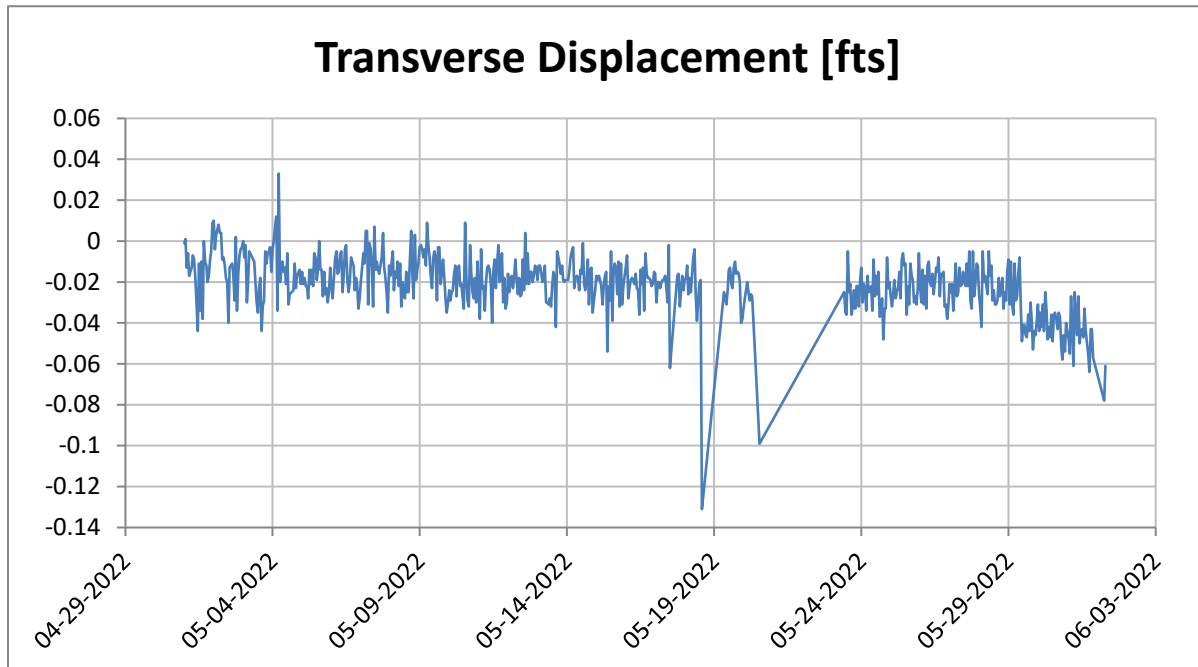
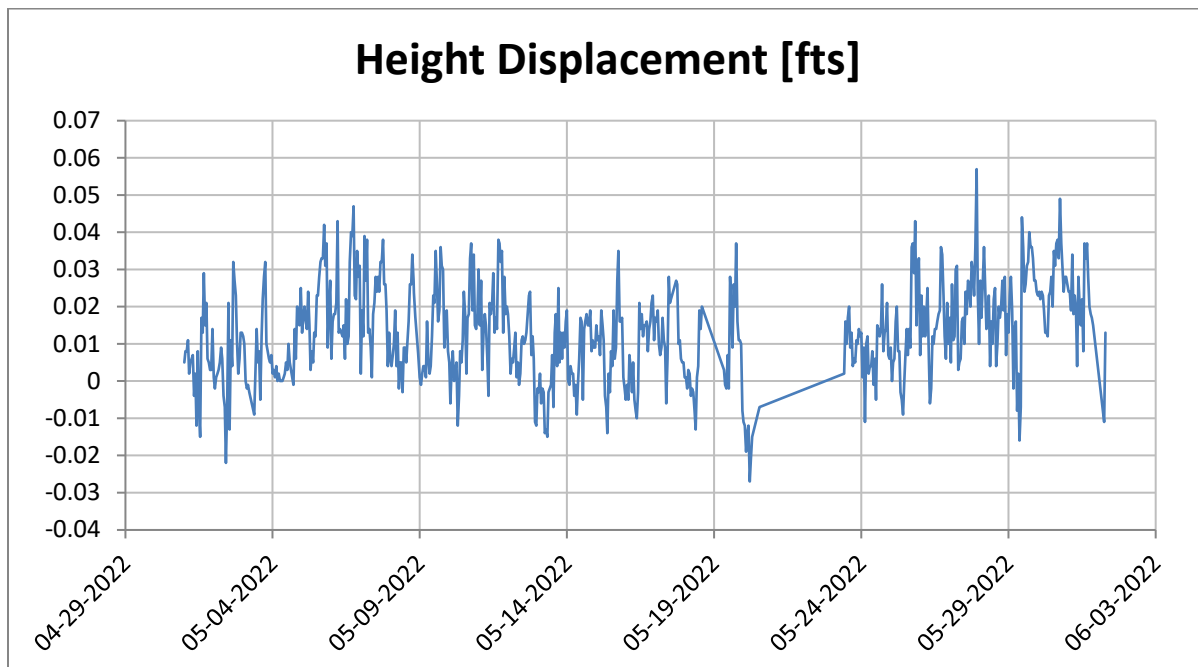
Prism TOE4

1. Survey accuracy is ± 0.016 feet.
2. Alarm threshold is ± 0.35 feet.
3. Transverse displacement is in the horizontal direction. Positive direction means closer to the robotic station.
4. Height displacement is in the vertical direction. Positive direction means higher in elevation.
5. Prism records slope creep movements with slow velocity.

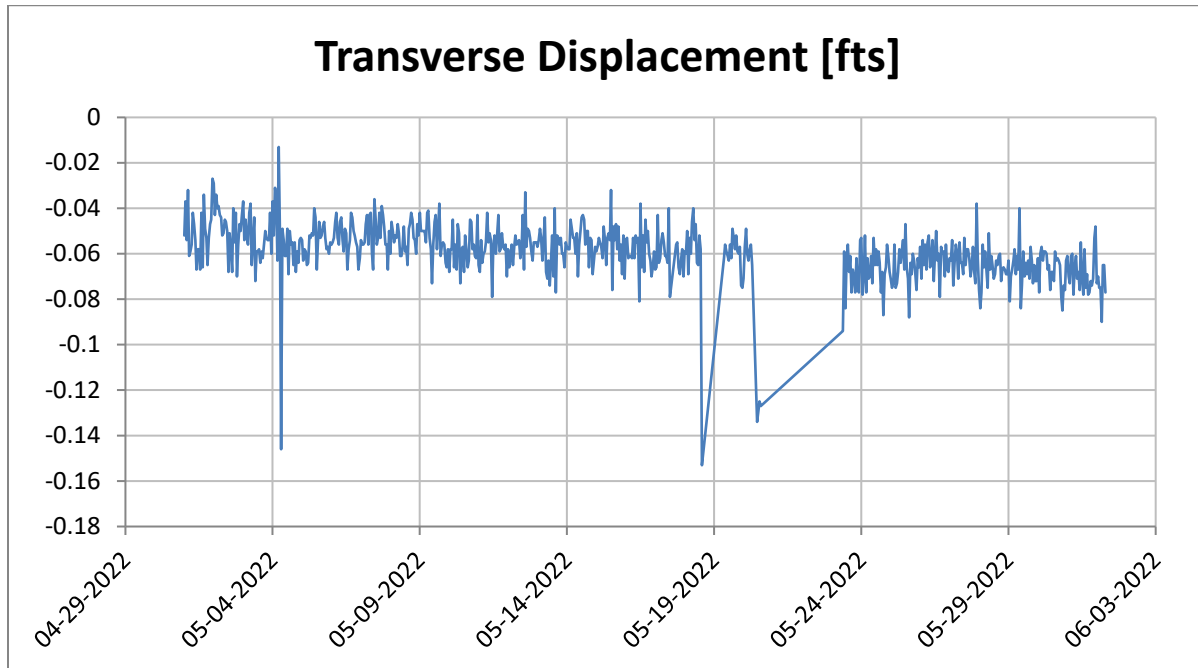
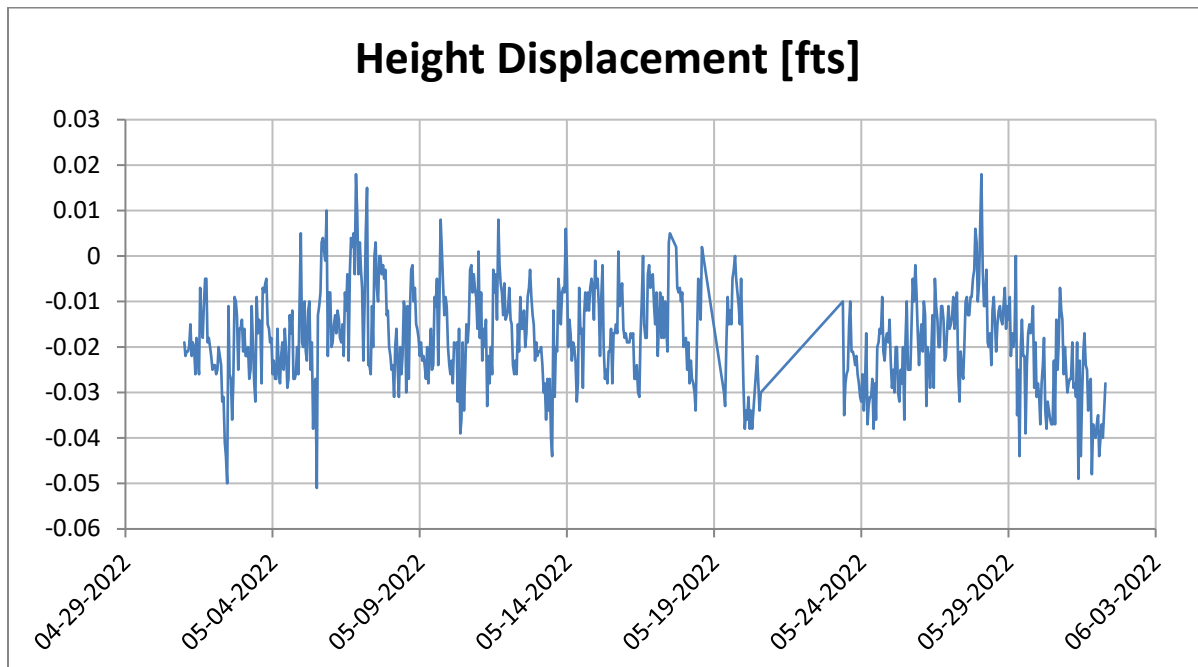
Prism TOE5

1. Survey accuracy is ± 0.016 feet.
2. Alarm threshold is ± 0.35 feet.
3. Transverse displacement is in the horizontal direction. Positive direction means closer to the robotic station.
4. Height displacement is in the vertical direction. Positive direction means higher in elevation.
5. Prism records slope creep movements with slow velocity.
