MINERALS PROGRAM INSPECTION REPORT
PHONE: (303) 866-3567

MINE NAME: The Pride of America Mine	MINE/PROSPECTING ID#: M-1999-058	MINERAL: Marble	COUNTY: Gunnison
INSPECTION TYPE: Monitoring	INSPECTOR(S): Dustin Czapla	INSP. DATE: June 21, 2022	INSP. TIME: 11:00
OPERATOR: Colorado Stone Quarries, Inc.	OPERATOR REPRESENTATIVE: Jean St-Onge	TYPE OF OPERATION: 112c - Construction Regular Operation	
REASON FOR INSPECTION: Normal I&E Program	BOND CALCULATION TYPE: Complete Bond	BOND AMOUNT: \$404,857.00	
DATE OF COMPLAINT: NA	POST INSP. CONTACTS: None	JOINT INSP. AGENCY: None	
WEATHER: Clear	INSPECTOR'S SIGNATURE:

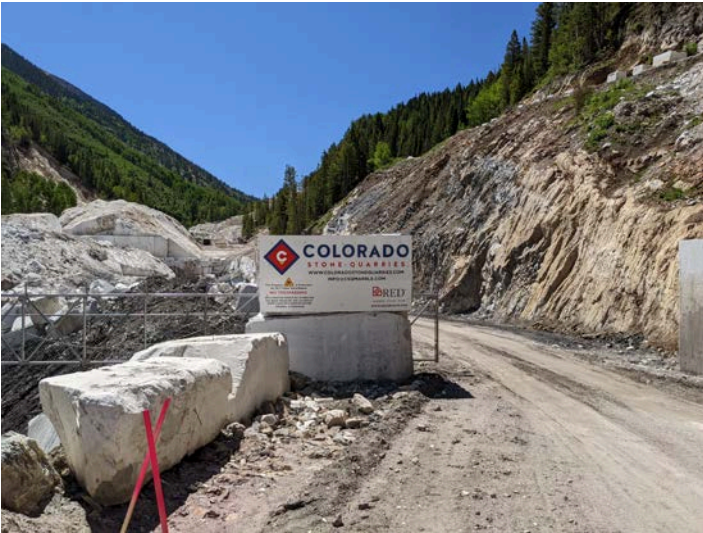
Adequate mine identification signage was noted at the entrance to the site.

Site Entrance Secured by Locked Gate

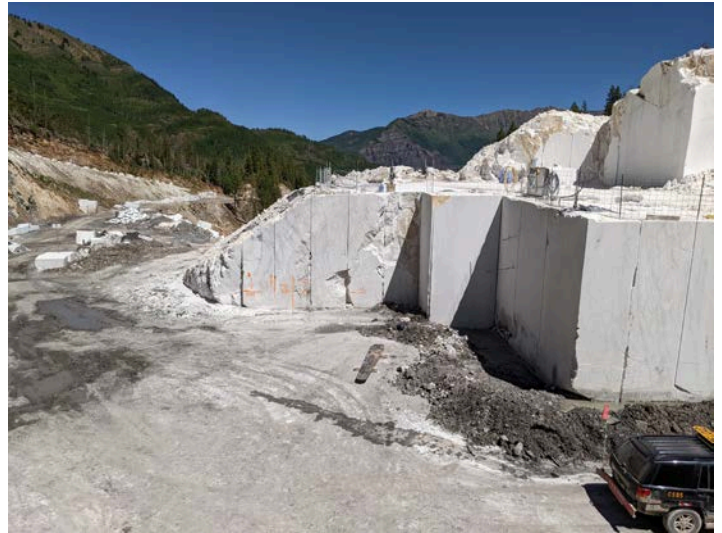
Franklin Quarry Area

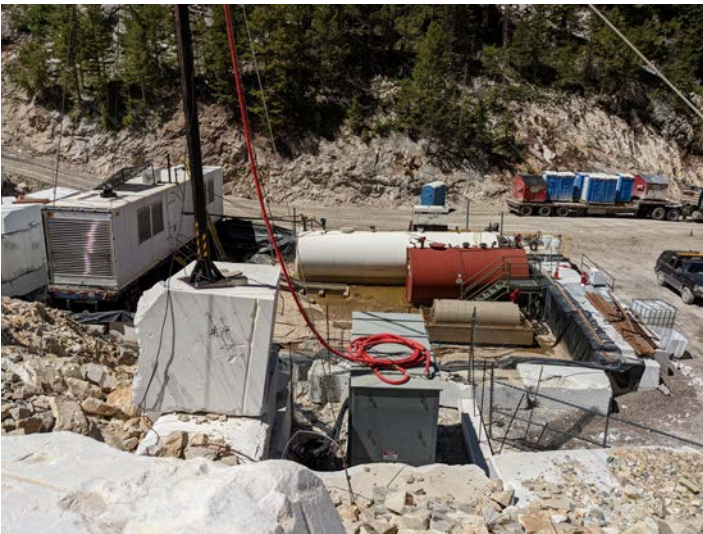
Fuel for the site is stored in the Franklin Quarry. This location was authorized through approval of TR-06. The two site gensets and associated fuel containers and fuel containment for equipment are located in a lined containment structure. Fuel tanks \geq 1,000 gallons are double walled. No problems with the containment facility were noted.

Gensets and Fuel Storage in Franklin area

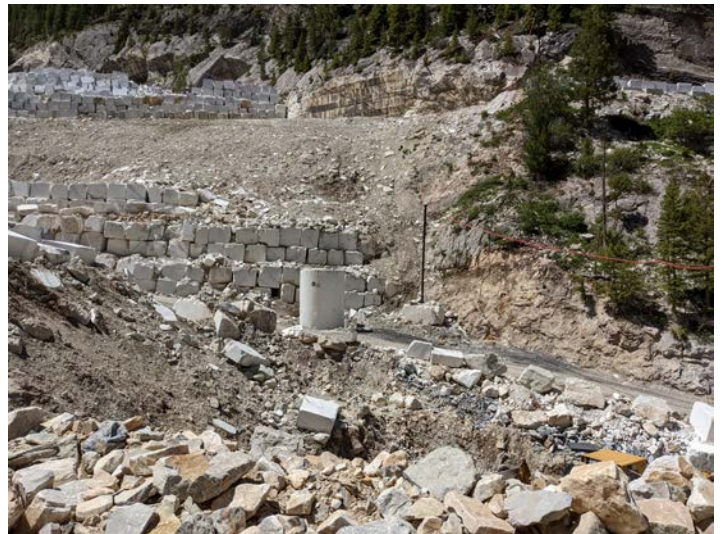
Mining observed at the site appeared in accordance with the approved mining plan. Waste rock piles appeared stable. No stormwater management or erosional concerns were noted.

Waste rock placed above Franklin Quarry

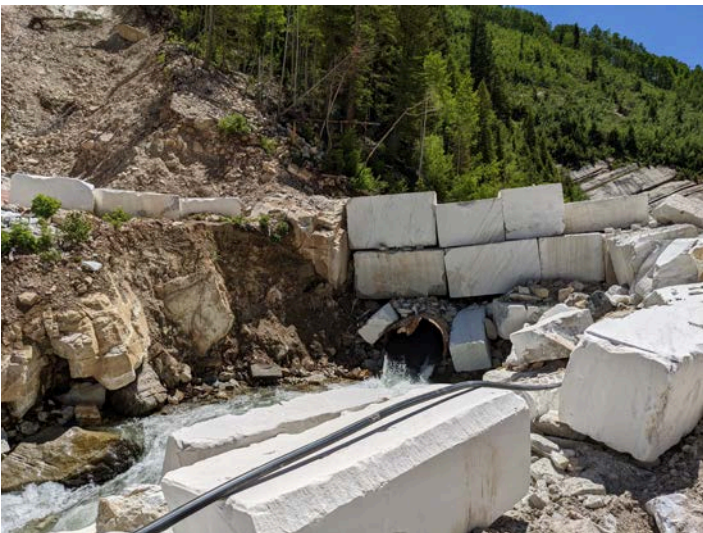
In March 2022 the U.S. Army Corp of Engineers (USACE) issued CSQ a permit authorizing the diversion of Yule Creek to its current eastern channel along with associated mitigation work to Yule Creek. Work authorized by the USACE permit, within the DRMS permit boundary, will need to be incorporated into the DRMS permit through a Technical Revision to the permit.

Yule Creek Diversion Area
