MINERALS PROGRAM INSPECTION REPORT
PHONE: (303) 866-3567

MINE NAME: 90 Road Pit	MINE/PROSPECTING ID#: M-2008-043	MINERAL: Sand and gravel	COUNTY: Montrose
INSPECTION TYPE: Monitoring	INSPECTOR(S): Dustin Czapla	INSP. DATE: June 23, 2022	INSP. TIME: 15:00
OPERATOR: Rocky Mountain Aggregate & Construction, Inc.	OPERATOR REPRESENTATIVE: None	TYPE OF OPERATION: 110c - Construction Limited Impact

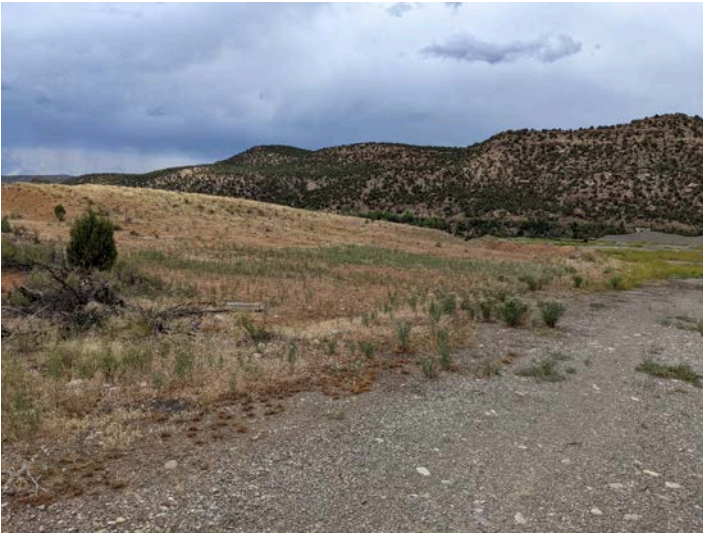
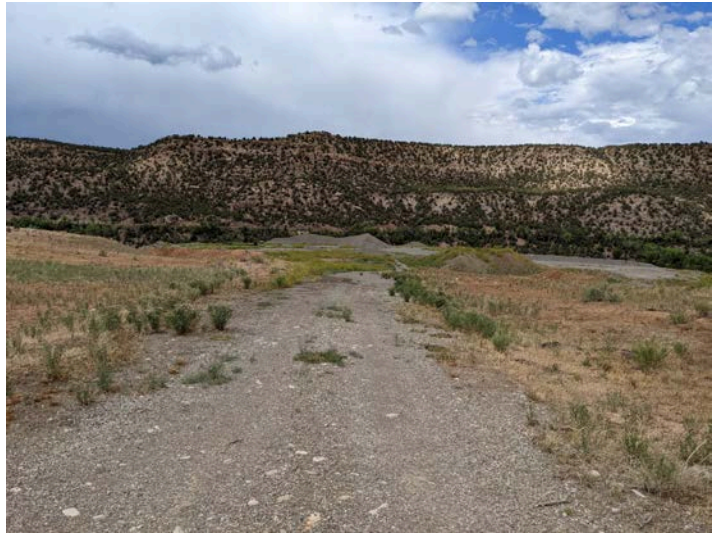
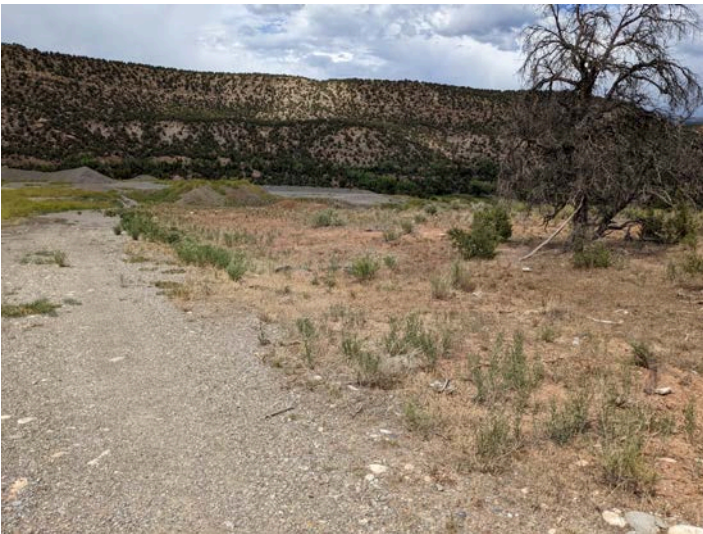
Adequate mine identification signage was not noted at the entrance to the site. This has been noted as a problem.

Mining has disturbed approximately two acres at the site. According to Operator's annual reports the mining took place in 2020. Topsoil has been stockpiled around the mined area. Processed gravel is stockpiled on the pit floor.

Small patches of knapweed were observed. These will need to be treated to prevent infestation.
