Stoner Engineering & Surveying

July 6, 2022

King Coal I – Quarterly Water Quality Improvements Inspection

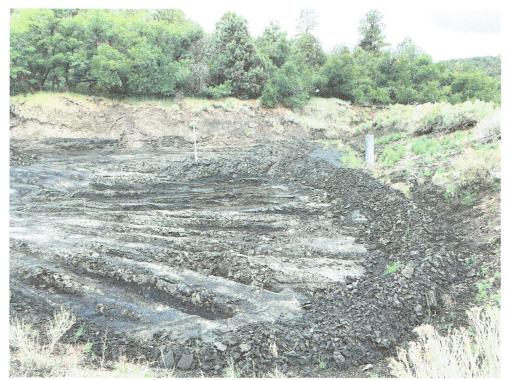
Both ponds held water at the time of the inspection. The water level in the west pond was minimal. Some sediment removal from the west pond had taken place since the previous inspection (see Pic. 1). The east pond water level was at the approximate level of sediment removed from the pond (see Pic. 2). The ponds should continue to be monitored after storm events to ensure that excess sediment does not reduce the required storage capacity available for storm water runoff.

Pic. 1 – Sediment removal ongoing, West pond.

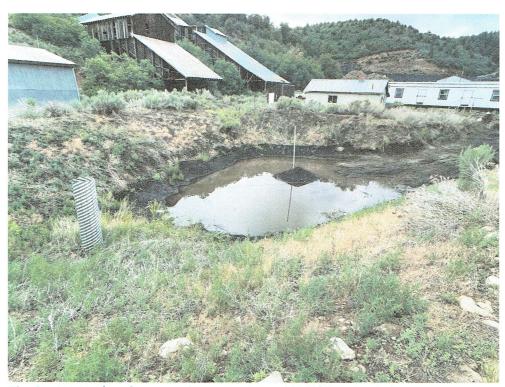
Pic. 2 – Water level near sediment removal level, East pond.

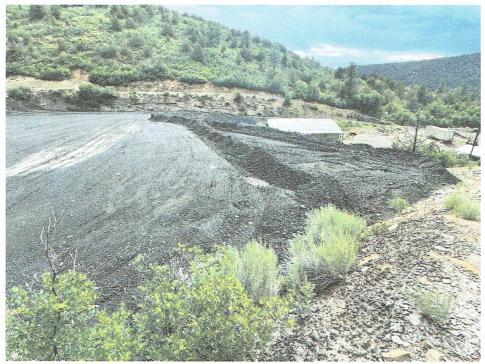
The sedimentation traps at the entrance to the site are generally in good condition. Waste material has been placed on the lower waste pile since the previous inspection. The grading of the lower waste embankment pile generally directs surface runoff generally to the south and west as required in the design documents. New berming has been constructed in the northeast corner of the lower pile which will minimize the potential for runoff from entering the clear water ditch (see Pic. 3). The treated water ditch should be monitored for weed growth to ensure capacity is not hindered due to plant growth (see Pic. 4).

Pic. 3 – Lower waste pile, new berming at top of pile.

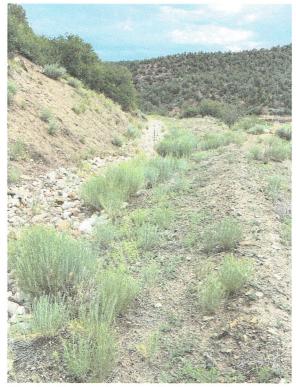
Pic. 4 – Treated water ditch, weed growth.
