QUARTERLY SEDIMENTATION POND INSPECTION REPORT

Mine: Lorencito

Inspection Period: Second Quarter 2022

QUARTERLY SEDIMENTATION POND INSPECTION REPORT
Lorencito Canyon Mine- June 20, 2022

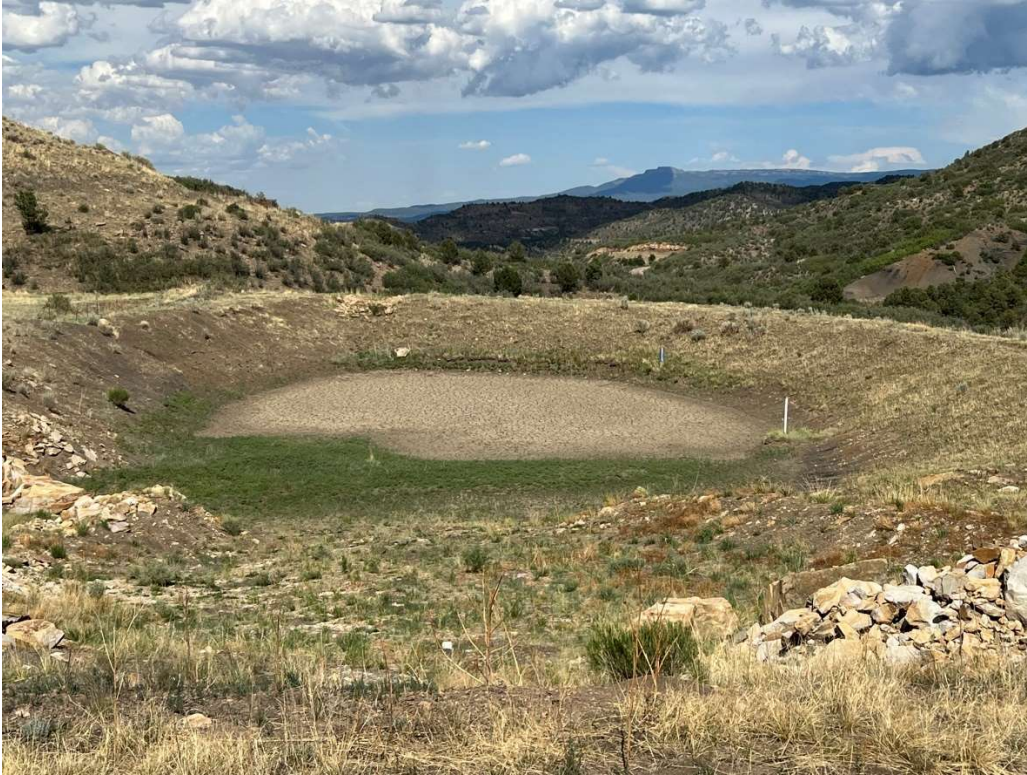
Pond was empty at time of inspection.

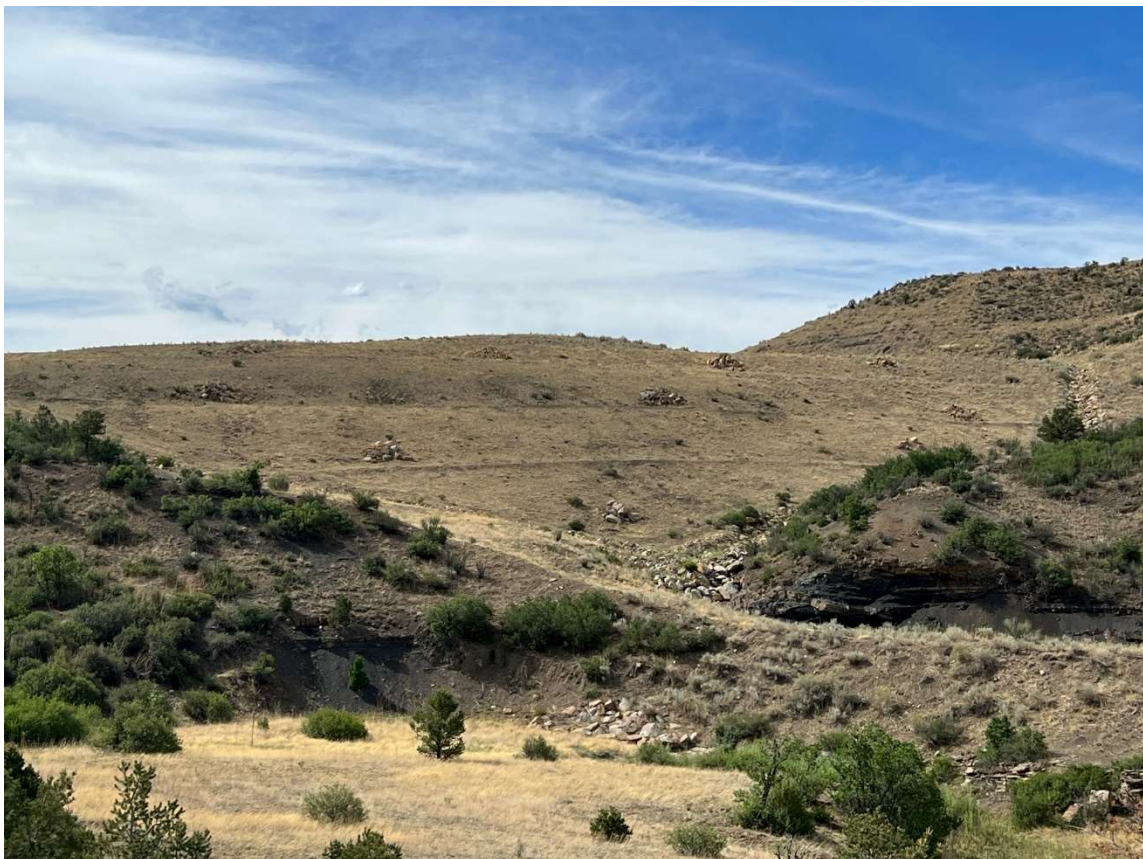
Pond 6

Pond was dry at time of inspection.

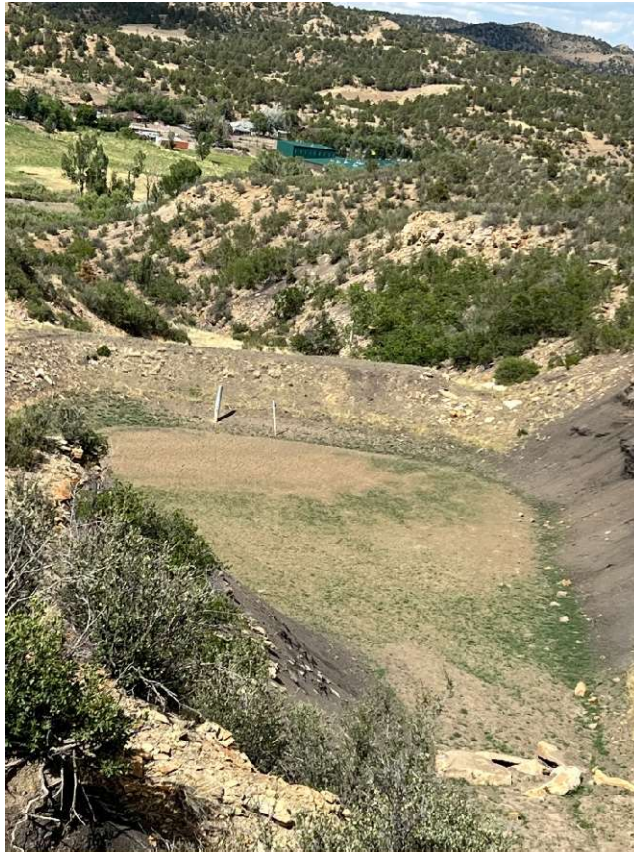
Pond 7 Embankment

Pond was dry at time of inspection.

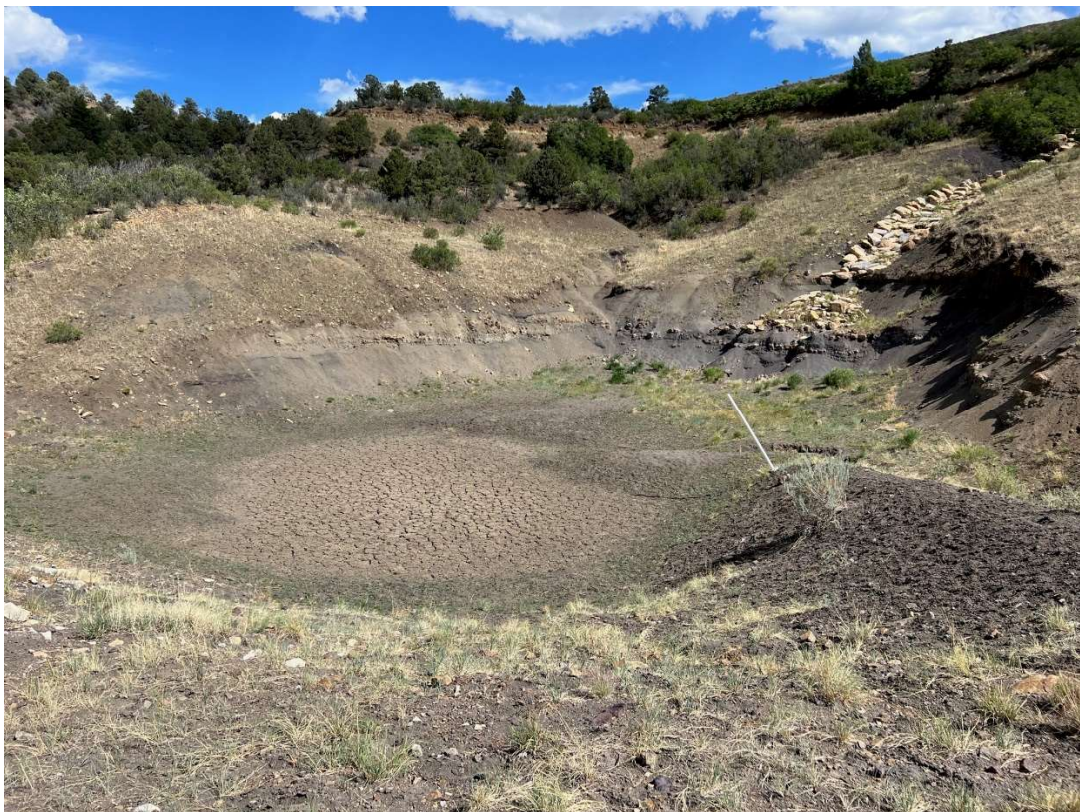
Pond 8

Pond was dry at time of inspection.

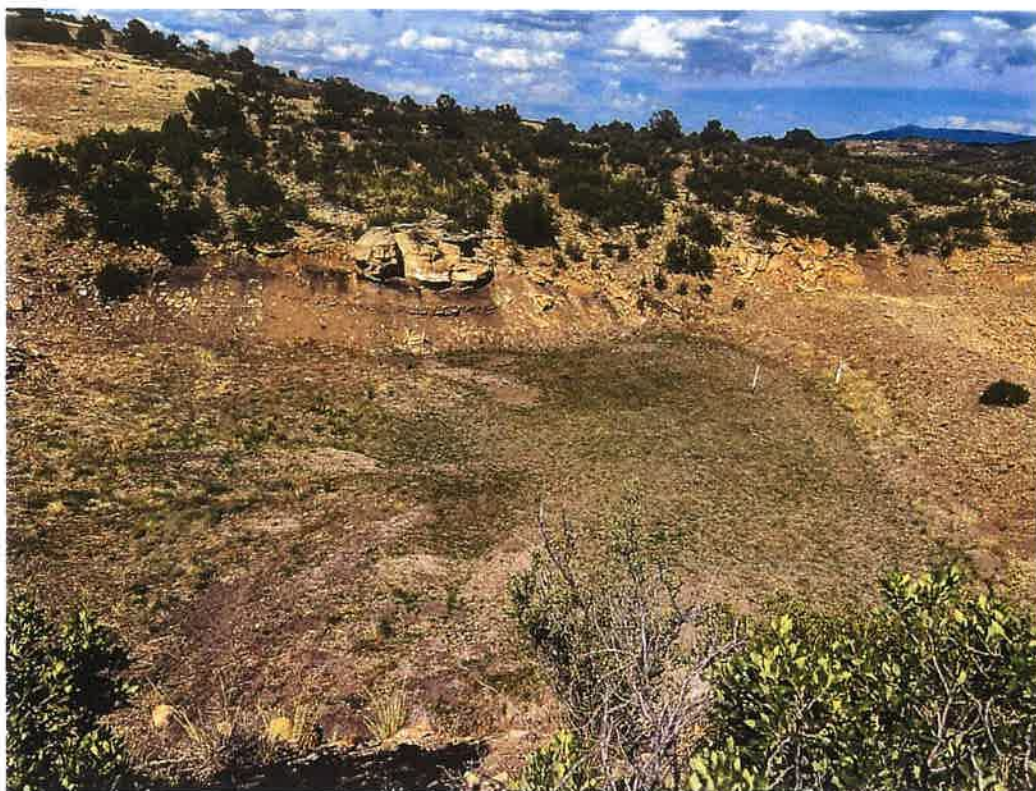
Pond 9

Pond was dry at time of inspection.
