Stoner Engineering & Surveying

July 6, 2022

King Coal I – Quarterly Waste Pile/Embankment Inspection

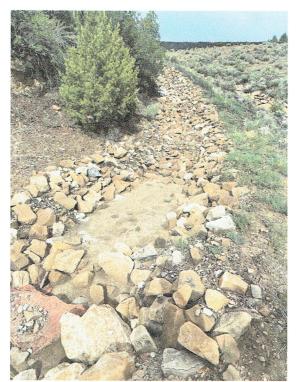
The south treated water ditch (Reach 10) and the north clear water ditch (Reach 1) are in generally good condition. There has been some sedimentation of the north clear water ditch where the ditch slope flattens out just above the lower waste embankment pile. This needs to be cleaned out to maintain ditch capacities (see Pic. 1). The south treated water ditch appeared to be in generally good condition though there has also been some sedimentation at the culvert inlet under the haul road located under the vertical face (see Pic. 2). The inlet area for the culvert should be cleaned to prevent the potential for clogging.

Pic. 1 –Reach 1 clear water channel with sedimentation from erosion.

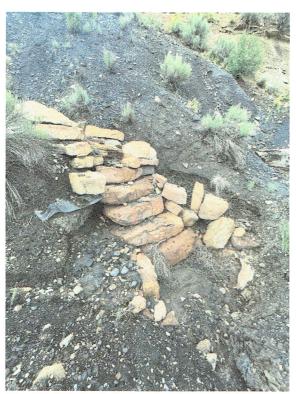
Pic. 2 –Culvert inlet under haul road, below vertical face.

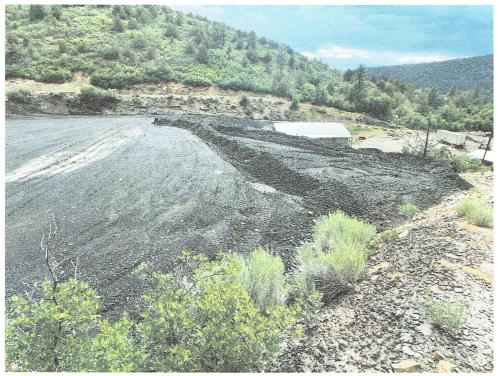
The lower waste pile material has been pulled back from the clear water ditch and a new berm has been installed at the top to prevent surface runoff from the lower pile from entering the clear water ditch (see Pic. 3).

Pic. 3 – NE corner of lower waste pile, new berming.

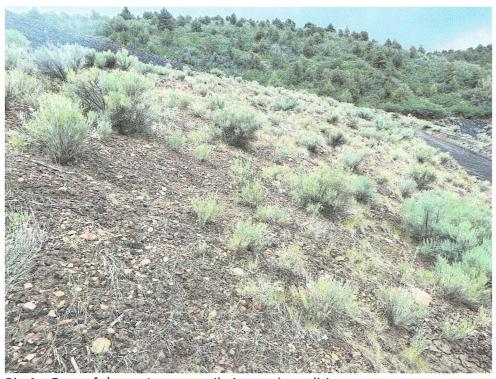
The face of the embankment appeared to be in generally good condition. There were no signs of excessive erosion, instability, sloughing or weakness observed on the face of the embankment of either of the waste embankment piles at the time of the inspection (see Pic. 4).

Pic 4 – Face of the main waste pile in good condition.
