LORENCITO CANYON MINE
Permit No. C-1996-084

INSPECTION OF EXCESS SPOIL-FILLS 7, 8, & 9
June 20, 2022

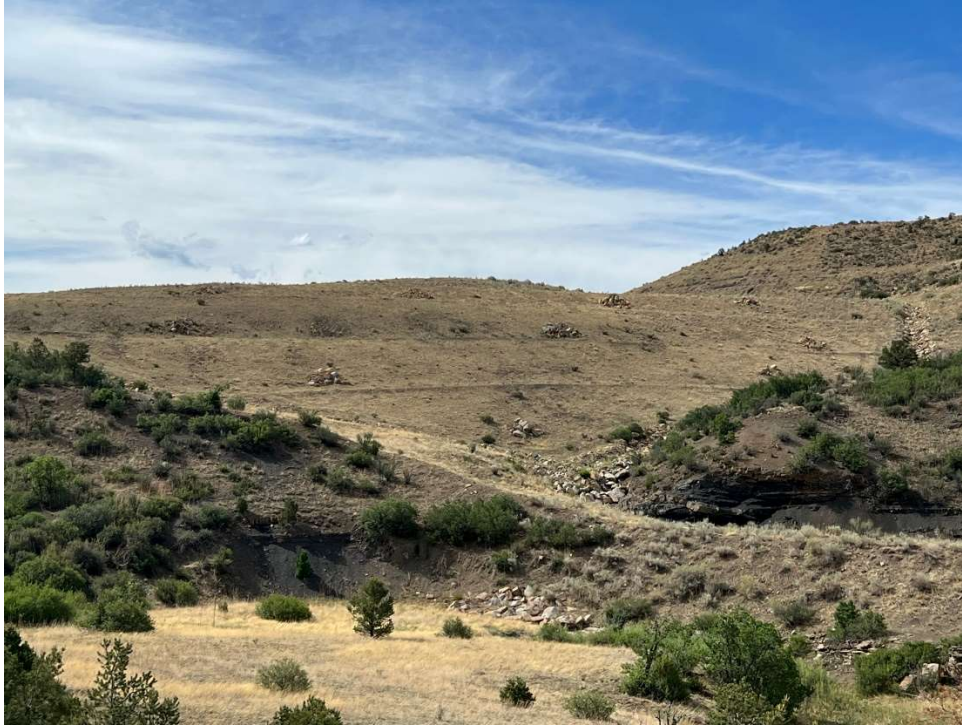
Fill #7

Armored Ditches line the east and west boundary of the fill area. Lateral ditches on the fill face direct runoff to these side ditches. A fourth east-west ditch was constructed at the upper most extent of the fill connecting to both armored ditches on the east and west perimeters. No erosional problems were noted at the intersections or along the lateral ditches and the armored ditches. Slopes are well vegetated and no erosional problems were observed.

The entire excess spoil fill facility was examined for signs of failure and instability such as tension cracks, ground movement, springs and seeps, and standing water. There was no indication of potential instability at time of inspection.

Overall the site is in good condition. The vegetation on the fill is encouraging.

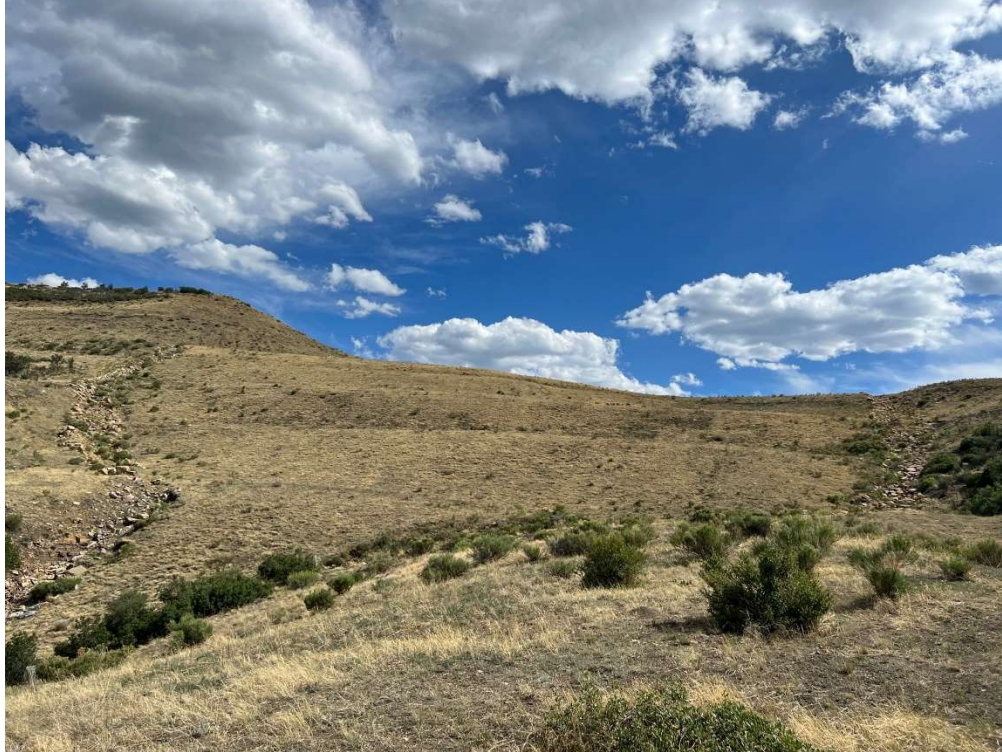
Fill #8

Armored Ditches line the east and west boundary of the fill area. Lateral ditches on the fill face direct runoff to these side ditches. No erosional problems were noted at the intersections or along the lateral ditches and the armored ditches. Slopes are well vegetated and no erosional problems were observed.

The entire excess spoil fill facility was examined for signs of failure and instability such as tension cracks, ground movement, springs and seeps, and standing water. There was no indication of potential instability at time of inspection.

Overall the site is in good condition. Vegetation is very good on the fill.

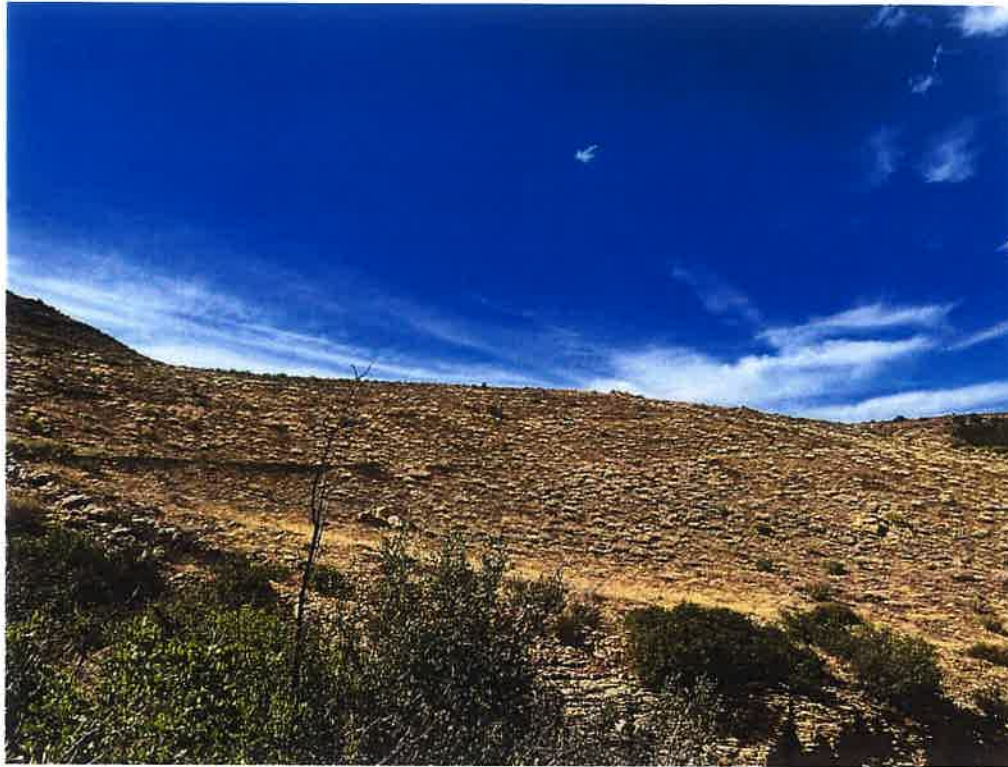
Fill #9

Armored Ditches line the east and west boundary of the fill area. Lateral ditches on the fill face direct runoff to these side ditches. No erosional problems were noted at the intersections or along the lateral ditches and the armored ditches. Slopes are well vegetated and no erosional problems were observed at the time of this inspection.

The entire excess spoil fill facility was examined for signs of failure and instability such as tension cracks, ground movement, springs and seeps, and standing water. There was no indication of potential instability at time of inspection.

Overall the site is in good condition.
