NEW ELK MINE
Permit No. C-1981-012

QUARTERLY COAL WASTE BANK INSPECTION REPORT
June 20, 2022

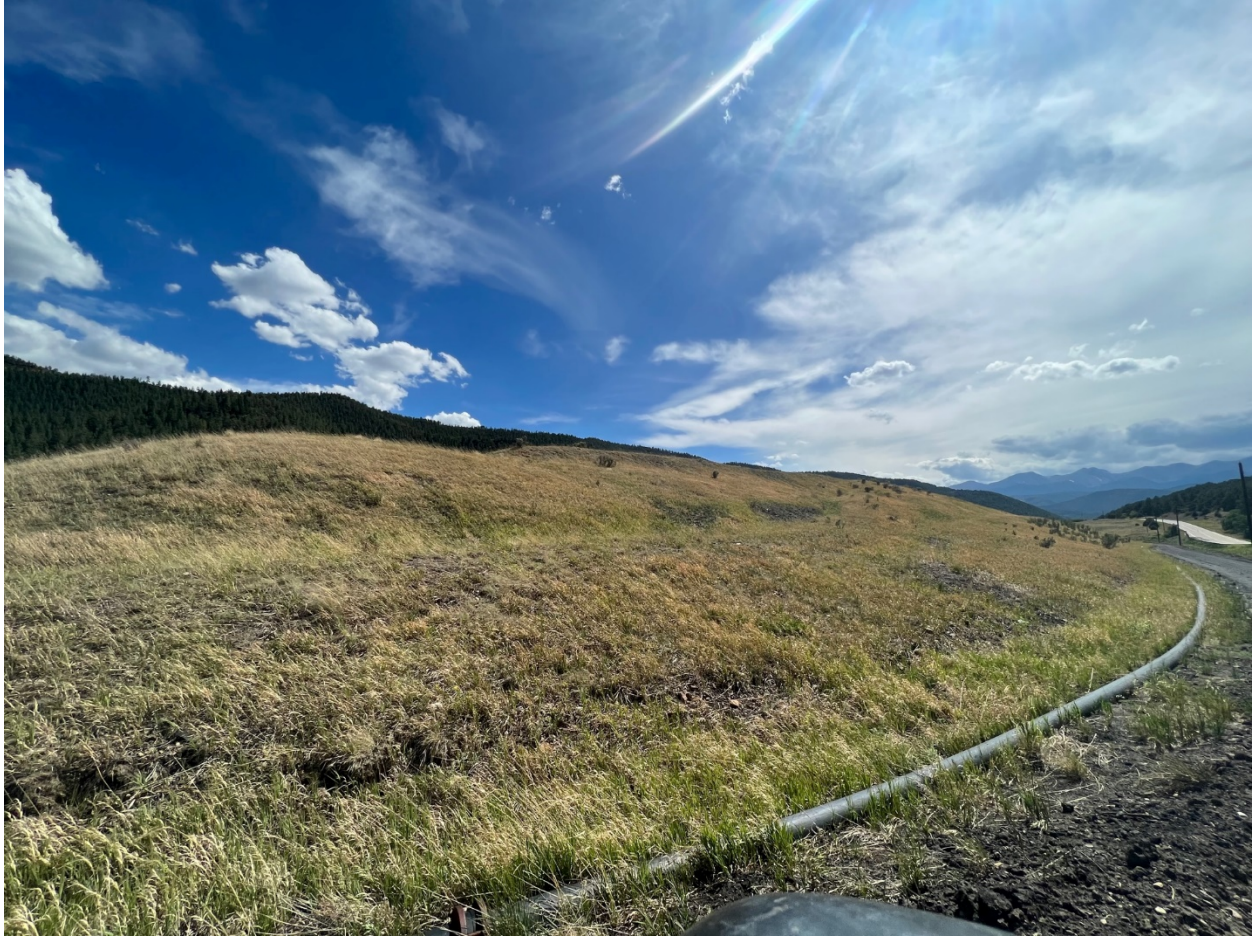
DWDA #1

Surface and out slopes of the pile were inspected for visible signs of potential failure or instability. None were observed.

Overall the disposal area is in good condition.

None at this time.

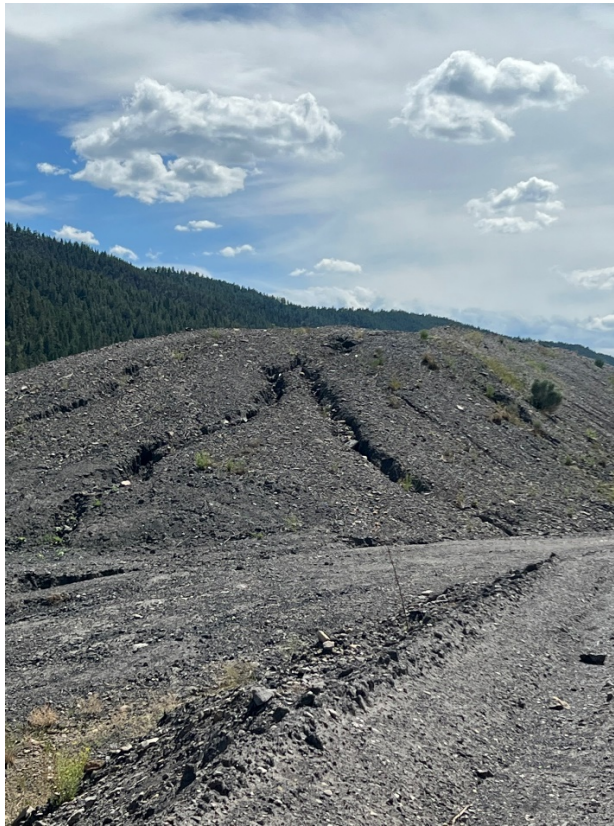
DWDA #2

Positive Drainage is maintained on the surface of the DWDA. Sump on East end of pile was being cleaned at time of inspection. Rills on the disposal area are being monitored. No evidence of springs nor seeps were observed.

Surface and out slopes of the pile were inspected for visible signs of potential failure or instability. There was some surface erosion but not enough to make the area unstable. In all no signs of failure or instability were observed.

Overall the disposal area is in good condition.

A rill has formed on the east end of the waste pile. Rill should be filled in and check dams put in place to prevent this rill developing again. Operator is evaluating either reclamation of the area or permitting alternative uses of the land north of the Purgatoire River and south of Highway 12.
