QUARTERLY SEDIMENTATION POND INSPECTION REPORT

Mine: New Elk

Inspection Period: Second Quarter 2022

Inspection Date: 6/20/2022

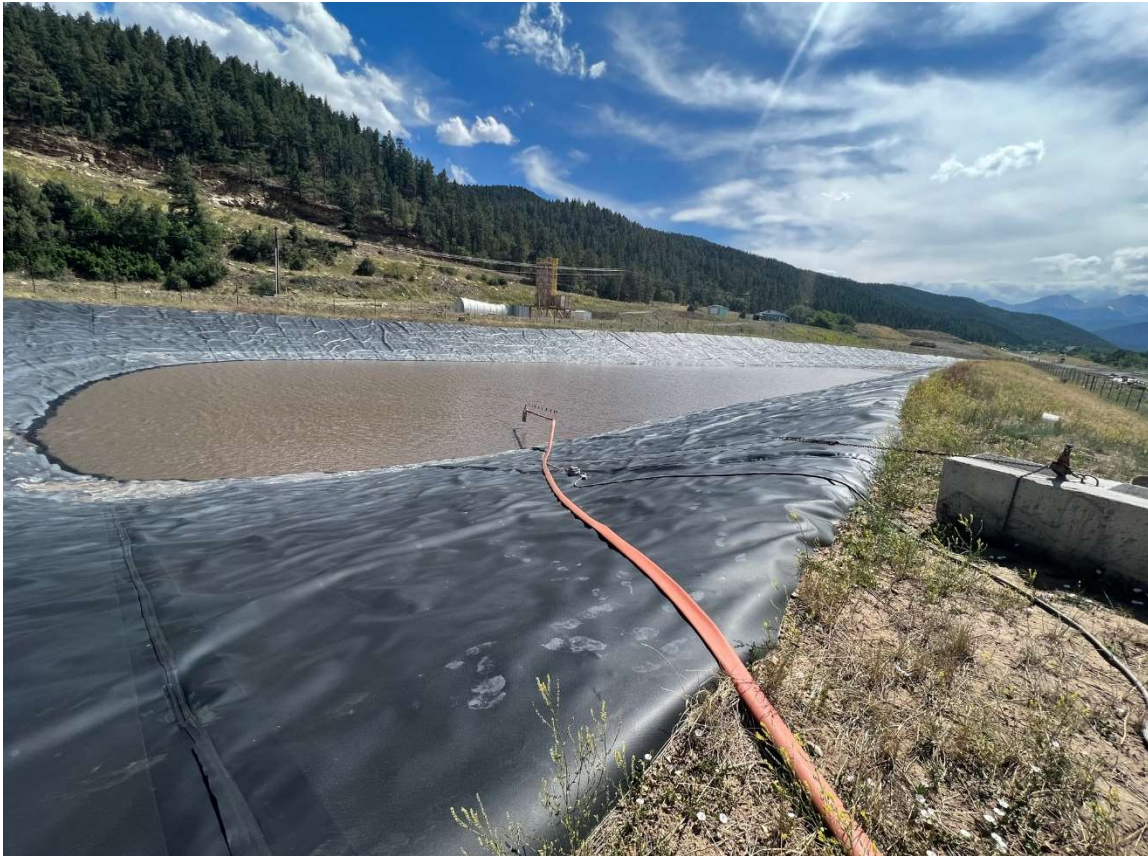
Pond 1

Pond liner is in good working condition at time of inspection. Pond was holding water at time of
inspection. The mine is putting water into the pond. Water is lower than previous inspection.

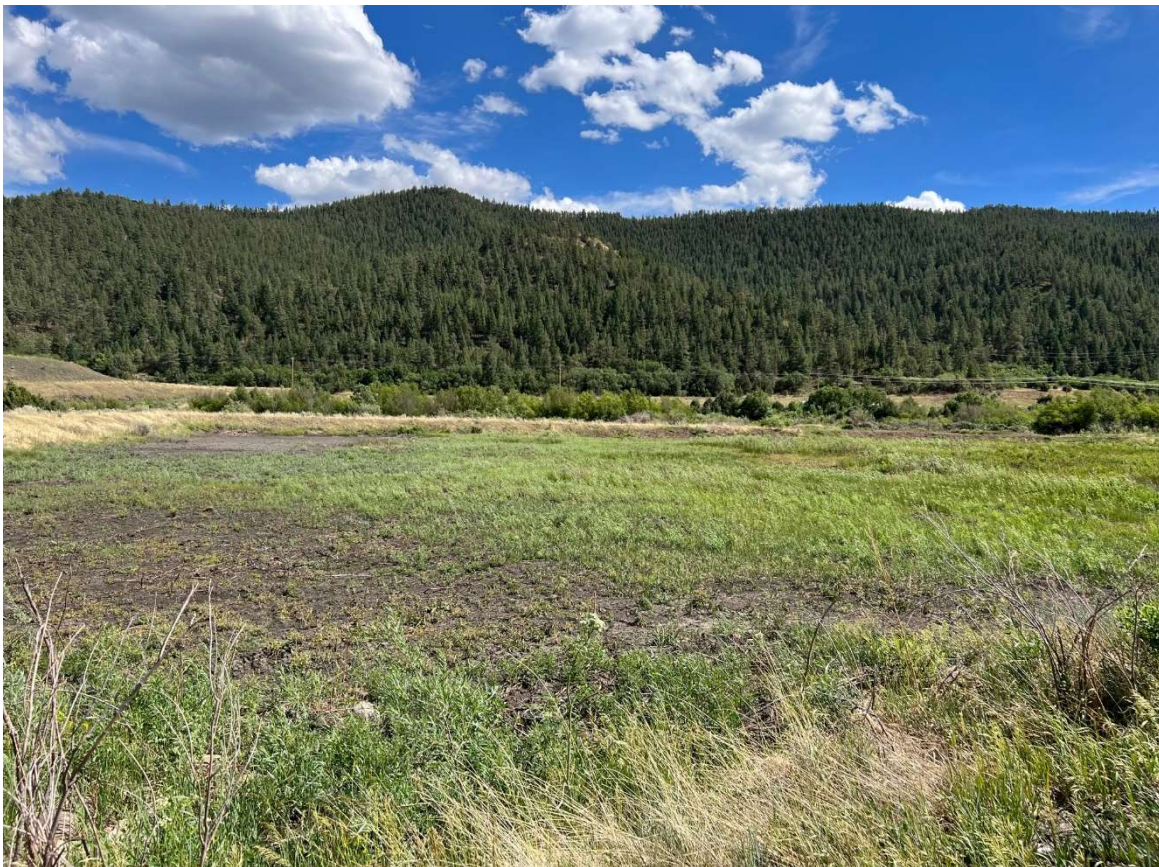
Pond 4

Pond was empty at the time of inspection.

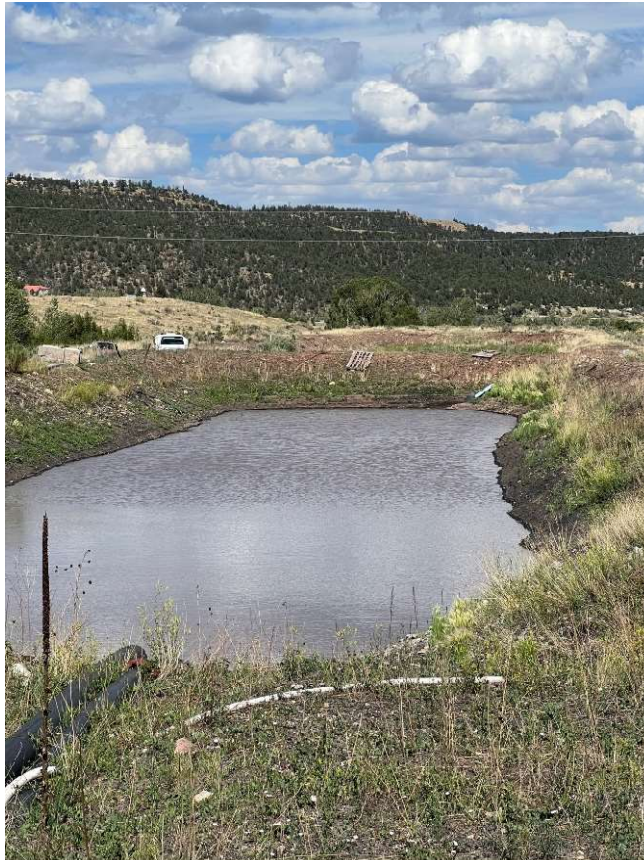
Pond 6

Pond had water in it at time of inspection

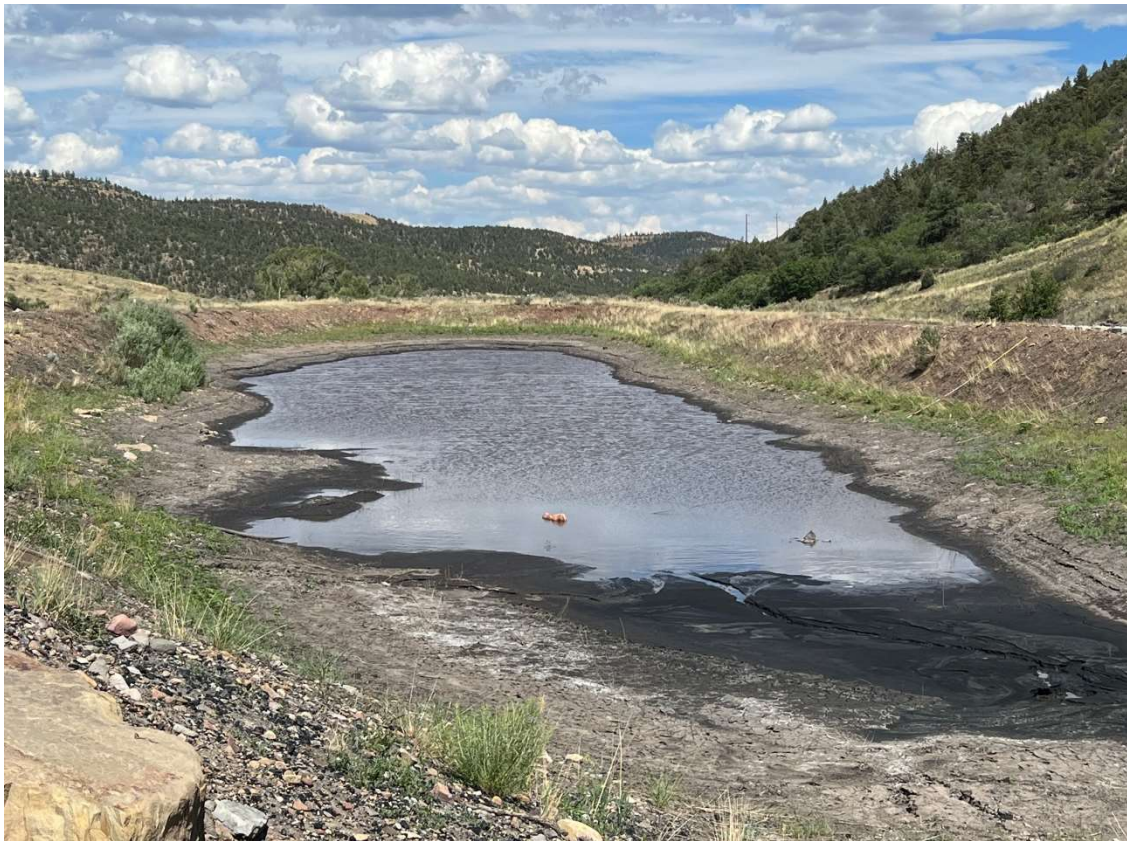
Pond 7

Pond is holding water at time of inspection. Less water than the previous inspection.

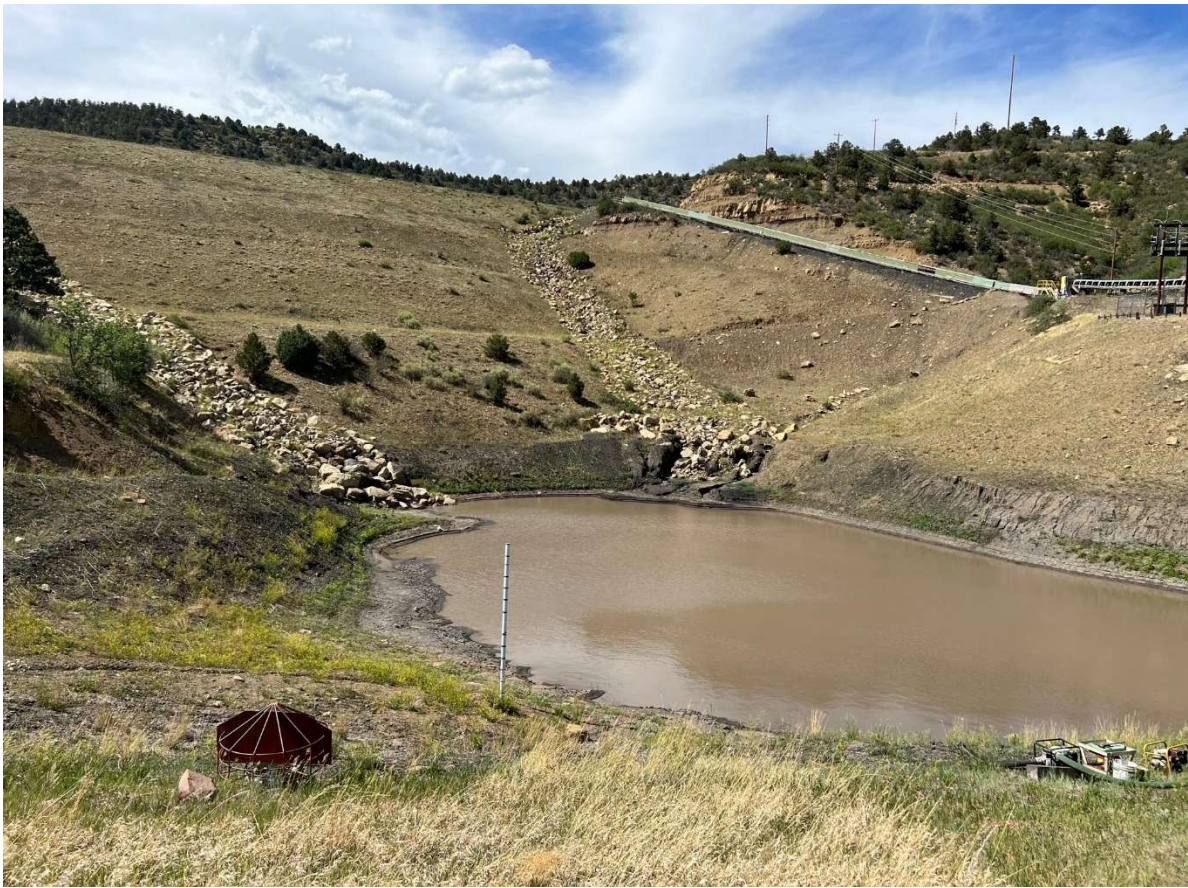
Pond 8

Pond is holding water at time of inspection.

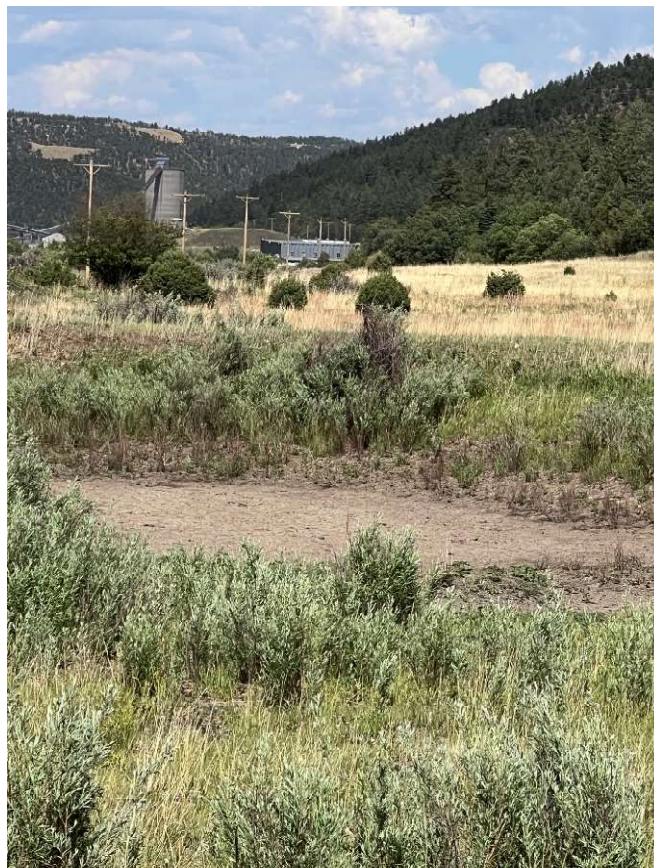
Containment Area #1

Containment was dry at time of inspection.

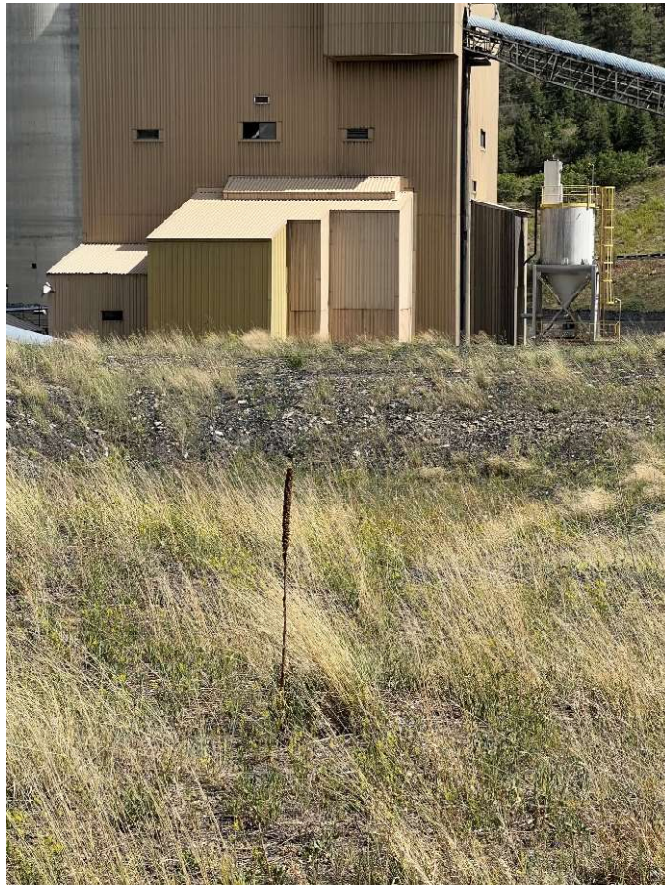
Containment Area #3

Containment Area was dry at time of inspection.

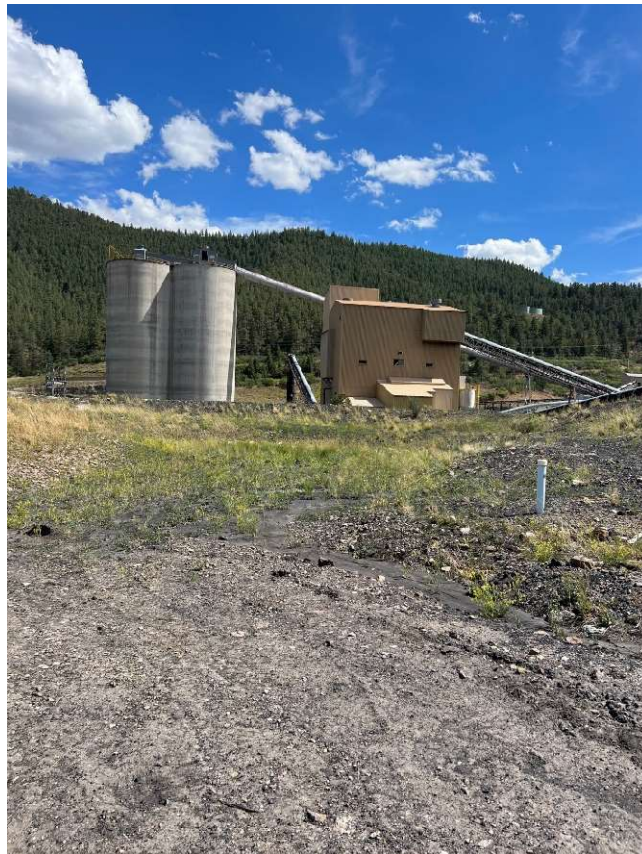
Containment Area #4

Containment Area was dry at time of inspection.

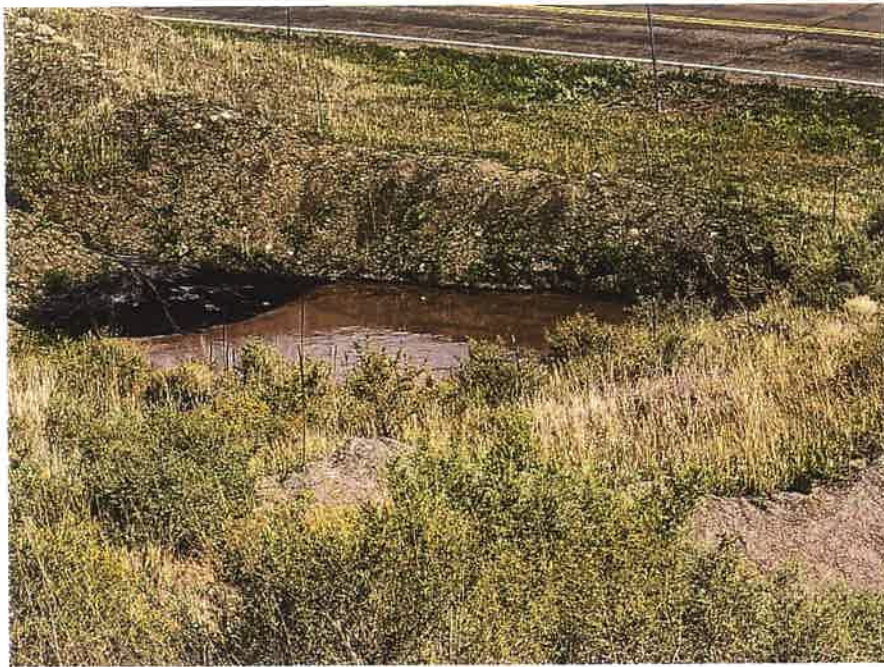
Containment Area #5

Containment Area was holding water at time of inspection.
