Job Number: 99-3983

Subject: Quarterly Observation Report, Refuse Pile, Foidel Creek Mine, Routt County, Colorado.

TCC Refuse Pile-Quarterly Inspection

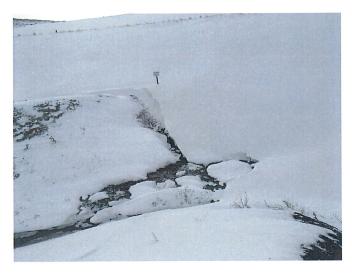
A seepage area at the toe of the northeast end of the refuse pile expansion area, approximately 30 feet northwest of the outlet of the underdrain, developed in fall 2014. At the time of our observations, the seepage was surfacing at the toe of the slope and flowing into the drainage from the undrain outlet then into the existing pond east of the Refuse Pile Expansion Area. The discharge was clear, with no evidence of sediment. No signs of washout, slumps or slope instability were observed at this time. The seepage area will be monitored during future inspections and noted in our inspection reports. Photographs of the seepage area taken at the time of our inspection on December 30, 2021 are attached.

December 30, 2021-Drain Outlet and Seepage Area

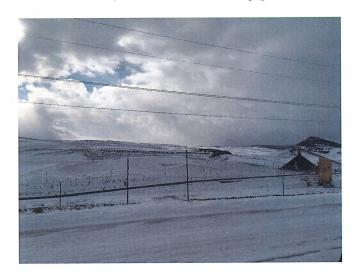
The internal roadways in the new expansion area of the pile are in good condition. The upper haul road to Areas 2, 3 and 4 of the refuse pile was not accessible at the time of our site visit, due to snow.

December 30, 2021- Expansion Area and Areas 2, 3, 4

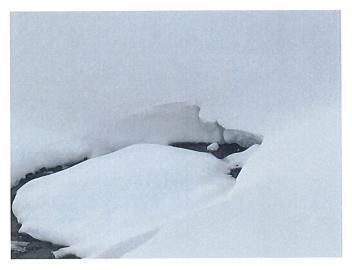
December 30, 2021-Seepage Area

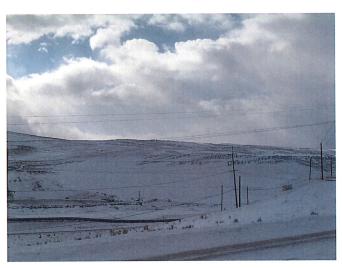
At the time of our site visit on December 30, 2021, NWCC completed a site inspection of the existing refuse pile. Based on our observations made during this visit, it appeared that the contractor was presently stockpiling, grading and compacting refuse coal in the new Expansion Area. At the time of our site visit, the refuse coal had been placed and compacted to an elevation above the third bench situated along the east side of the stockpile.

December 30, 2021- Benches on East Side of Refuse Pile
