**MINERALS PROGRAM INSPECTION REPORT**  
**PHONE: (303) 866-3567**

<b>MINE NAME:</b> Florence Pit	<b>MINE/PROSPECTING ID#:</b> M-2001-070	<b>MINERAL:</b> Gemstones	<b>COUNTY:</b> Teller
<b>INSPECTION TYPE:</b> Monitoring	<b>INSPECTOR(S):</b> Elliott Russell	<b>INSP. DATE:</b> May 26, 2022	<b>INSP. TIME:</b> 12:00
<b>OPERATOR:</b> Wallace F. Burtis	<b>OPERATOR REPRESENTATIVE:</b> None	<b>TYPE OF OPERATION:</b> 110(2) - Hard Rock Limited Impact

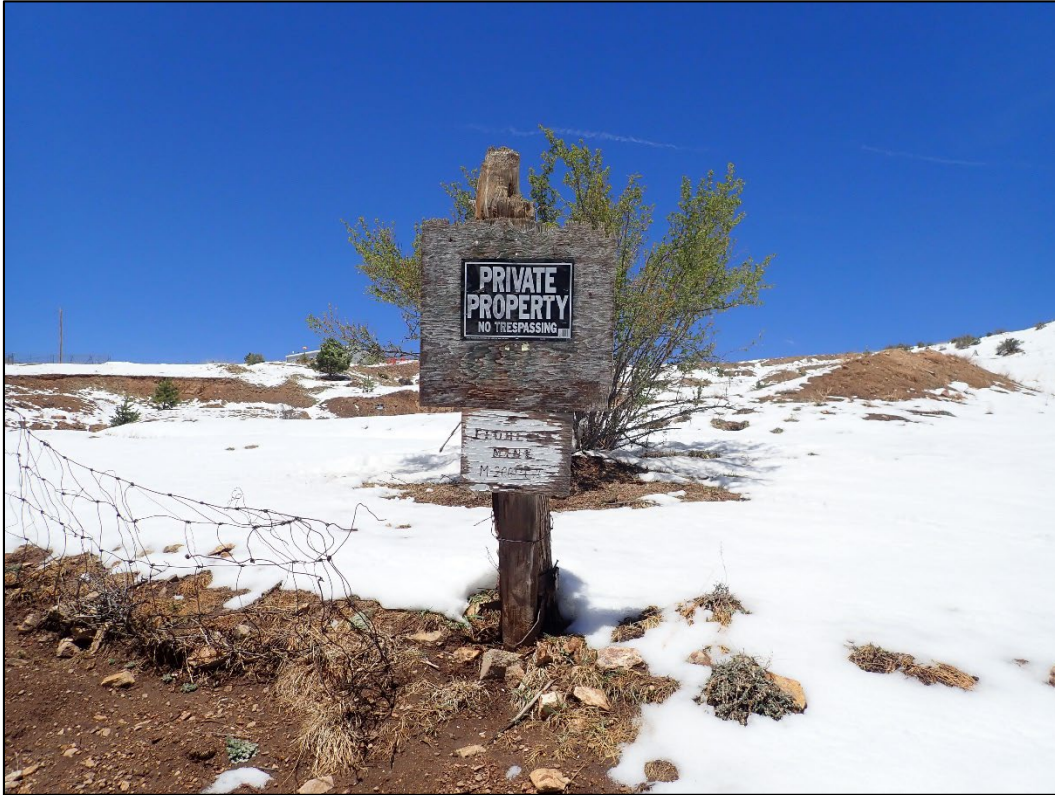
**COMPLIANCE PROBLEM #1:** The mine identification sign was illegible and needs to be refreshed. This is a problem for failure to post a mine identification sign as required by Rule 3.1.12(1).

Signs and Markers: The permit sign was posted along the access road. The sign has deteriorated and will need to be refreshed; this has been cited as Compliance Problem #1, requiring the Operator to post a new permit identification sign. The Division was unable to locate the boundary markers which are required to delineate the permit boundary; this has been cited as Compliance Problem #2, requiring the Operator to delineate to permit boundary with markers.

**Photo 1.** Mine identification sign; looking northwest.

**CORRECTIVE ACTIONS:** The Operator shall, at the entrance of the mine site post a sign, which shall be clearly visible from the access road, with a minimum size equaling one hundred and eighty-seven (187) square inches, such as eleven (11) inches in height and seventeen (17) inches in width, with appropriate font size, with the following:

The Operator shall submit photo documentation that a proper sign has been posted by the corrective action date.

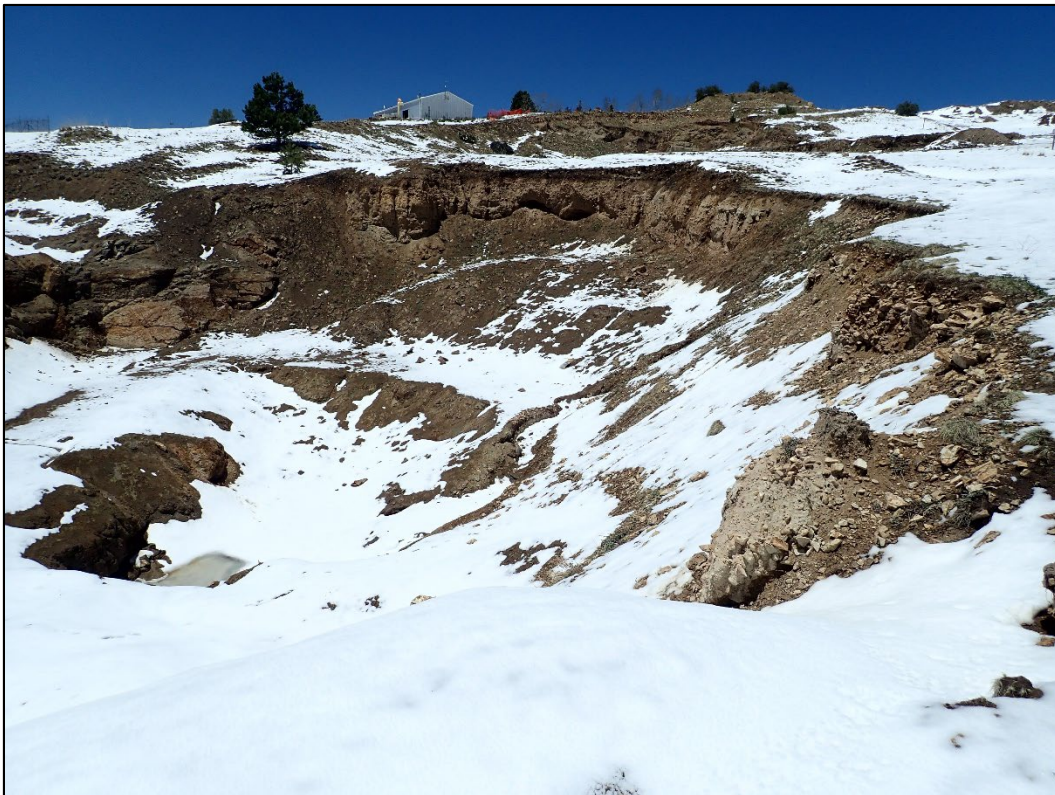
Hydrologic Balance: No exposed groundwater was observed during the inspection. Some water was observed in the bottom of the pit, however this was accumulating due to the melting snow from a recent spring storm.

**Photo 2.** Pit overview; looking northwest.

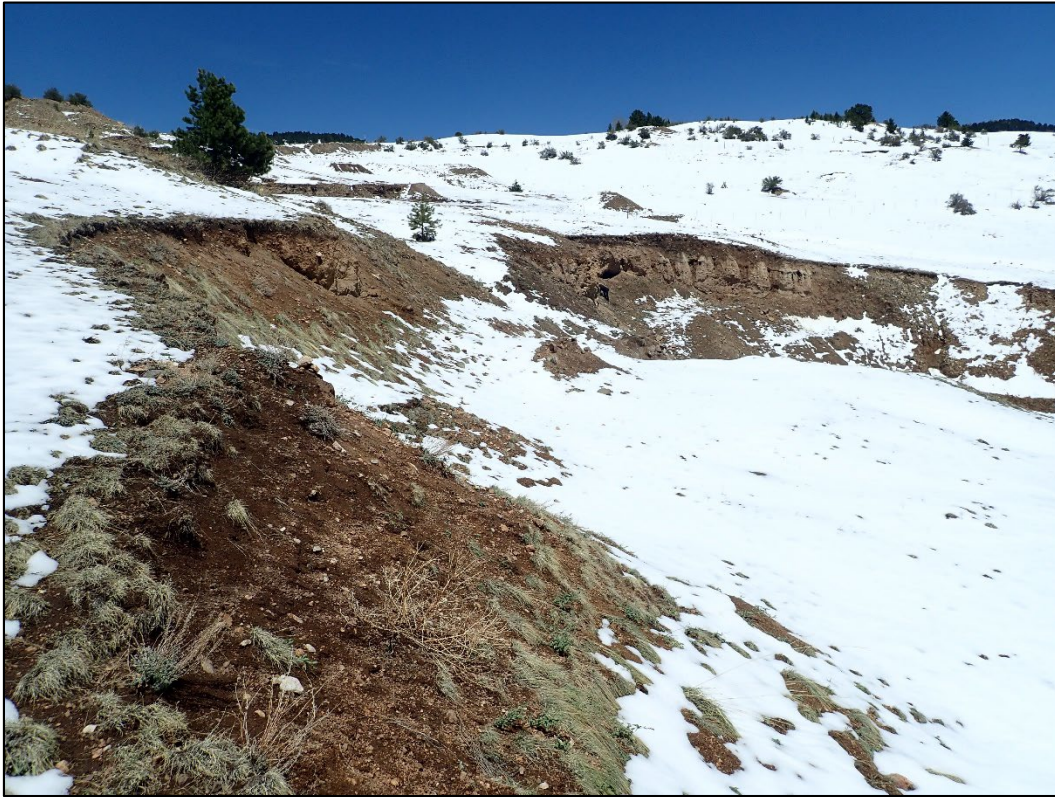
**Photo 3.** Western portion of pit; looking north.

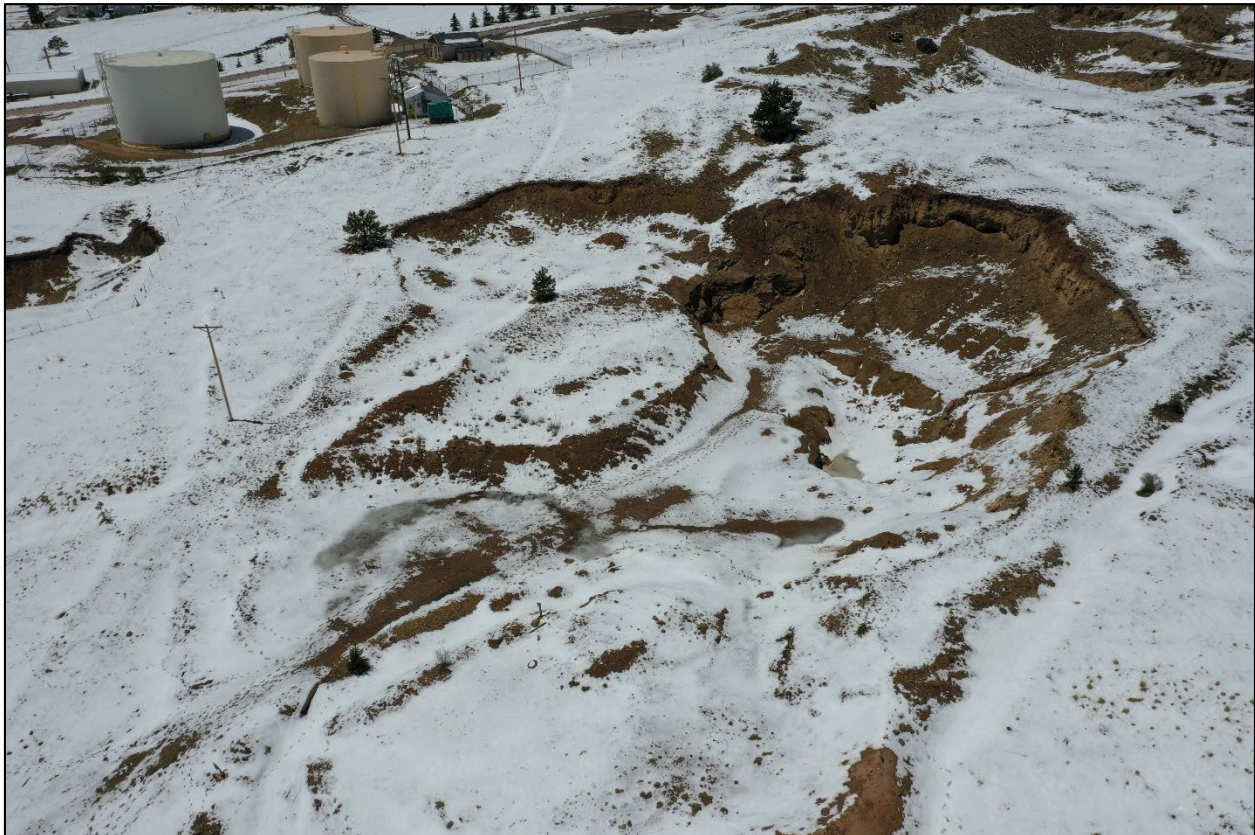
**Photo 4:** Site overview; looking northwest.

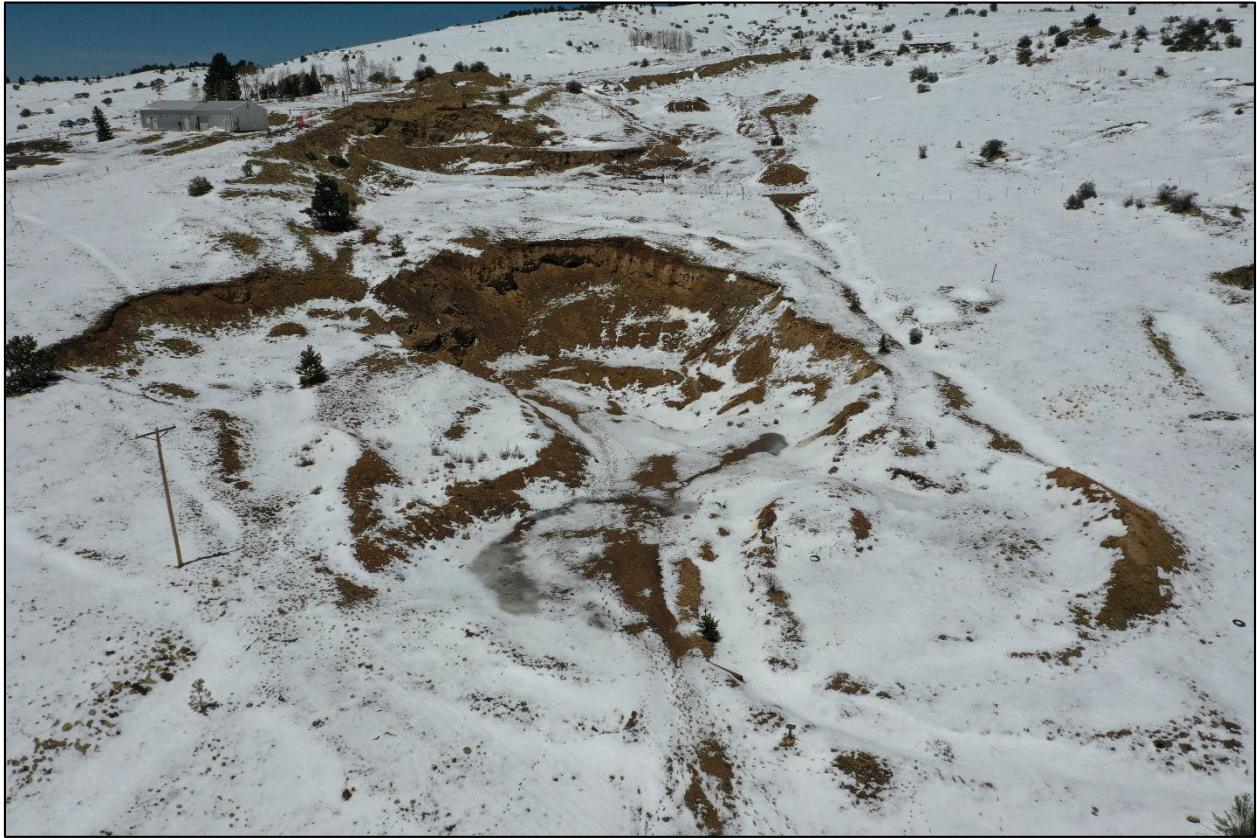
**Photo 5.** Site overview; looking north.
