MINERALS PROGRAM INSPECTION REPORT

MINE NAME: Cresson Project	MINE/PROSPECTING ID#: M-1980-244	MINERAL: Gold	COUNTY: Teller
INSPECTION TYPE: Monitoring	INSPECTOR(S): Patrick Lennberg	INSP. DATE: June 29, 2022	INSP. TIME: 08:00
OPERATOR: Cripple Creek & Victor Gold Mining Company	OPERATOR REPRESENTATIVE: Katie Blake	TYPE OF OPERATION: 112d-3 - Designated Mining Operation	
REASON FOR INSPECTION: Normal I&E Program	BOND CALCULATION TYPE: None	BOND AMOUNT: \$209,491,188.00	
DATE OF COMPLAINT: NA	POST INSP. CONTACTS: None	JOINT INSP. AGENCY: None	
WEATHER: Clear	INSPECTOR'S SIGNATURE:

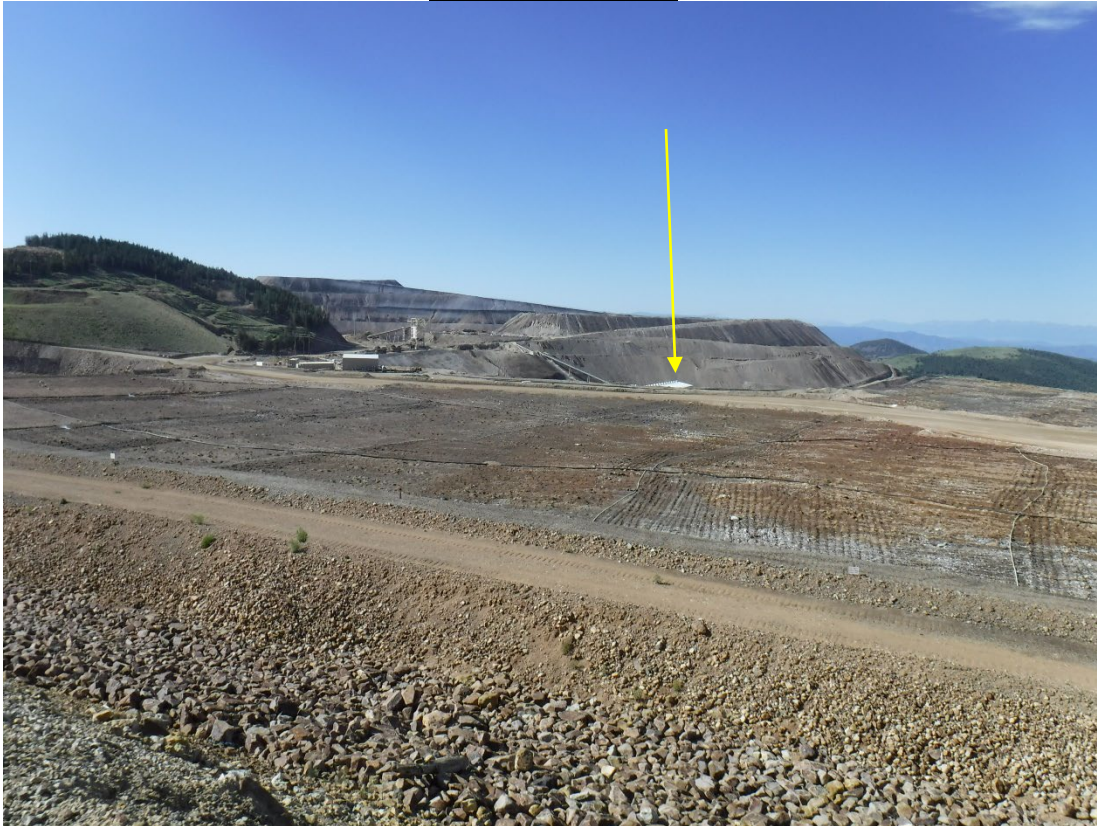
The Division observed VLF2 area from near the Brahma Warehouse. The operation is currently placing lifts, 10,100 foot level, with run of mine material mixed with cement material, which is dispensed directly into the truck beds. The Division inspected active leaching surfaces, 10,100 foot level, on the SGVLF. The operation is required to minimize ponding of leaching solution to less than 3 feet by 3 feet in area. This is to prevent the ponds from being a wildlife attractant. Active leaching areas appeared to be well-ripped to minimize ponding. Little to no ponding was observed.

Photo 1: Looking south across 10,100 level the VLF, the arrow indicates the roof of the High Grade Mill

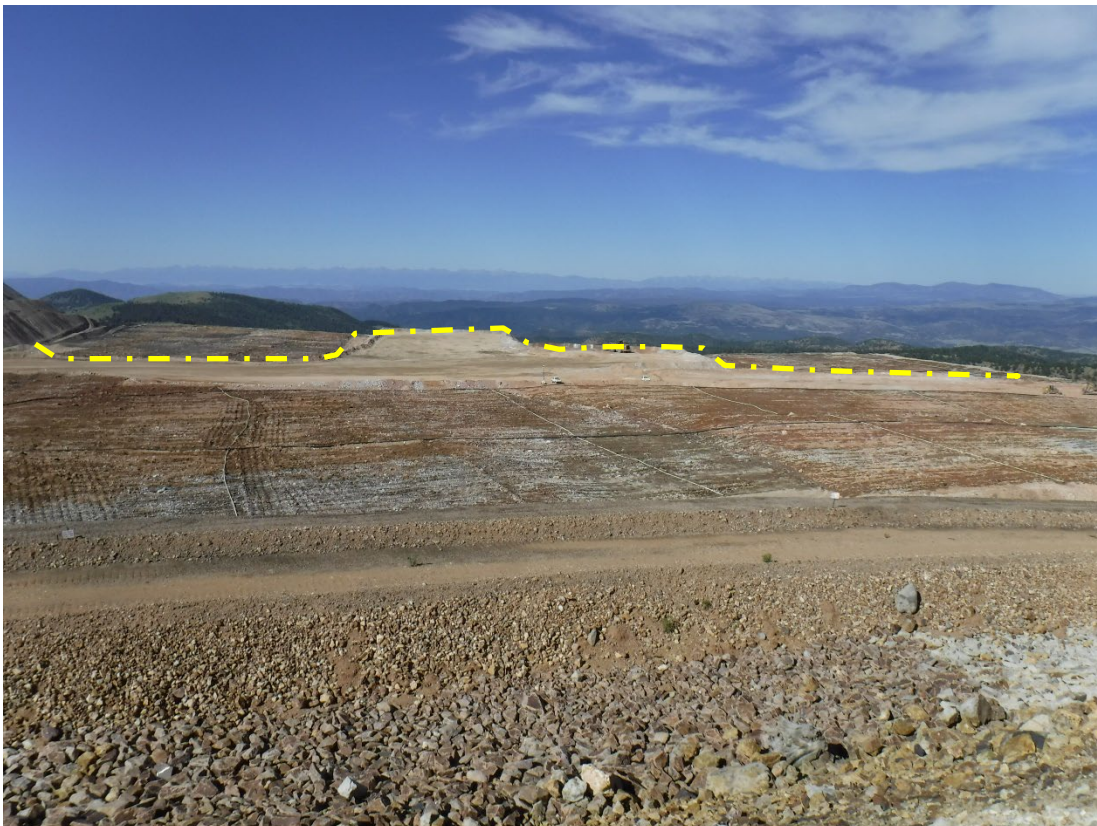
Photo 2: Looking south across the 10,100 level of VLF2 the dashed line divides the 10,100 from the 10,050

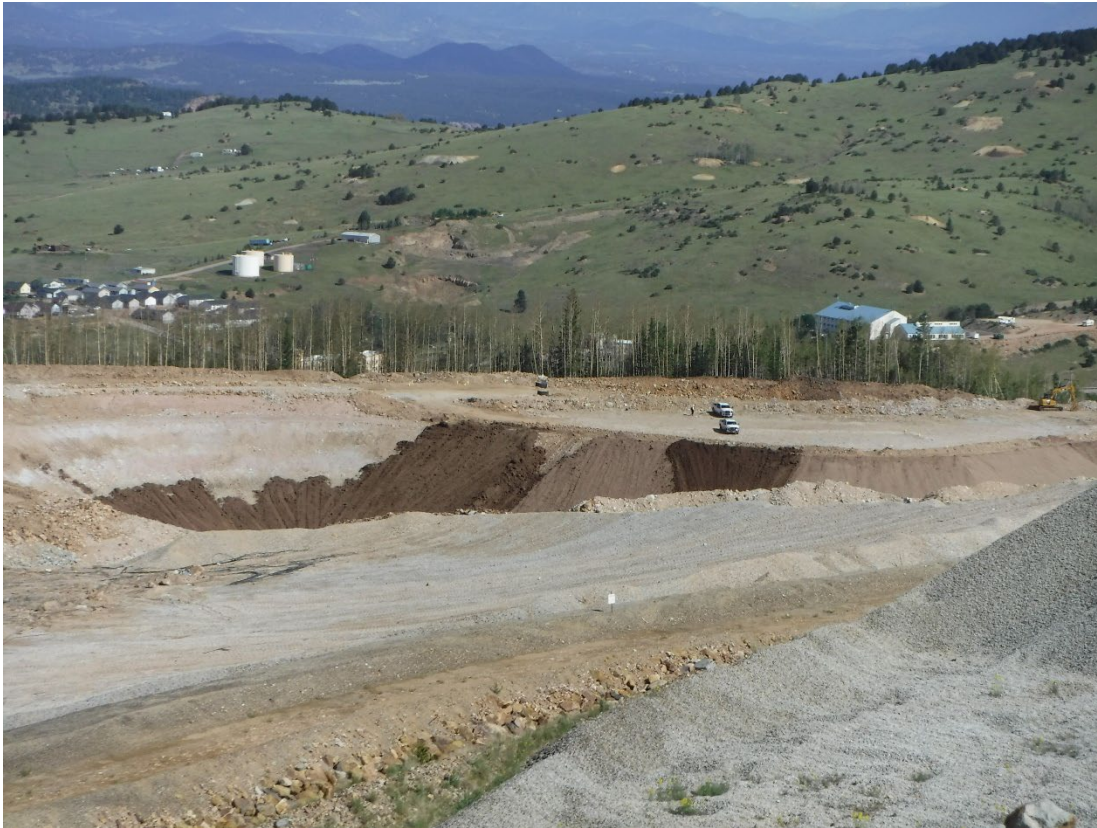
The Division observed, from a distance, the placement of clay material that makes up the base that liner material will be placed on. The clay material is sourced, stockpiled, and processed in the same location as Phase 2 liner construction. Material placement activities were scheduled to be completed by the end of the week of the inspection and liner crews were to be onsite to begin liner placement and welding the following week, the first week of July.

Photo 3: Placement of the clay base layer in preparation for liner material

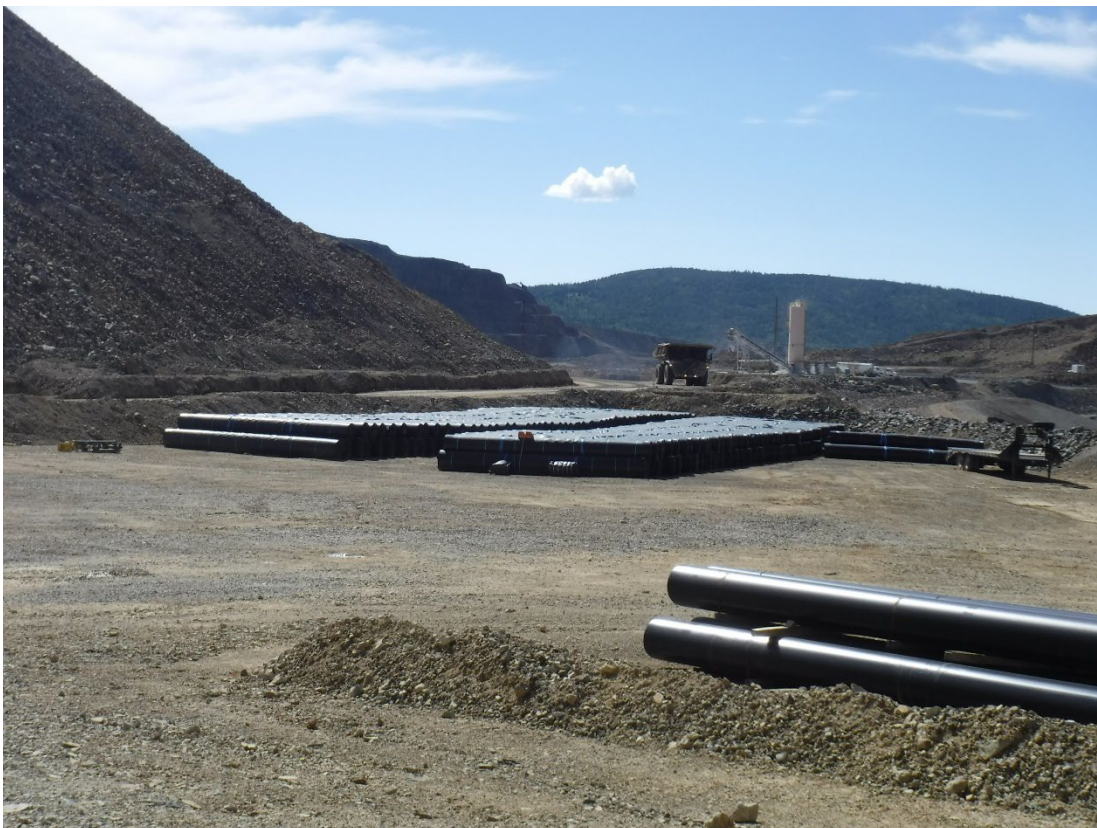
Photo 4: Staged liner material near the warehouse area in preparation for deployment

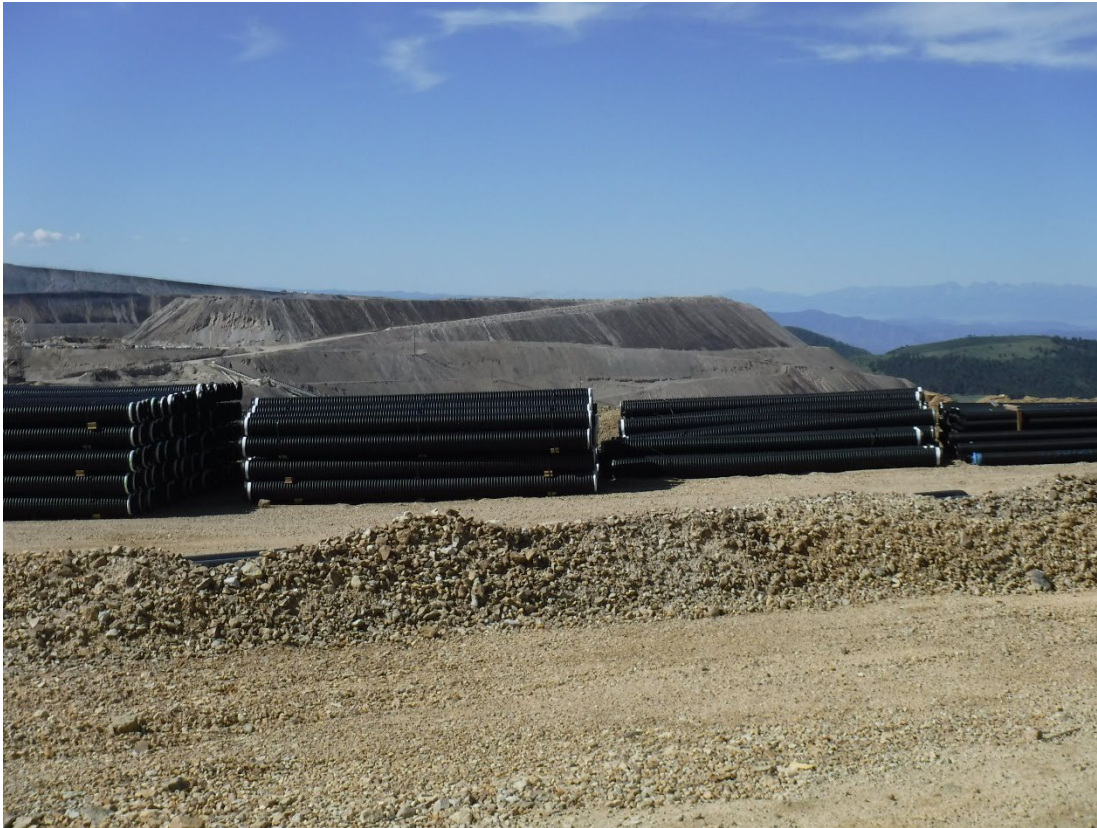
Photo 5: Staged under-drain materials near the warehouse area in preparation for deployment

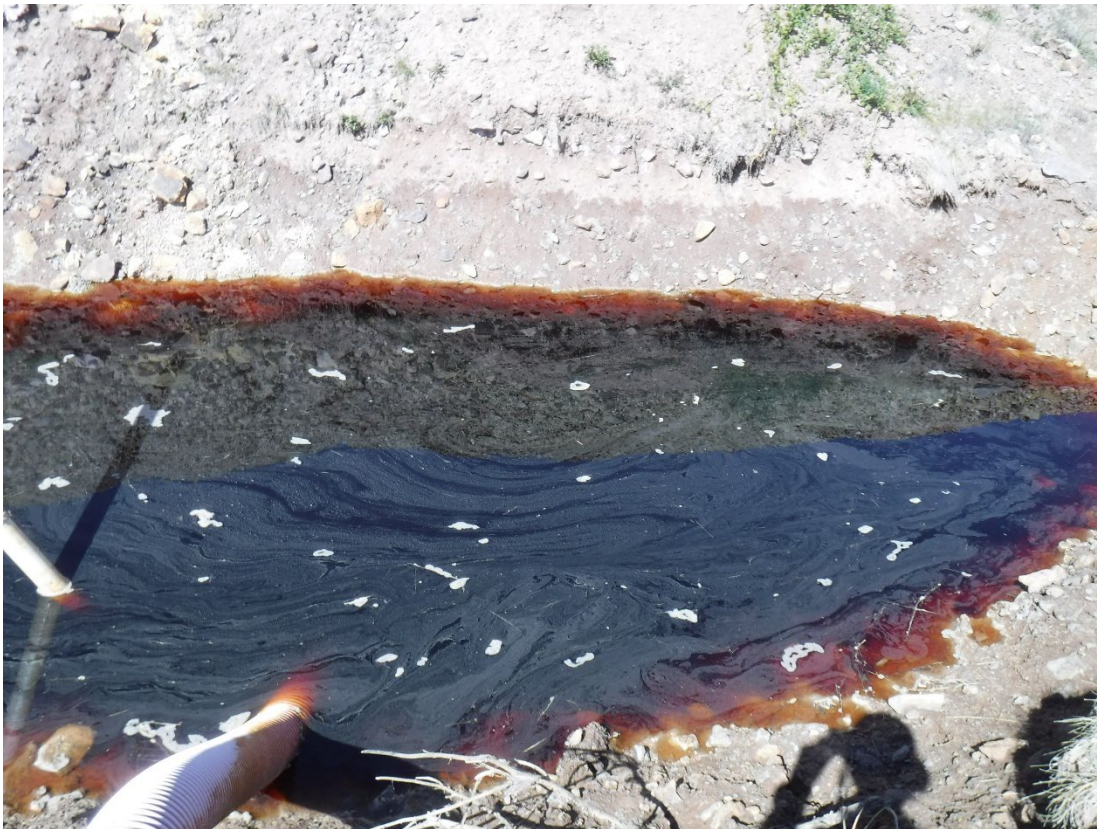
The Division inspected the seep areas located along the eastern toe of the ECOSA. The seep accumulation, in the first seep furthest to the south, trench was holding water during the inspection. The water was reddish-brown in color and was difficult to determine the depth of water. The staff gauge that was present was leaning to one side and no one present knew the total graduations on the gauge. No water was observed flowing into the trench from the south/southeast. The second seep, furthest to the north, was not holding any water at the time of inspection. The Operator last pumped the seep sumps on June 4. Water removed from the seeps is transported and dumped onto a lined facility (one of the valley leach facilities).

Photo 6: ECOSA southern seep collection sump, close-up

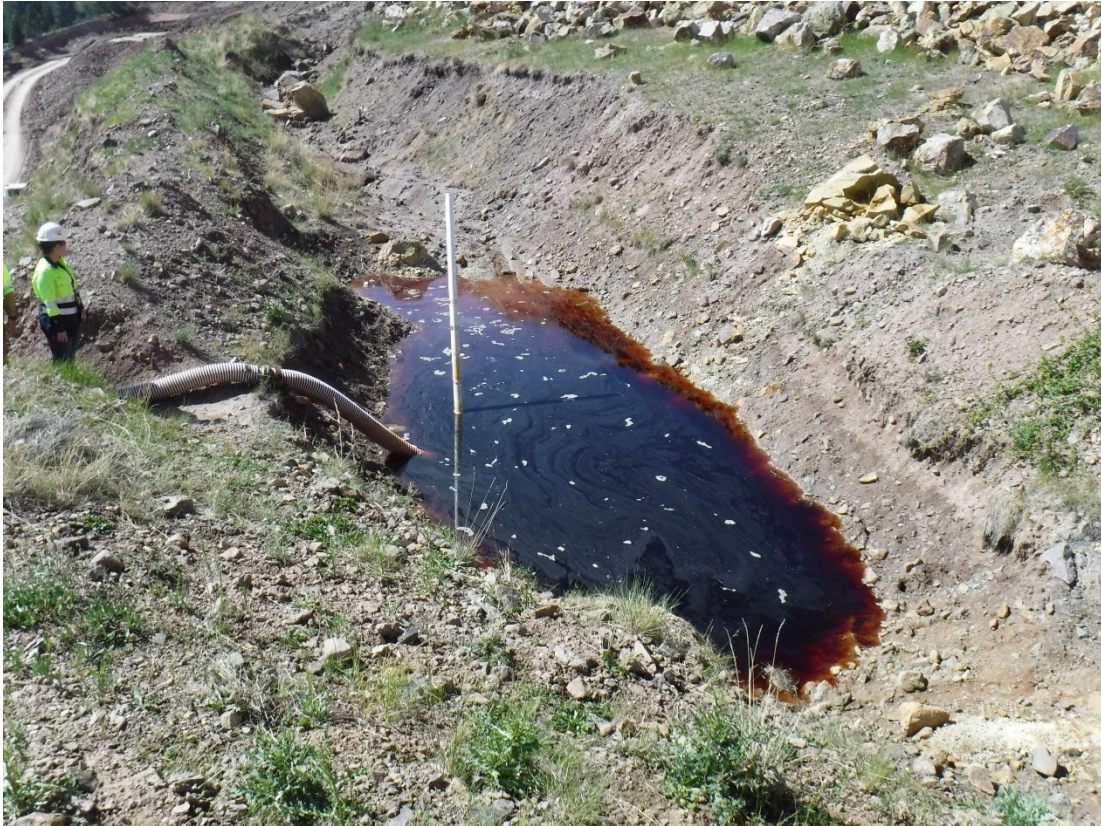
Photo 7: ECOSA southern seep collection sump

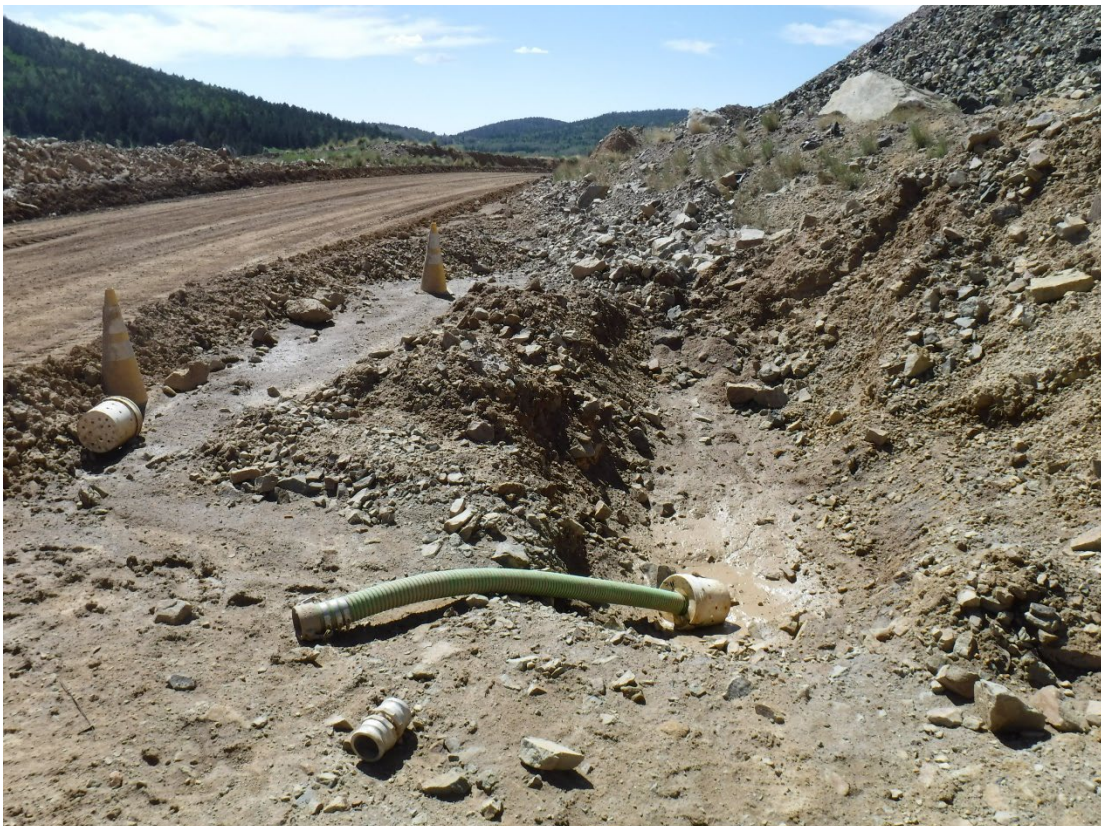
Photo 8: ECOSA northern seep collection sump

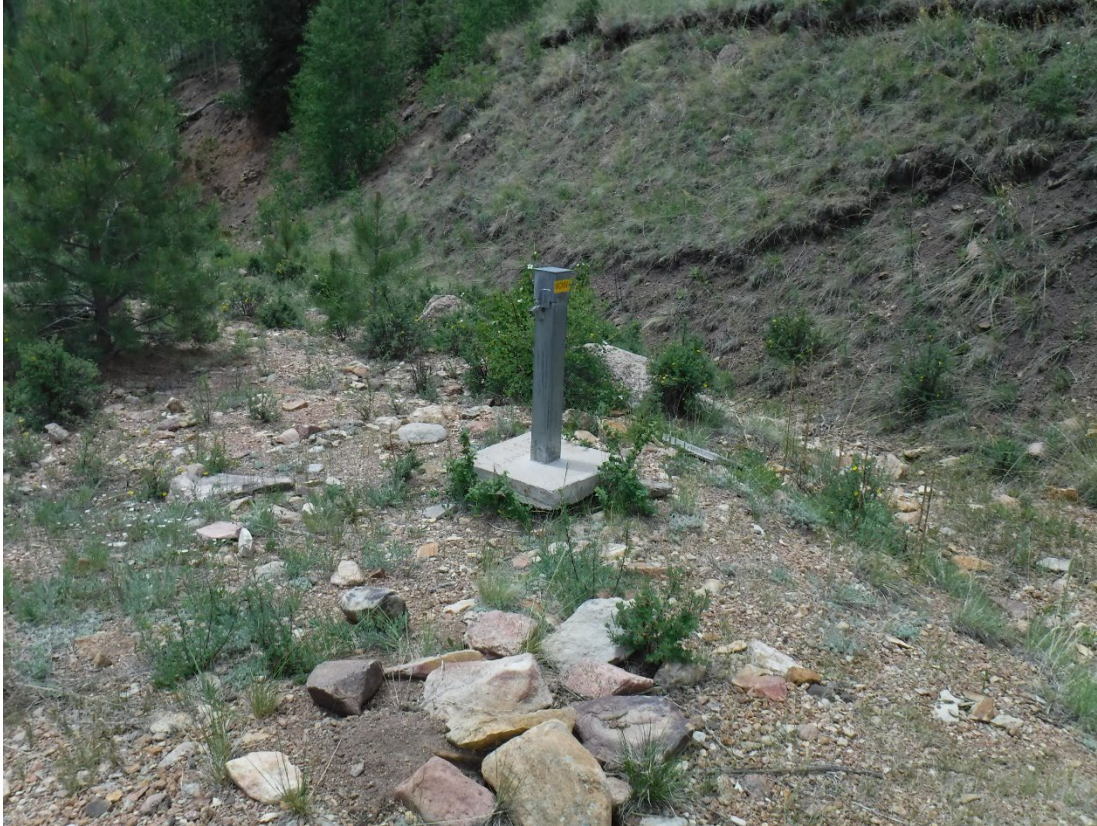
The Division inspected the WCMW-6 which is located in the Wilson Creek drainage. The monitoring well is located on an elevated area the middle of the main drainage channel. The drainage was not flowing at the time of inspection and it appears that the drainage does not see free flowing water that often. Vegetation is growing throughout the channel area where flow would be expected. The monitoring well itself has a concrete pad that has been undercut and is no long touching the ground. The Operator should replace the material under the pad for stability, to ensure water, when present, does not have an opportunity to migrate down the casing, and to protect the surface seal. Also noted in the drainage near the monitoring well were pieces of a broken concrete well pad, discarded steel well protective casings, and shards of broken PVC pipe. The observed piece of concrete pad had "MW-6" inscribed on it. To the best of the Divisions knowledge and a search of DWR records the current WCMW-6 is the only well to have been drilled in this location. The Operator did not know where these items came from or for how long they had been there either.

Photo 9: WCMW-6, note vegetation growing up from underneath the concrete pad

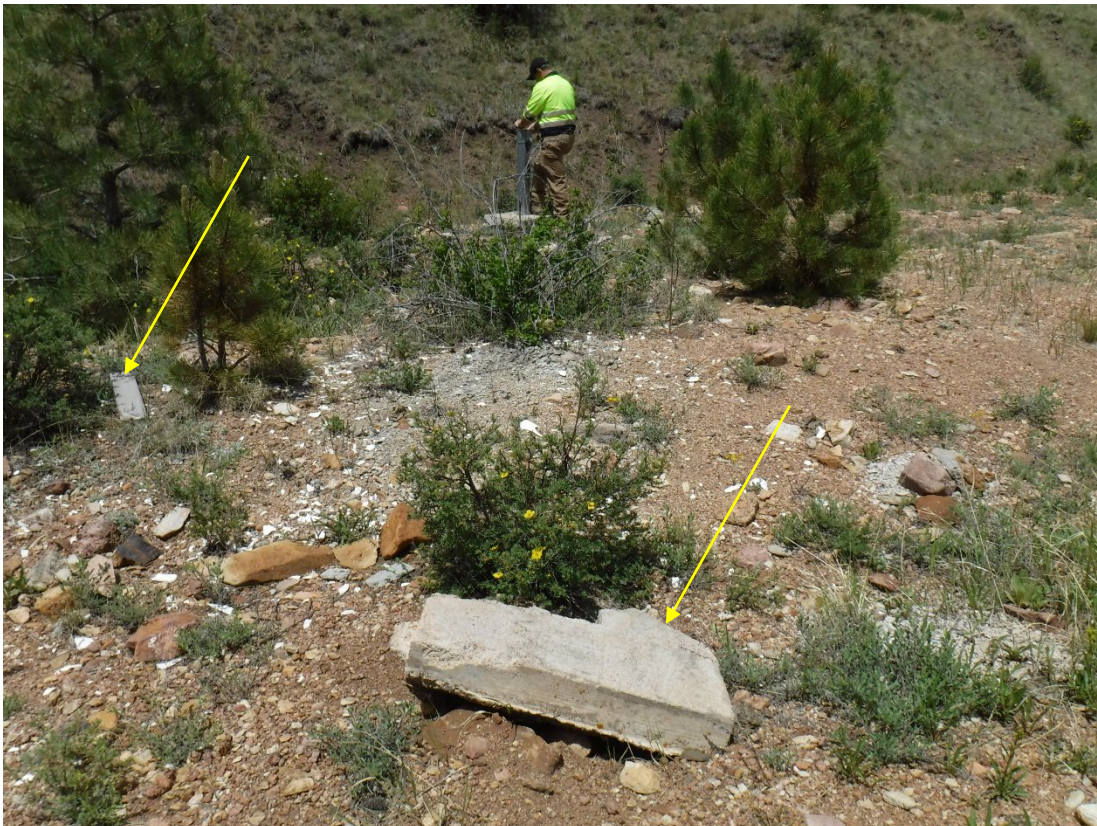
Photo 10: WCMW-6 in the background, arrows point to broken concrete pad and 1 of 3 discarded protective casings

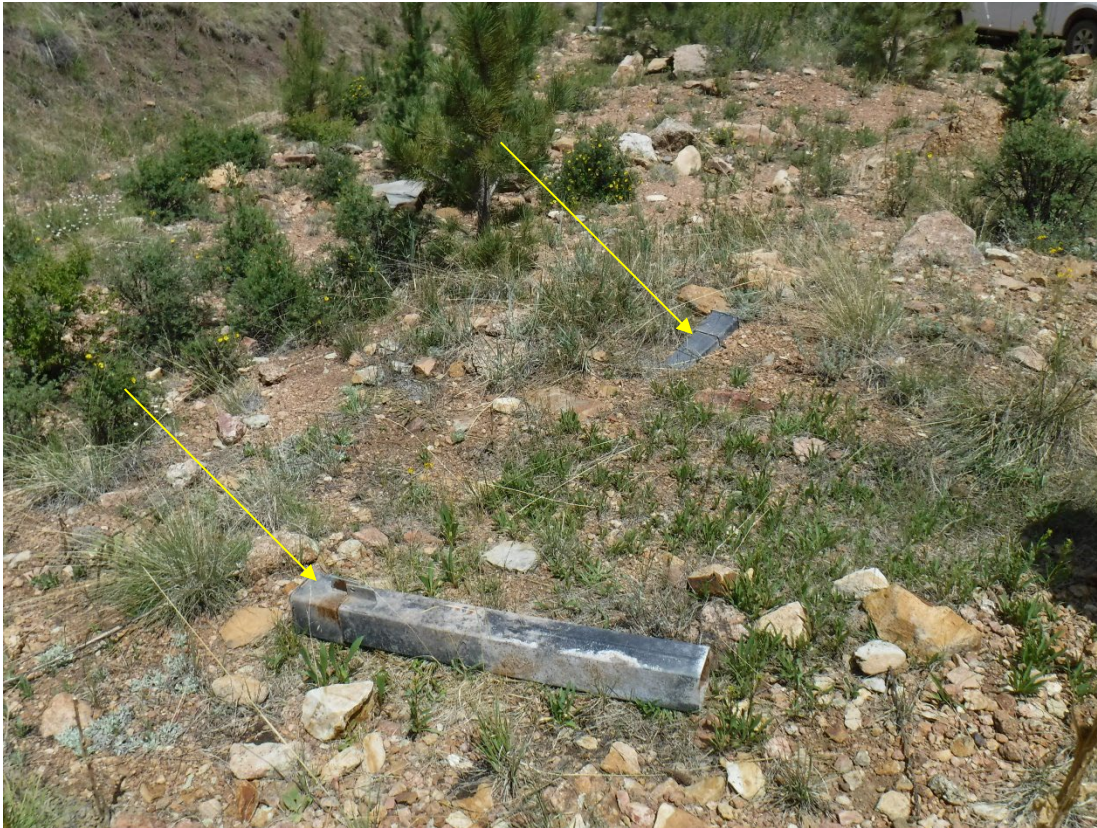
Photo 11: 2 of 3 discarded protective casings

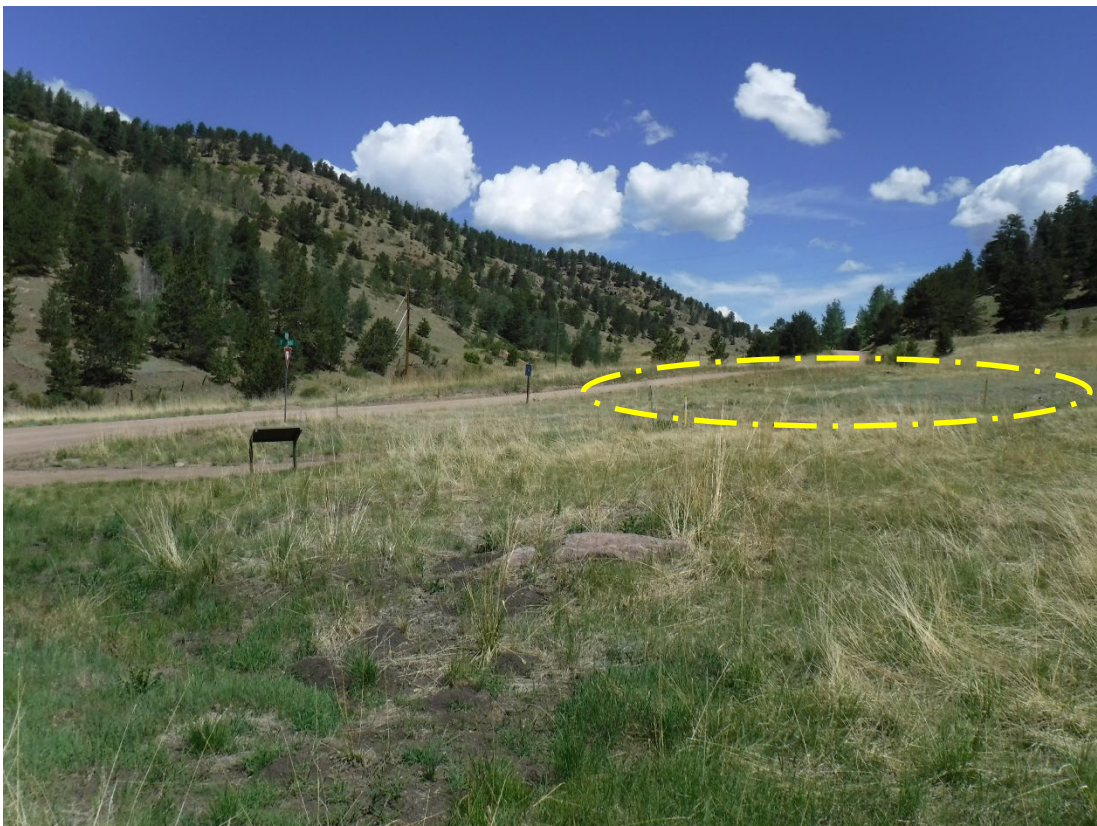
Finally, the Division went to Squaw Gulch where it intersects with Shelf Road to view the proposed location of SGMW-8. The proposed location is approximately 170 feet northwest of SGMW-7A and SGMW-7B. It should be noted that drilling in this area will likely involve drilling multiple pilot holes to determine the presence of groundwater to target for a monitoring well installation.

Photo 12: Intersection of Shelf Road, left of photo, and Squaw Gulch. Circled area approximate location of SGMW-8

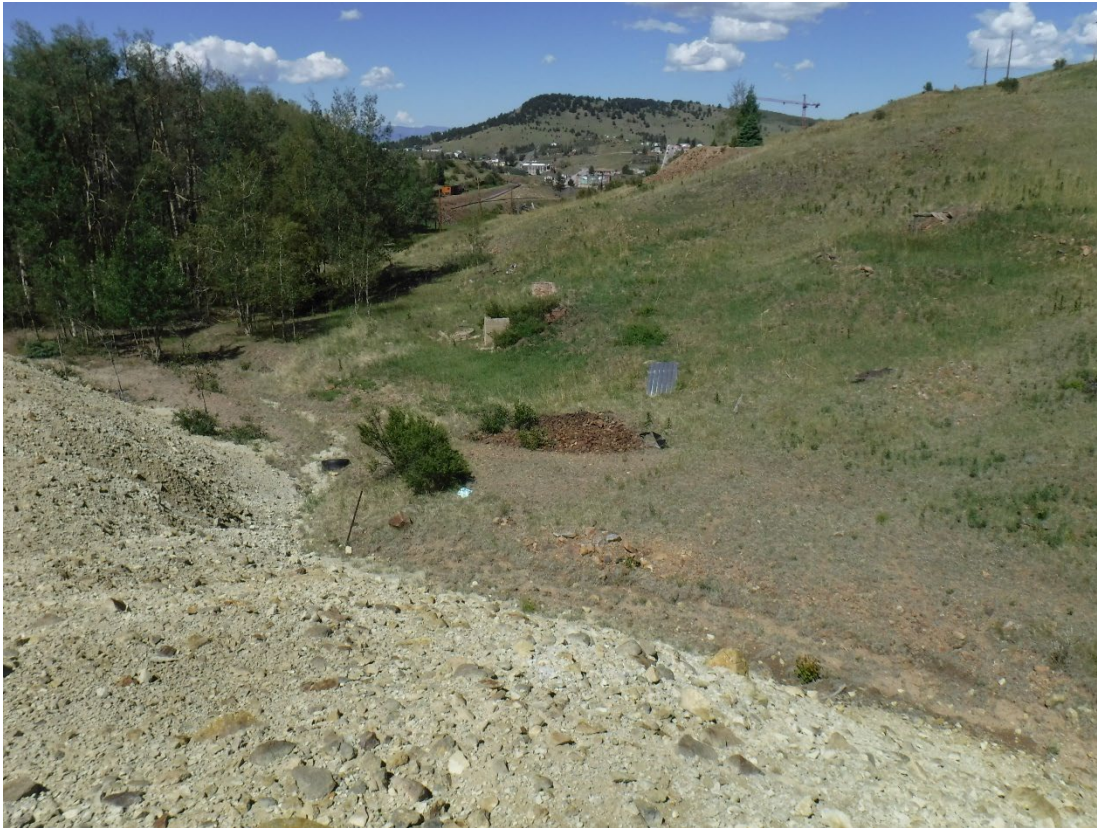
The Division went to Poverty Gulch to view the proposed location for PGMW-5. The location is immediately down gradient of stormwater detention basins in Poverty Gulch. The proposed location is approximately 400 feet west southwest of PGMW-3 and 420 feet northeast of PGMW 2, in an undisturbed area down gradient of the basins.

Photo 13: The area where PGMW-5 is proposed to be installed.

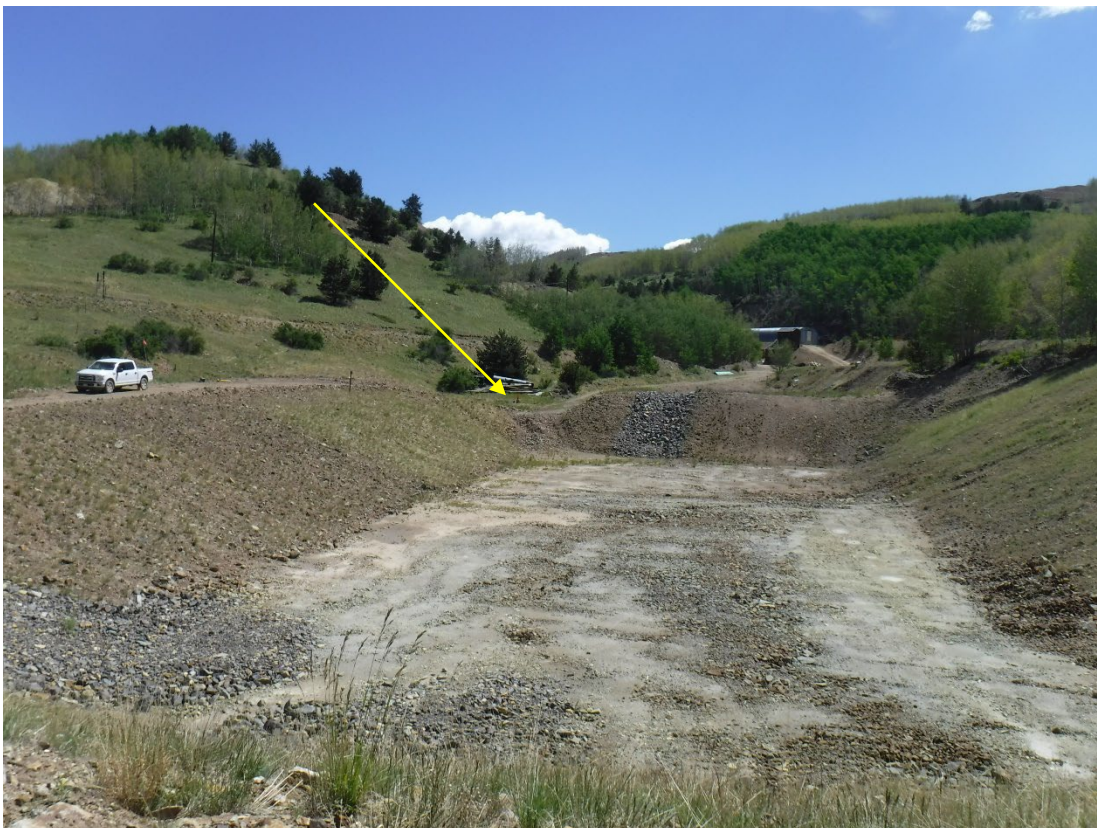
Photo 14: Detention basin immediately up-gradient from PGMW-5 location, arrow denotes the location of PGMW-3

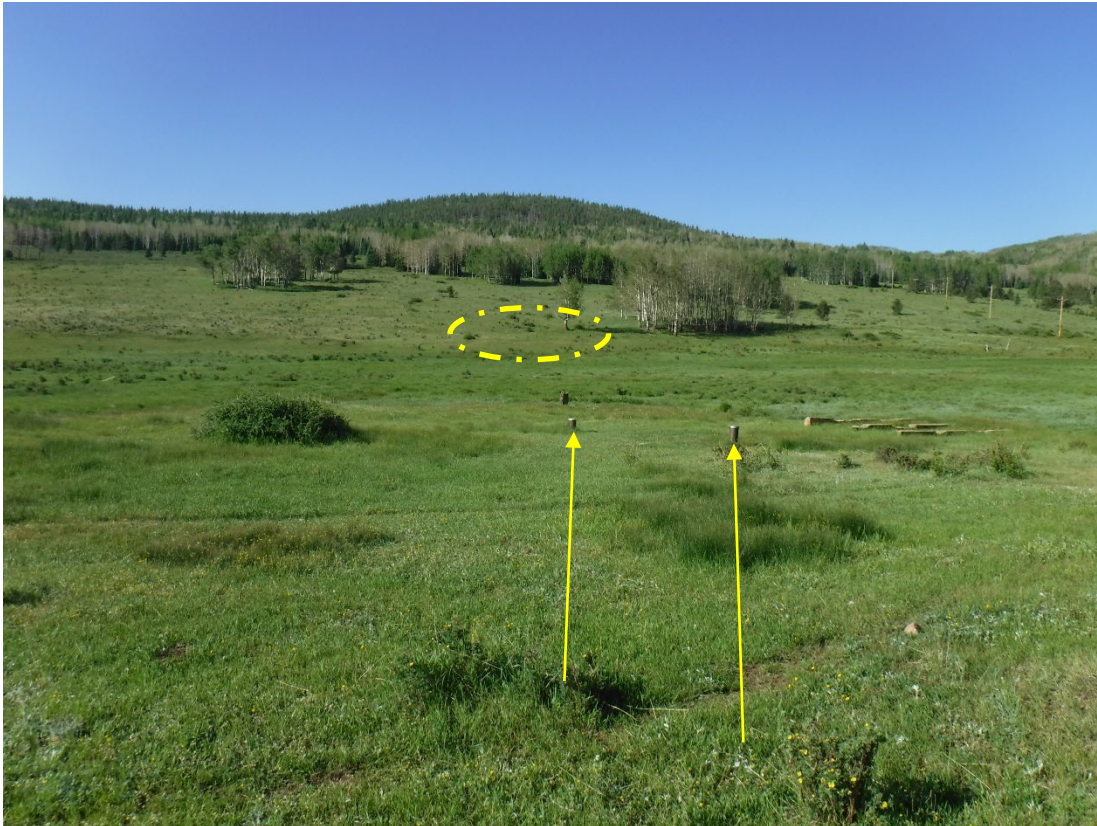
The Division went to the proposed area for GVMW-26 located in Grassy Valley. The Division accessed the area by walking south from GVMW-22A and GVMW-22B. The location area is near the wettest portion of thalweg although surface flow in the area is dispersed. The proposed location appears to be properly placed for a new point-of-compliance well.

Photo 15: Grassy Valley at GVWM-22A and 22B (yellow arrows) looking south to the proposed area for GVMW-26 installation

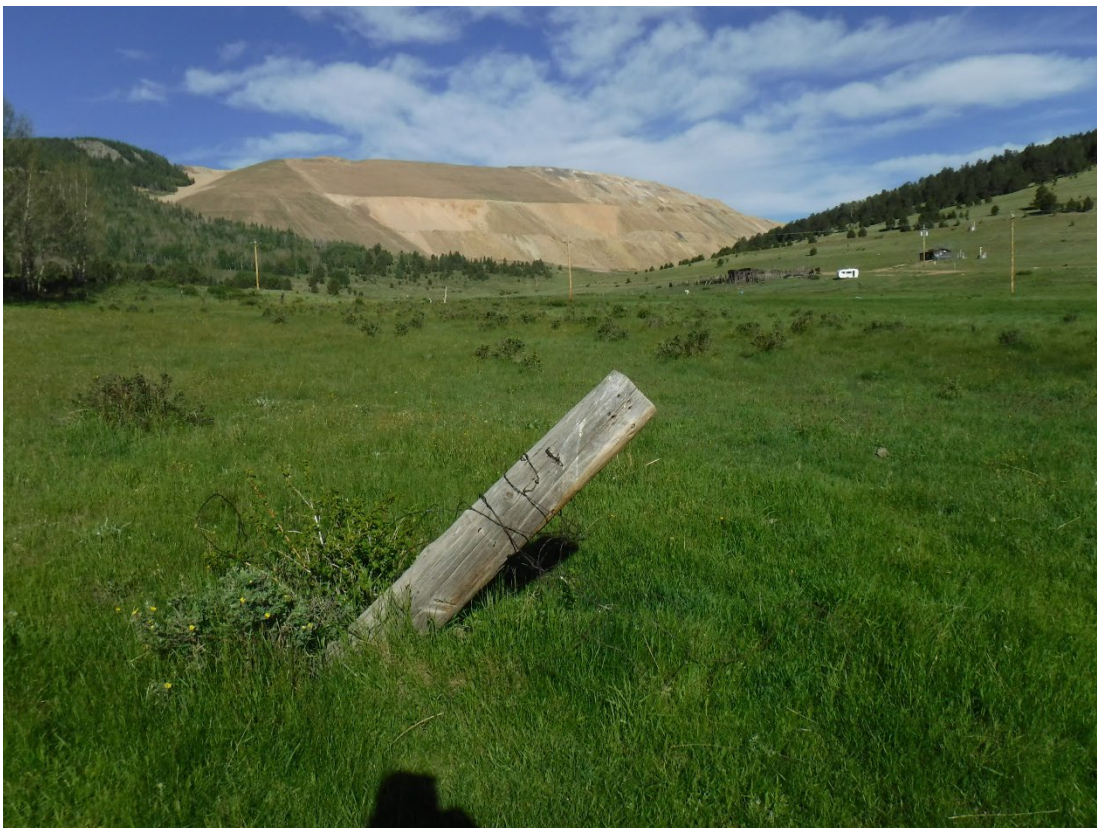
Photo 16: The proposed area for GVMW-26 installation

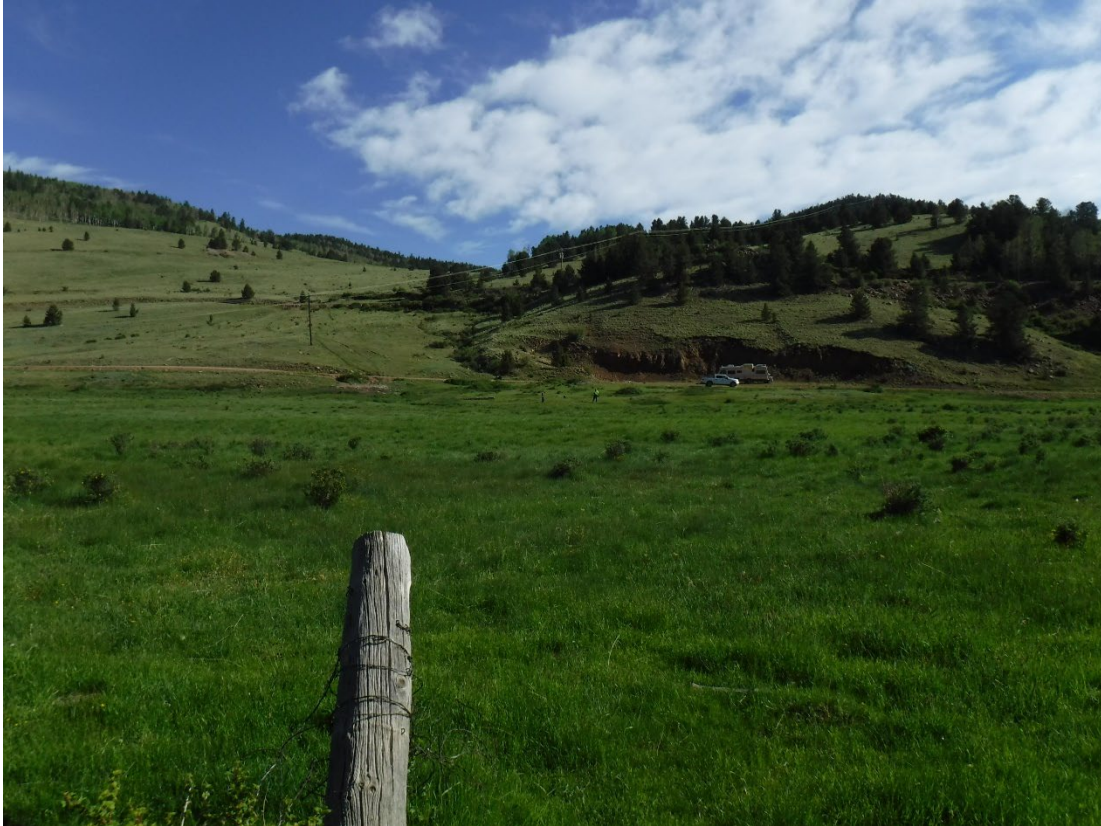
Photo 17: Looking north from the proposed GVMW-26 installation area towards GVMW-22A and 22B
