July 2022: Daniels Slope Monitoring Report

July 9, 2022
Project No.: 19125

Regarding: Daniels Sand Pit 2, Permit No. M-1973-007-SG
Slope Stability Monthly Monitoring Report

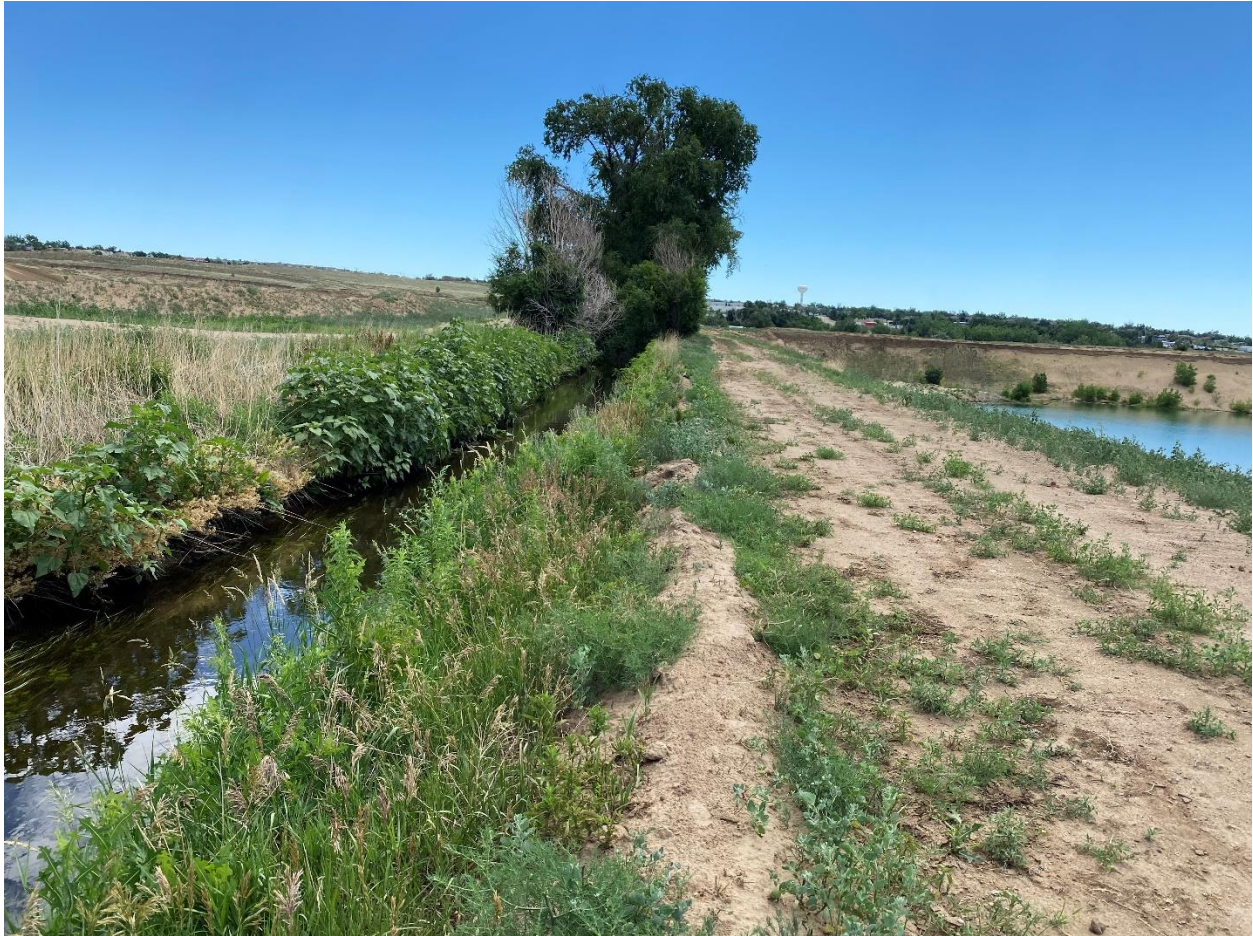
Photo 1. Fountain Mutual Ditch looking east

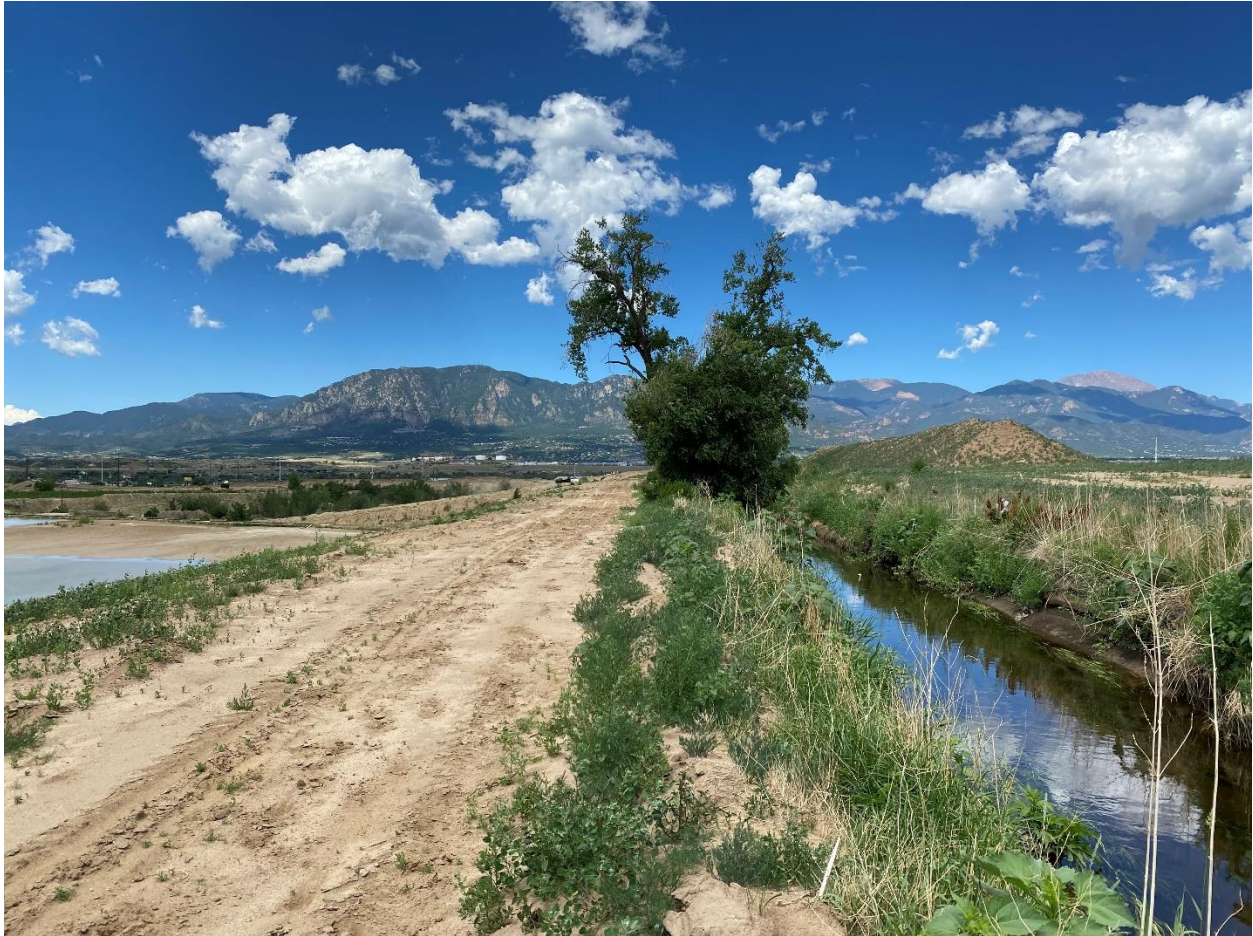
Photo 2. Fountain Mutual Ditch looking west

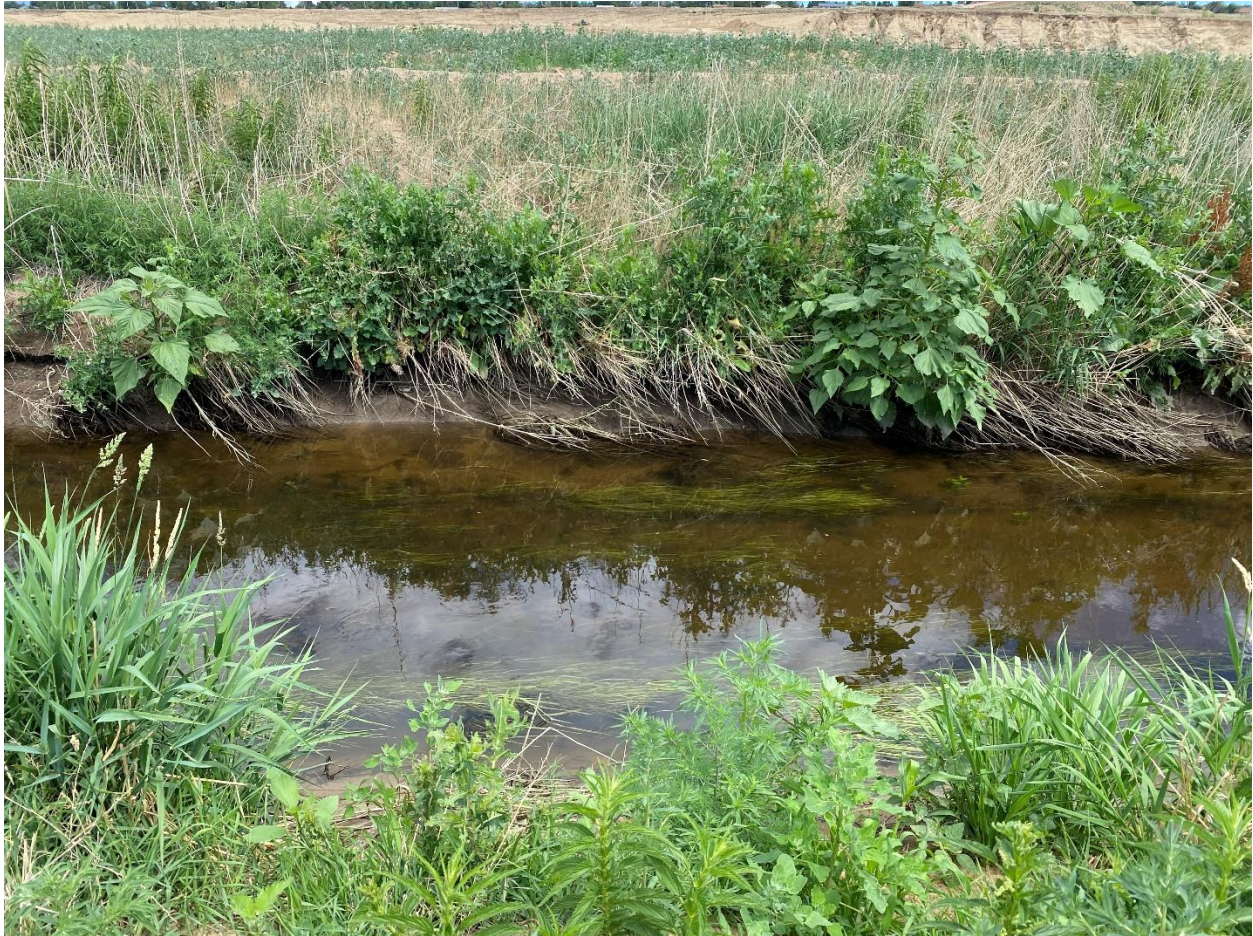
Photo 3. Fountain Mutual Ditch invert looking north (note vegetation)

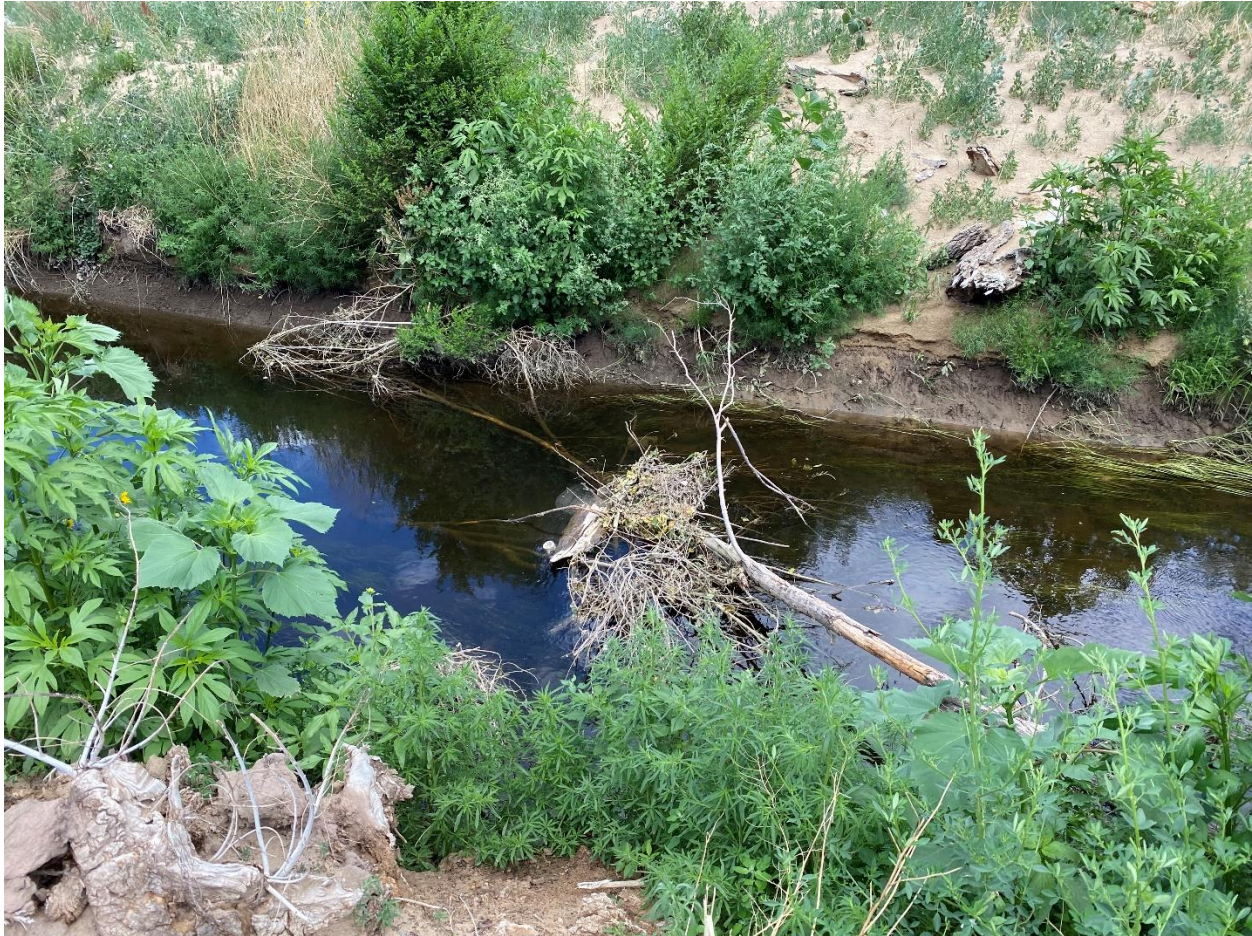
Photo 4. Fountain Mutual Ditch with branches

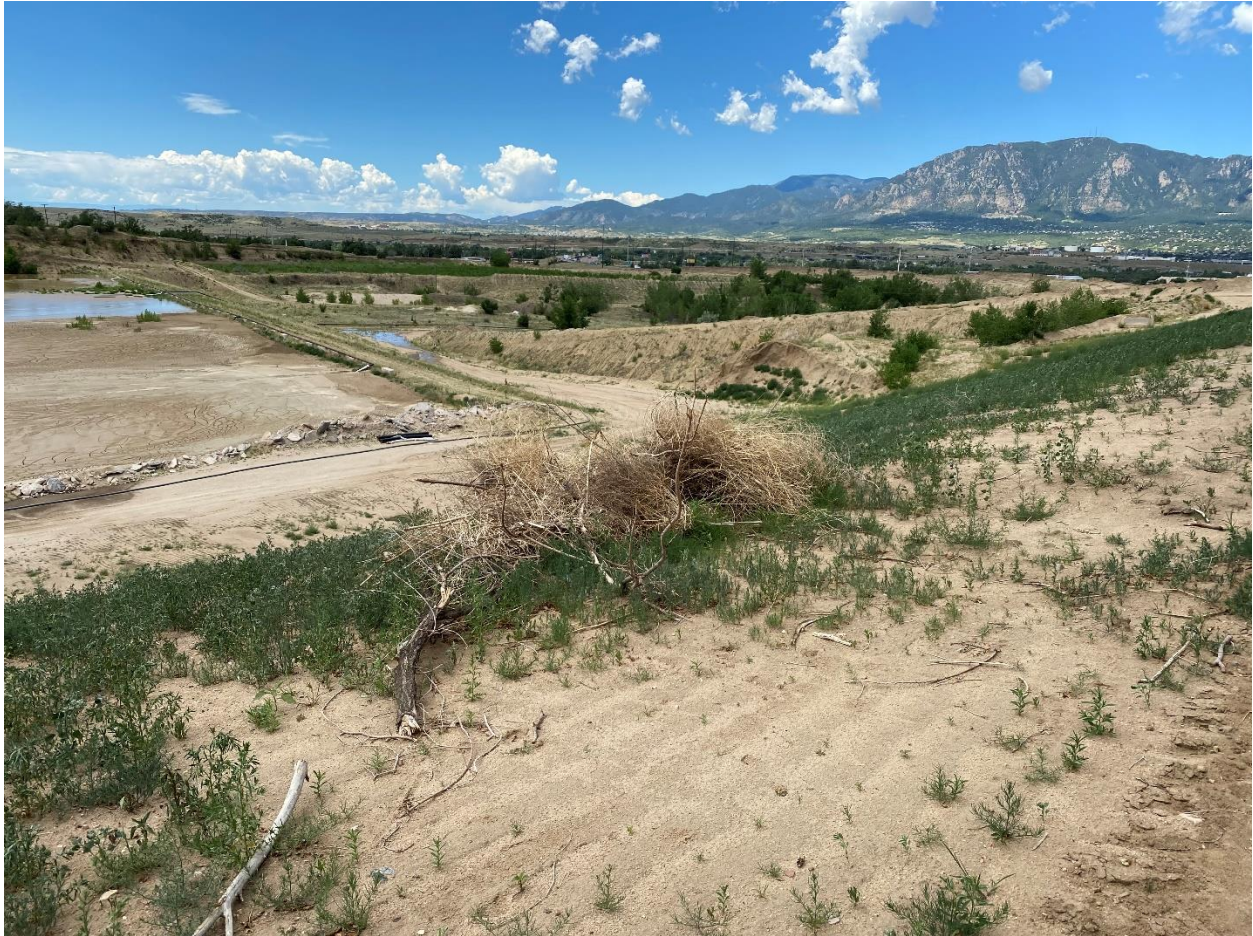
Photo 5. Buttress slope with branches

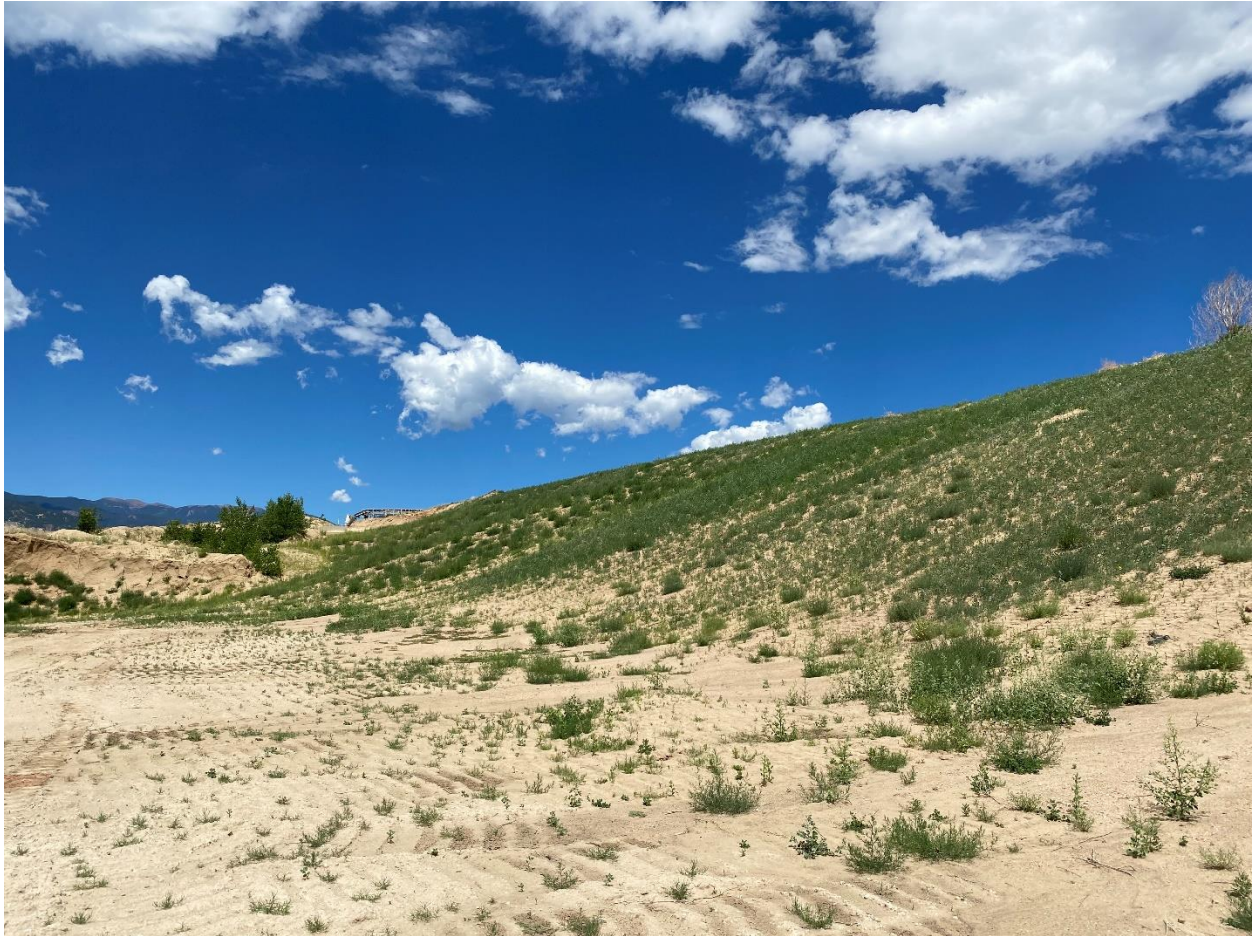
Photo 6. Buttress slope looking west from toe

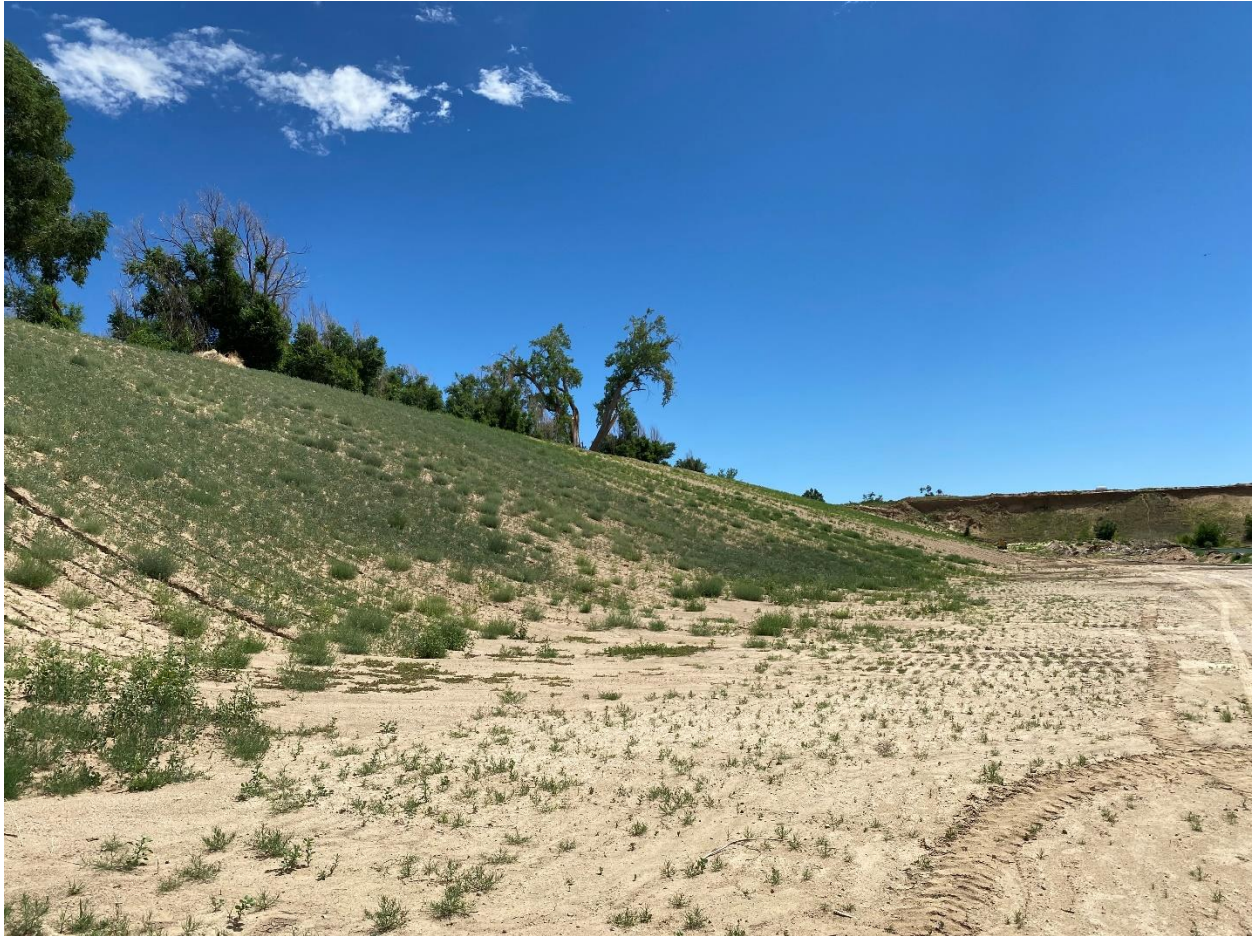
Photo 7. Buttress slope looking east from toe

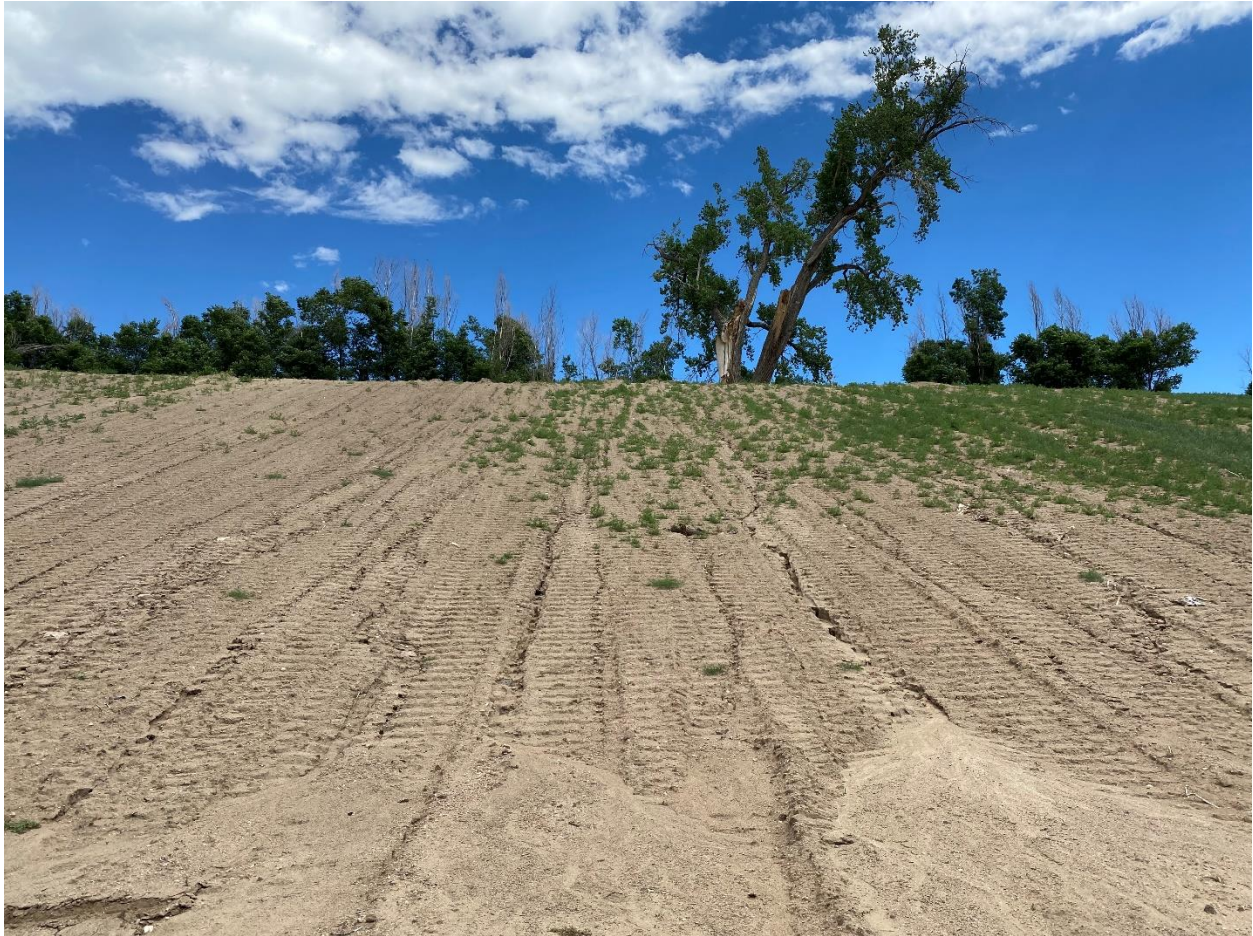
Photo 8. Buttress slope looking north, evidence of surface water drainage

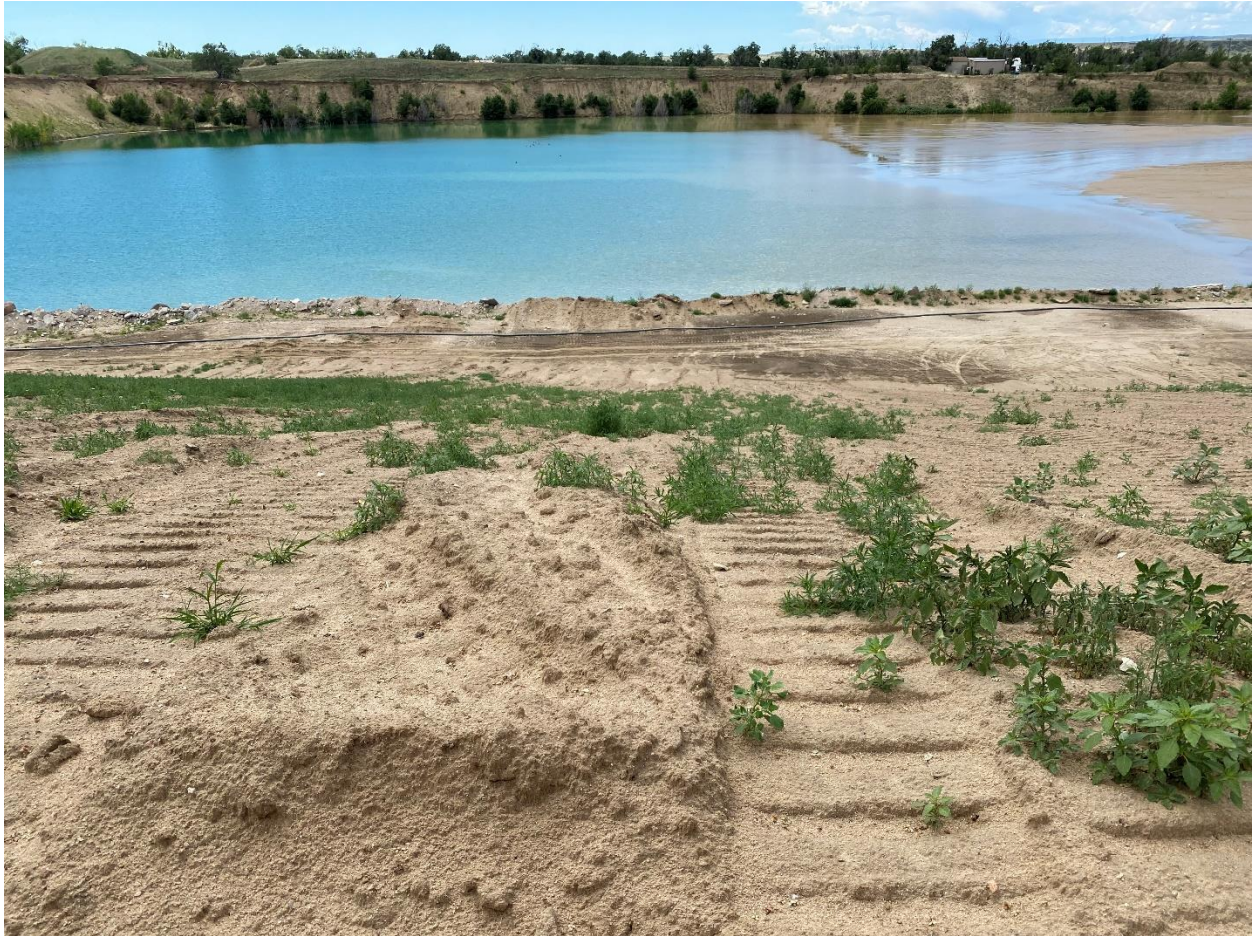
Photo 9. Buttress slope looking south, area needs regrading

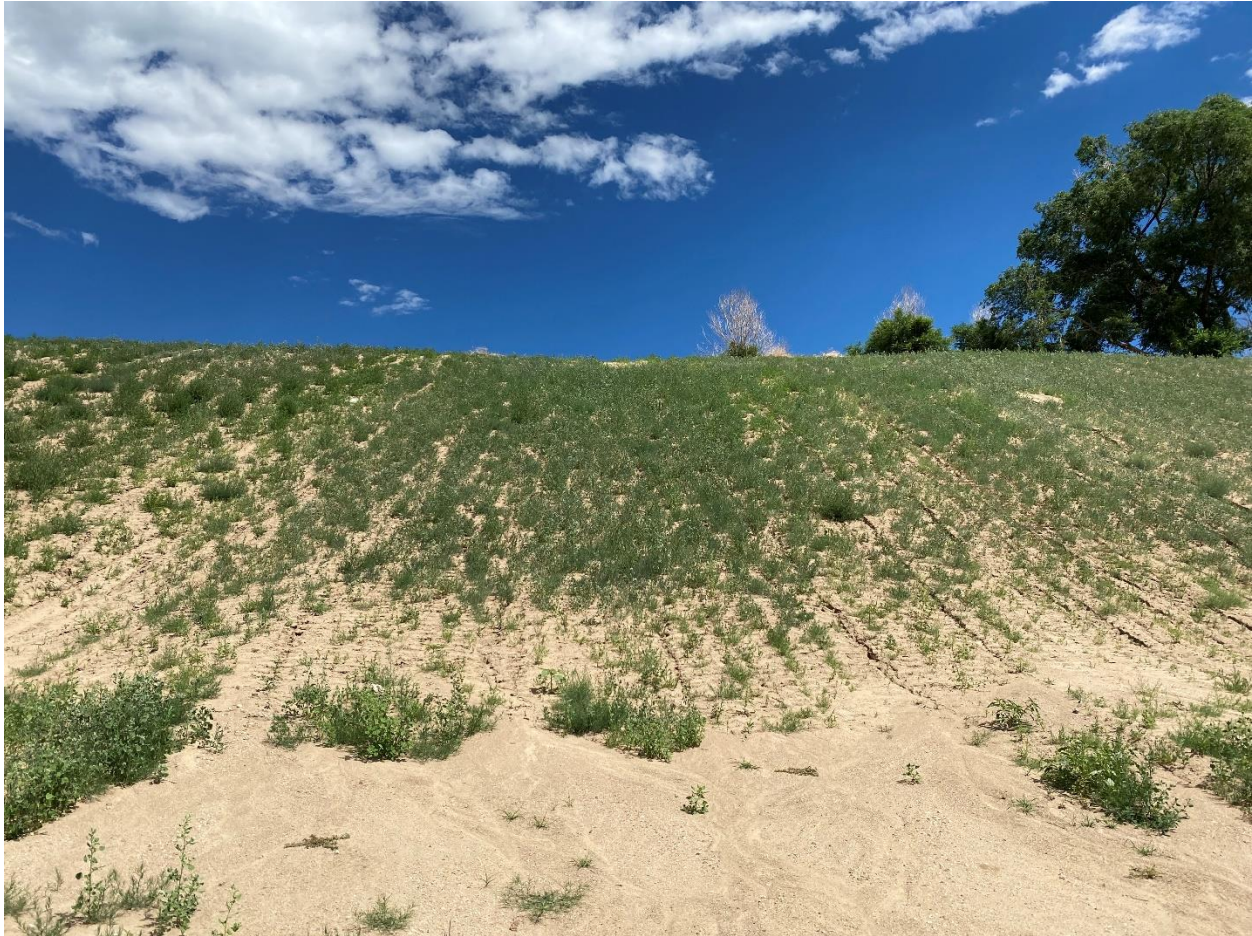
Photo 10. Buttress slope looking north, weeds growing
