MINERALS PROGRAM INSPECTION REPORT

MINE NAME: San Luis Project	MINE/PROSPECTING ID#: M-1988-112	MINERAL: Gold and silver	COUNTY: Costilla
INSPECTION TYPE: Monitoring	INSPECTOR(S): Lucas West	INSP. DATE: June 14, 2022	INSP. TIME: 09:50
OPERATOR: Battle Mountain Resources, Inc.	OPERATOR REPRESENTATIVE: Julio Madrid, Karen DeAgüero	TYPE OF OPERATION: 112d-3 - Designated Mining Operation	
REASON FOR INSPECTION: Normal I&E Program	BOND CALCULATION TYPE: None	BOND AMOUNT: \$7,400,000.00	
DATE OF COMPLAINT: NA	POST INSP. CONTACTS: None	JOINT INSP. AGENCY: None	
WEATHER: Clear	INSPECTOR'S SIGNATURE:

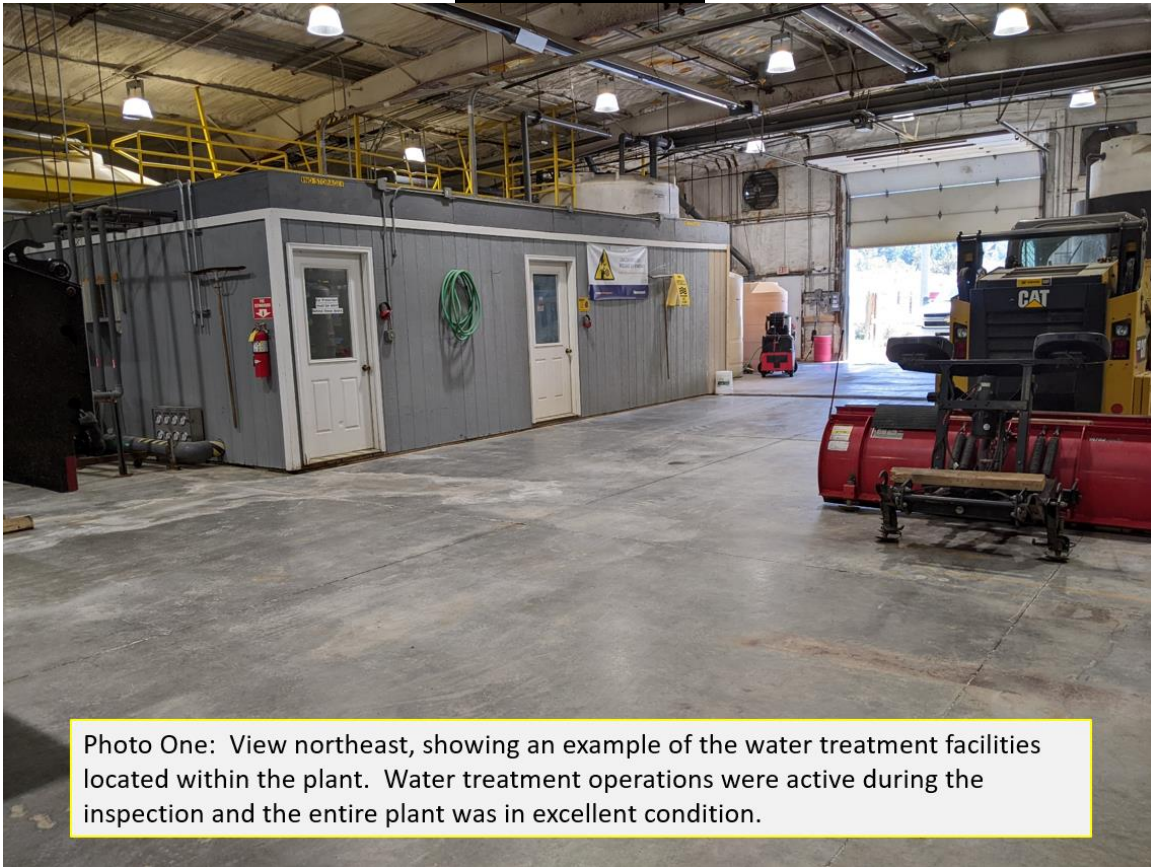
Photo One: View northeast, showing an example of the water treatment facilities located within the plant. Water treatment operations were active during the inspection and the entire plant was in excellent condition.

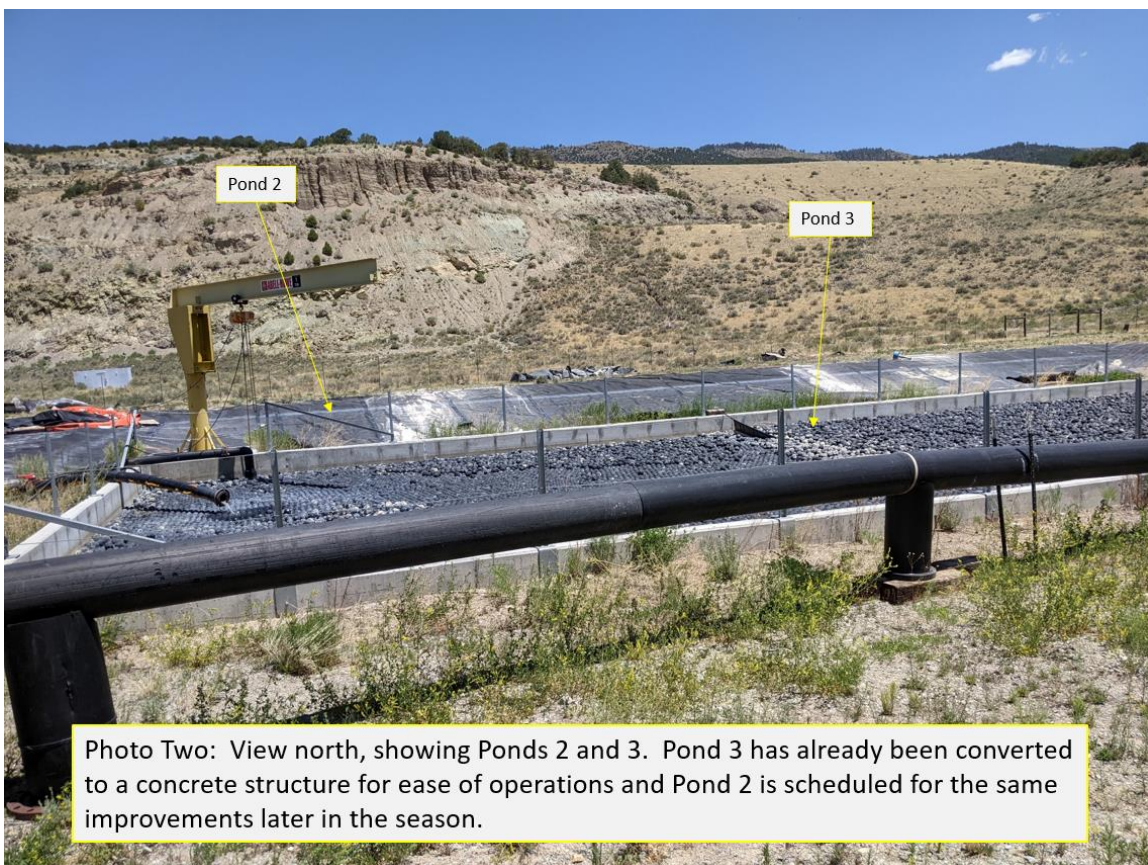
The main purpose of this inspection was to conduct a complete inspection of the site with Division Staff as well as the Operator and their representatives. The site was not active but the water treatment facility was operating during this inspection. The water treatment facilities utilizes a series of holding ponds, tanks, media filters and a reverse osmosis (RO) system to treat ground water prior to discharge. The interior of the plant can be seen in Photo One, the plant is in excellent condition, neat and well-kept and operating during the inspection. At the time of the inspection the RO system was treating and discharging water at approximately 580gpm at their discharge point. The holding ponds are all fenced in facilities. Pond 1 consists of raw water pumped from a series of wells and feeds the treatment system. Ponds 2, 3 and 4 are used to store water at various stages of the treatment procedure. The areas around the water treatment facility include access roads, equipment storage areas and parking areas are all in good condition. Recently, Pond 3 had been converted from an HDPE lined facility, to a concrete contained holding pond to make for easier maintenance and life of the pond. On site discussions indicate that Pond 2 is scheduled for similar upgrades in the coming weeks. To document the change, a Technical Revision was discussed in which the Operator should provide construction details and drawings of the ponds as well as an engineer certified as-built. The Division will continue to coordinate with the Operator on the details of the revision. The two ponds can be seen in Photos Two and Three.

Photo Two: View north, showing Ponds 2 and 3. Pond 3 has already been converted to a concrete structure for ease of operations and Pond 2 is scheduled for the same improvements later in the season.
