**PERMIT INFORMATION**

<b>Permit Number:</b> C1981033 <b>Mine Name:</b> Bear Mine <b>Operator:</b> N/A <b>Operator Address:</b> N/A	<b>County:</b> Gunnison <b>Operation Type:</b> Underground <b>Permit Status:</b> Revoked <b>Ownership:</b> Private
	<b>Operator Representative Present:</b>  N/A
<b>Operator Representative Signature: (Field Issuance Only)</b>

**INSPECTION INFORMATION**

<b>Inspection Start Date:</b> May 4, 2022 <b>Inspection Start Time:</b> 09:00 <b>Inspection End Date:</b> May 4, 2022 <b>Inspection End Time:</b> 10:00		<b>Inspection Type:</b> Coal Complete Inspection <b>Inspection Reason:</b> Normal I&E Program <b>Weather:</b> Cloudy	
<b>Joint Inspection Agency:</b>  None		<b>Joint Inspection Contacts:</b>  	
<b>Post Inspection Agency:</b>  None		<b>Post Inspection Contacts:</b>  	
<b>Inspector(s):</b>  Leigh Simmons	<b>Inspector's Signature:</b>

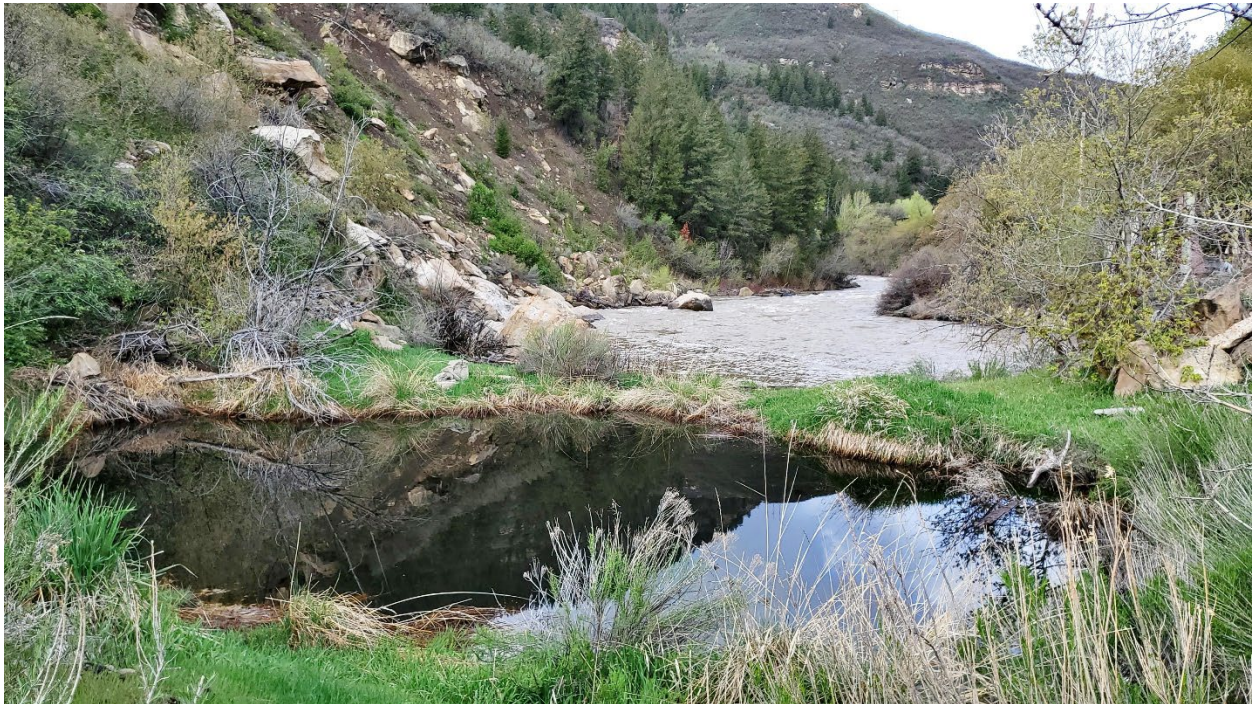
The seep was flowing from the eastern edge of the toe of the slide area. A small pool of dark brown water from the seep had accumulated at the lower end of the sinuous channel, beside the river bank.

*Figure 2: Pooled water from the groundwater seep*

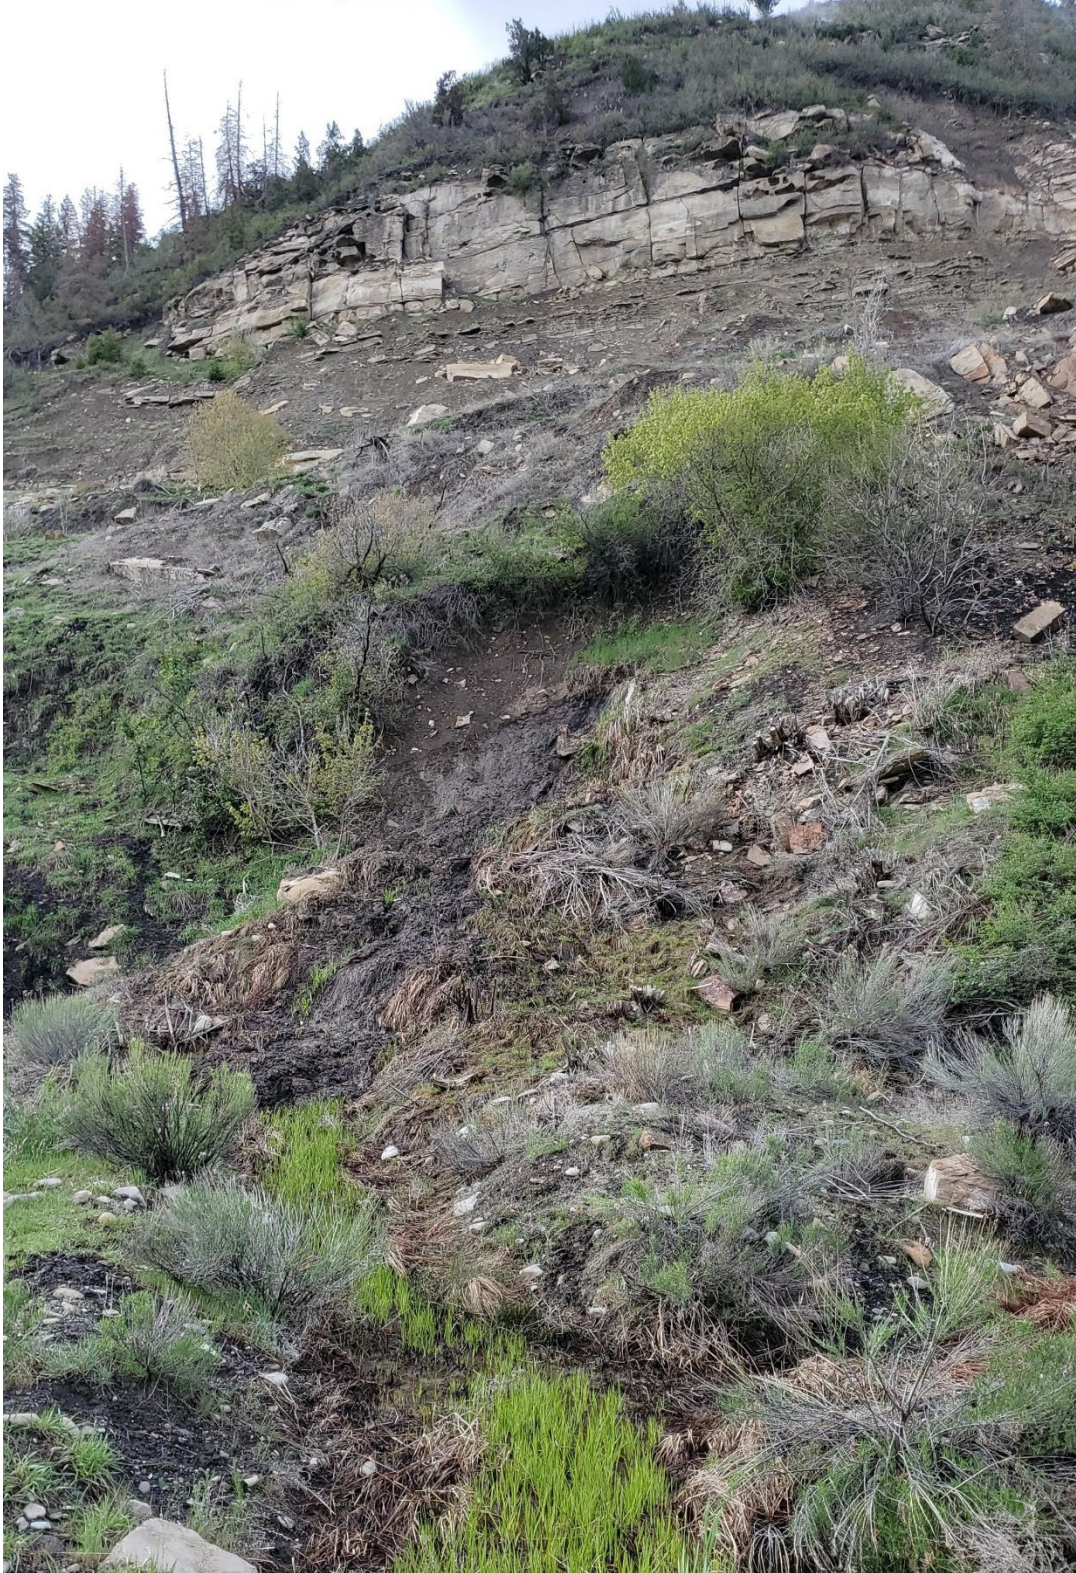
*Figure 3: Seep, with the scarpe above*

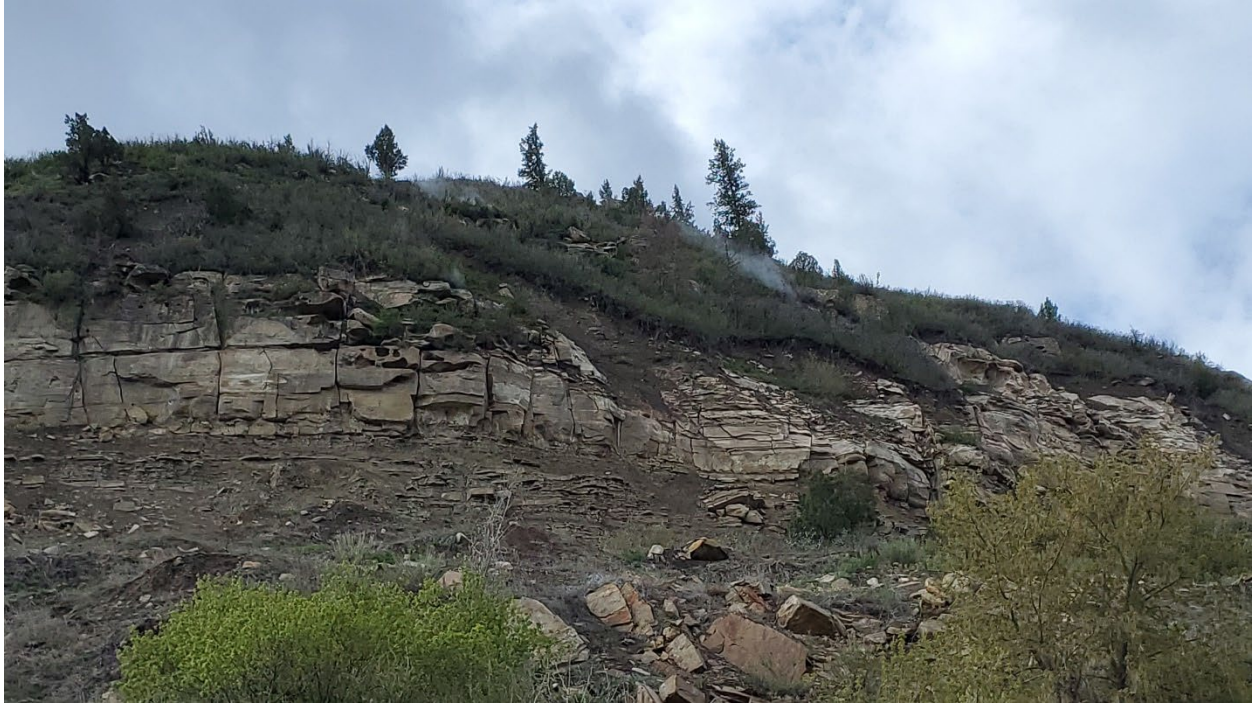
Smoke/steam was clearly visible from vents above the slide escarpment. There was no obvious change to the fire activity when viewed from below, and there was evidence of any recent slide activity.

*Figure 4: Smoke/steam visible from vents above the scarpe*

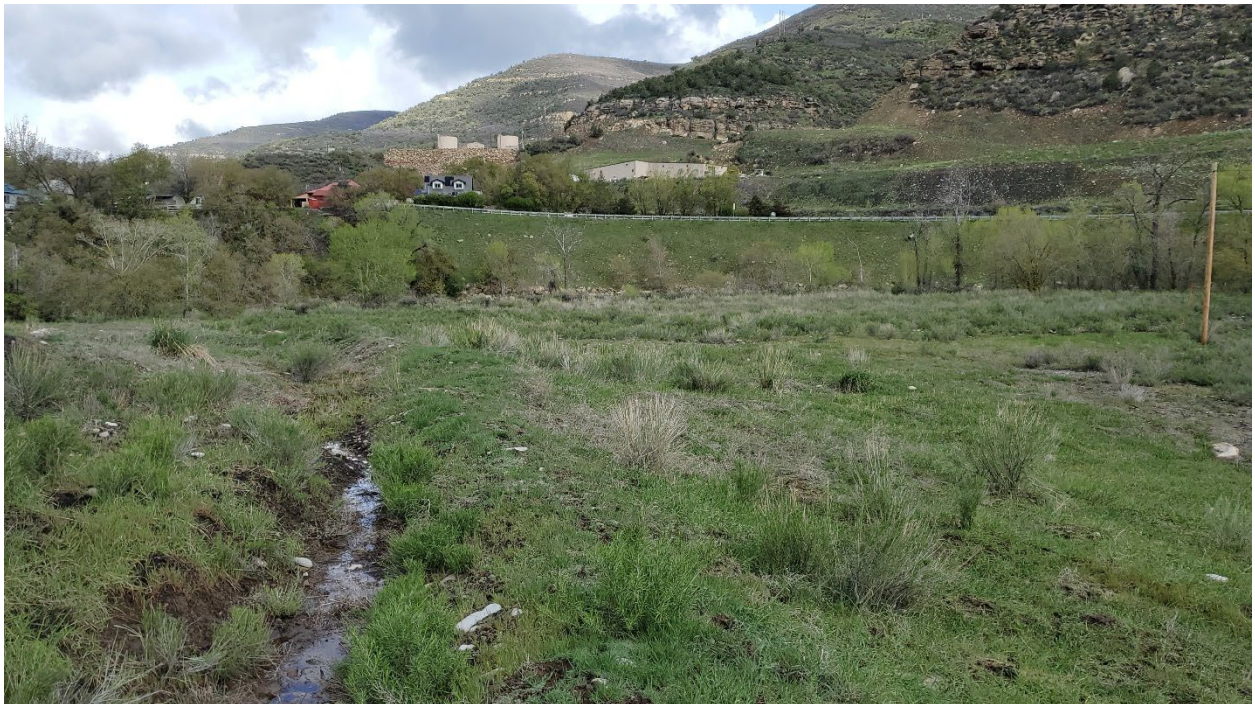
*Figure 5: Seep water in the sinuous channel*

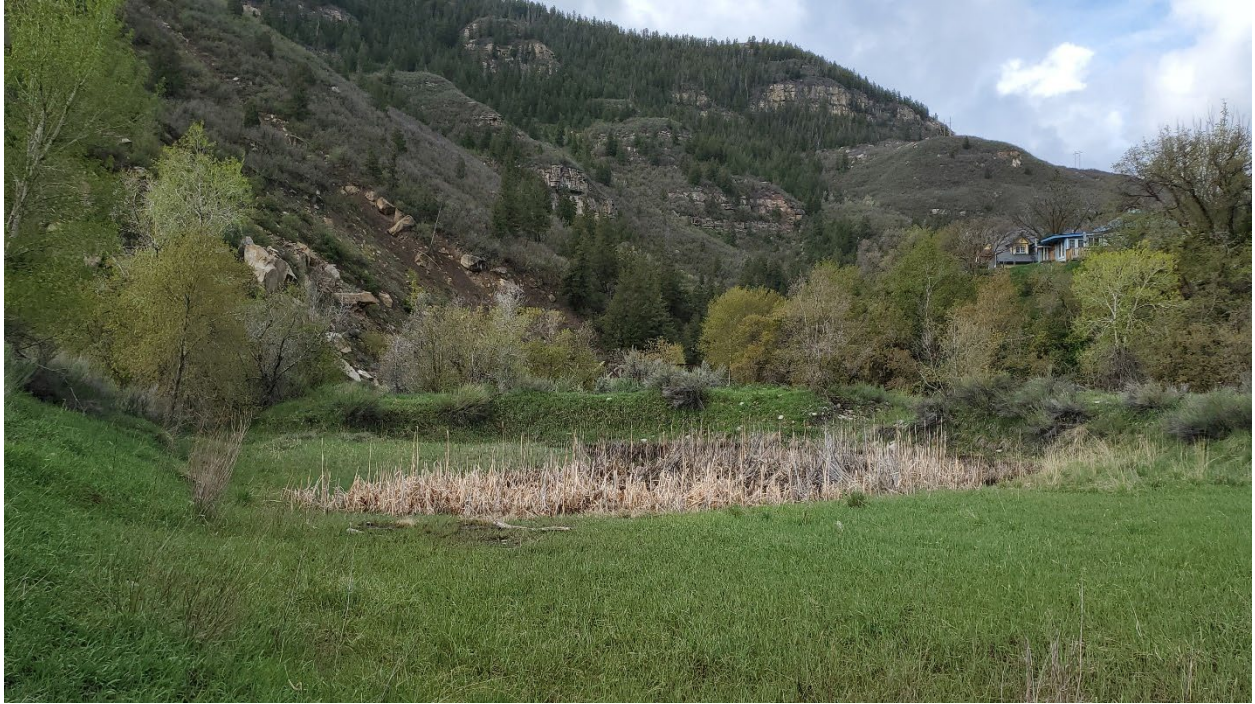
*Figure 6: Previous location of the sediment pond*
