## MINERALS PROGRAM INSPECTION REPORT PHONE: (303) 866-3567

MINE NAME:		MINE/PROSPECTING ID#:	MINERAL:	COUNTY:
Empire Pit		M-1977-534	Sand and gravel	Clear Creek
INSPECTION TYPE:		INSPECTOR(S):	INSP. DATE:	INSP. TIME:
Monitoring		Peter Hays	June 30, 2022	10:00
OPERATOR:		<b>OPERATOR REPRESENTATIVE:</b>	TYPE OF OPERATION:	
City of Golden		Anne Beierle	112c - Construction Regular Operation	
<b>REASON FOR INSPECTION:</b>		BOND CALCULATION TYPE:	BOND AMOUNT:	
Normal I&E Program		None	\$0.00	
DATE OF COMPLAINT:		POST INSP. CONTACTS:	JOINT INSP. AGENCY:	
NA		None	None	
WEATHER:	INSPECTOR'S SIGNATURE:		SIGNATURE DATE:	
Clear	11.1		July 20, 2022	
	h The			
	0

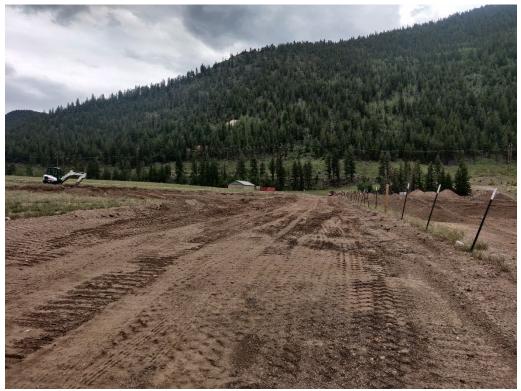
View of the road construction from the north end looking south

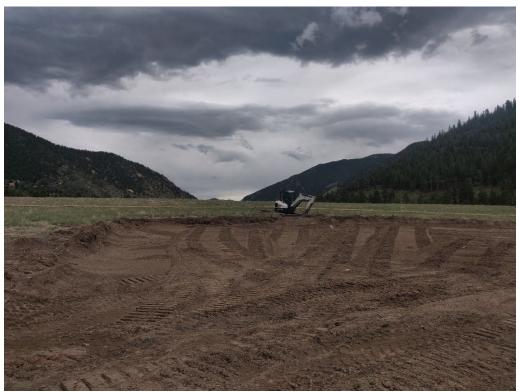
View of the excavation in the project area

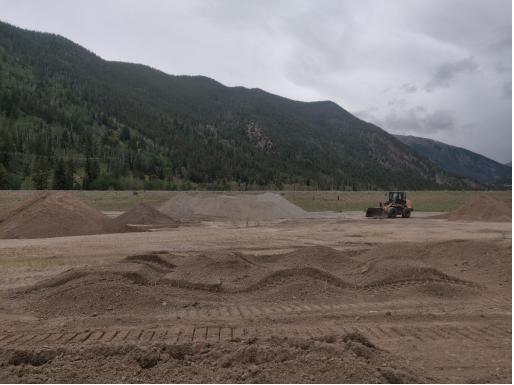
View of stockpiles of topsoil, overburden and road base

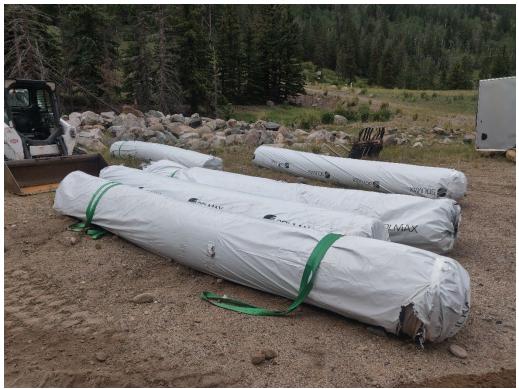
View of geosynthetic clay liner rolls

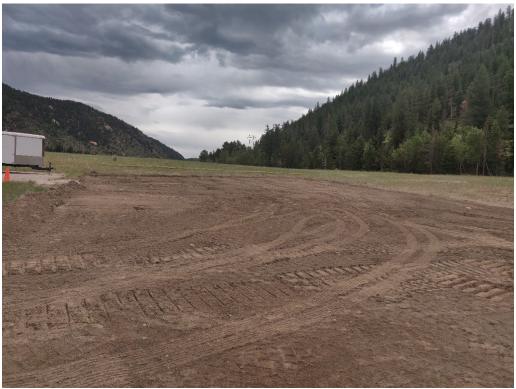
View of the turnaround area

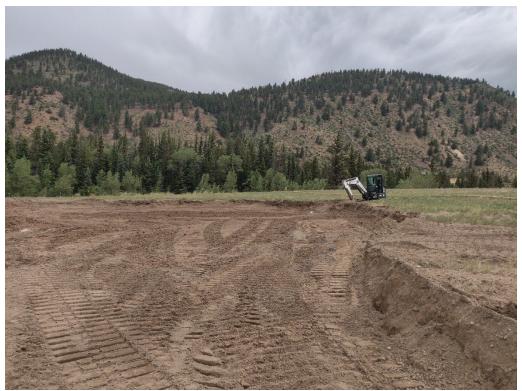
View of the excavation in the project area
