**MINERALS PROGRAM INSPECTION REPORT**  
**PHONE: (303) 866-3567**

<b>MINE NAME:</b> Baurer Pit	<b>MINE/PROSPECTING ID#:</b> M-2020-058	<b>MINERAL:</b> Sand and gravel	<b>COUNTY:</b> Weld
<b>INSPECTION TYPE:</b> Monitoring	<b>INSPECTOR(S):</b> Peter Hays	<b>INSP. DATE:</b> April 22, 2022	<b>INSP. TIME:</b> 10:00
<b>OPERATOR:</b> Aggregate Industries - WCR, Inc.	<b>OPERATOR REPRESENTATIVE:</b> Neil Whitmer	<b>TYPE OF OPERATION:</b> 112c - Construction Regular Operation	
<b>REASON FOR INSPECTION:</b> Normal I&E Program	<b>BOND CALCULATION TYPE:</b> None	<b>BOND AMOUNT:</b> \$2,011,924.00	
<b>DATE OF COMPLAINT:</b> NA	<b>POST INSP. CONTACTS:</b> None	<b>JOINT INSP. AGENCY:</b> None	
<b>WEATHER:</b> Clear	<b>INSPECTOR'S SIGNATURE:</b>

<b>MINE NAME:</b> Wattenberg Lakes	<b>MINE/PROSPECTING ID#:</b> M-2004-051	<b>MINERAL:</b> Aggregate	<b>COUNTY:</b> Weld
<b>INSPECTION TYPE:</b> Monitoring	<b>INSPECTOR(S):</b> Peter Hays	<b>INSP. DATE:</b> April 22, 2022	<b>INSP. TIME:</b> 10:00
<b>OPERATOR:</b> Aggregate Industries - WCR, Inc.	<b>OPERATOR REPRESENTATIVE:</b> Neil Whitmer	<b>TYPE OF OPERATION:</b> 112c - Construction Regular Operation

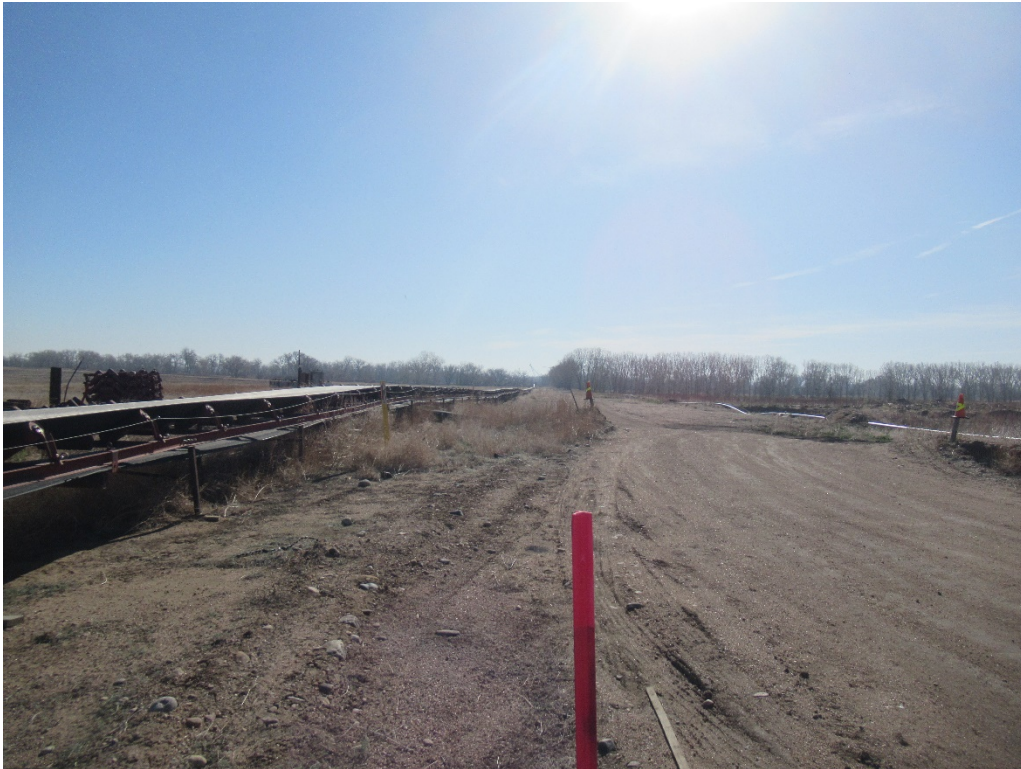
The infrastructure between the Wattenberg Lakes site and the Baurer Pit are contained within property owned by Aggregate Industries. Based on the Weld County Assessors map there is not an offset for the county road or other utilities. The county road and utilities are contained within easements on the AI property. During the inspection, the Operator confirmed the permit boundaries for the two sites adjoin each other. Additionally, the Division confirmed the conveyor along the southern boundary of Pond 3 was contained within the Wattenberg Lakes site.

View of the permit boundary between the Wattenberg Lakes and Baurer Pit from the northeast corner of the Baurer Pit looking east. The conveyor is located on the Wattenberg permit area in the location of one of the two roads reference in the complaint.

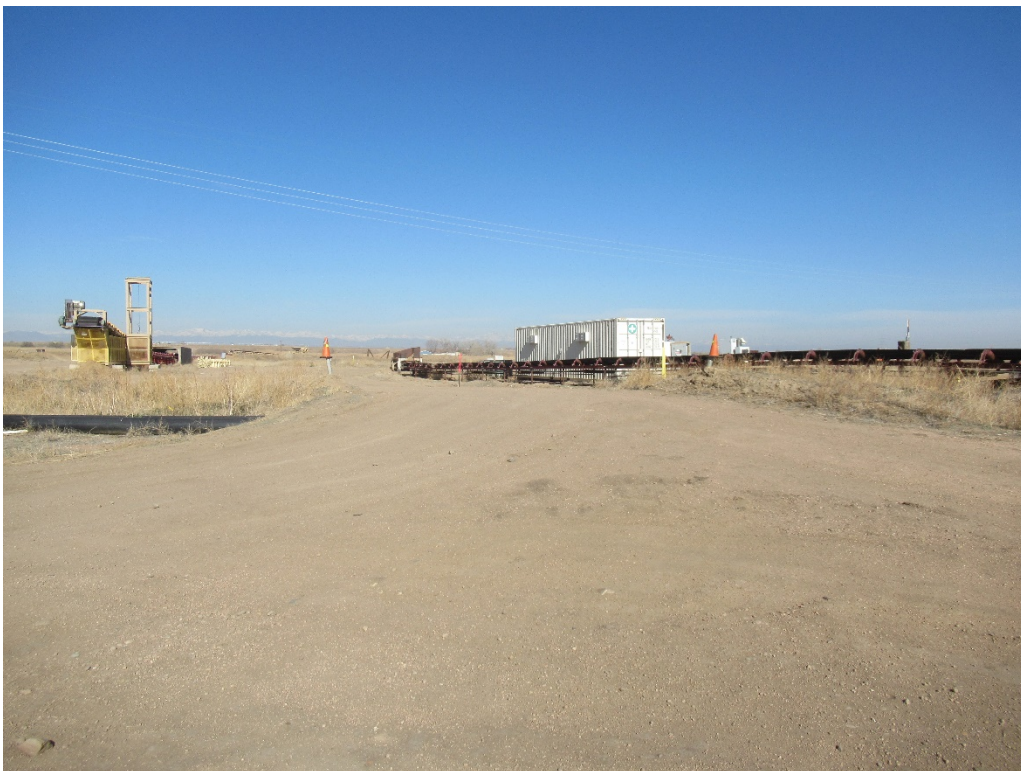
Based on Google Earth images, County Road 23 ¾ has historically crossed into the Baurer property in the northwest corner of the property. A small portion of the Baurer property between the northwest side of the county road and the northwest corner of the Baurer property, approximately 0.10 acres, was disturbed during the installation of dewatering pipes to deliver water to the Stillwater Ski Lake from the Wattenberg Lakes site between June 2017 and May 2018 based on the Google Earth images.

The Baurer Pit application was issued by the Division on April 18, 2022. The Baurer Pit is permitted for 79.4 acres with 62.2 acres of mining activity, however the approved affected land boundary is the same as the permitted boundary. Since the disturbance for the Stillwater Lake piping is contained within the affected land boundary for the Baurer Pit a problem will not be cited for the disturbance by the Division.

View of the disturbed area in the northwest corner of the Baurer Pit

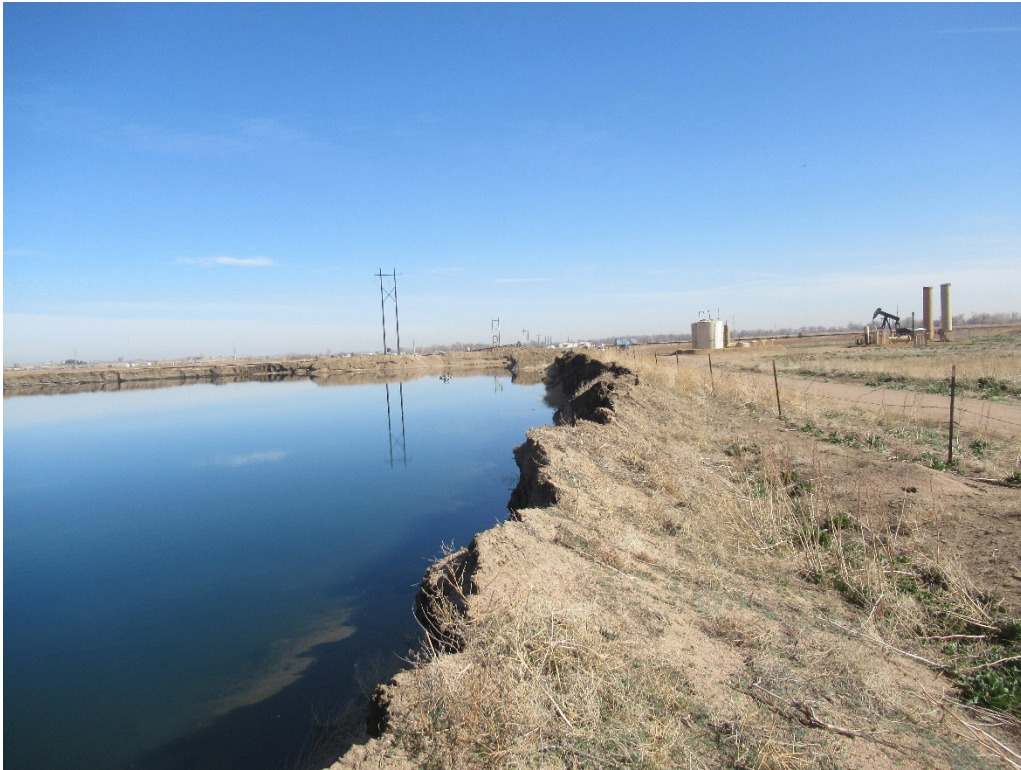
The surveyor install permit boundary markers at 200 foot intervals along the east shore line of the Phase 2 / Pond 1 Mining Area. The Operator stated the east shoreline was mined to the required 40 foot offset, however the area was allowed to fill with groundwater and has been dormant for several years, which has allowed the east shoreline to erode to the east into the required offset area.

View of the east shoreline in the Phase 2 / Pond 1 Mining Area looking north

**CORRECTIVE ACTIONS:** The Division will require the Operator to backfill and grade the Phase 2 / Pond 1 Mining Area to re-establish the required 40 foot offset from the eastern permit boundary / County Road 23 ¾ and provide evidence this has been corrected by the corrective action date.

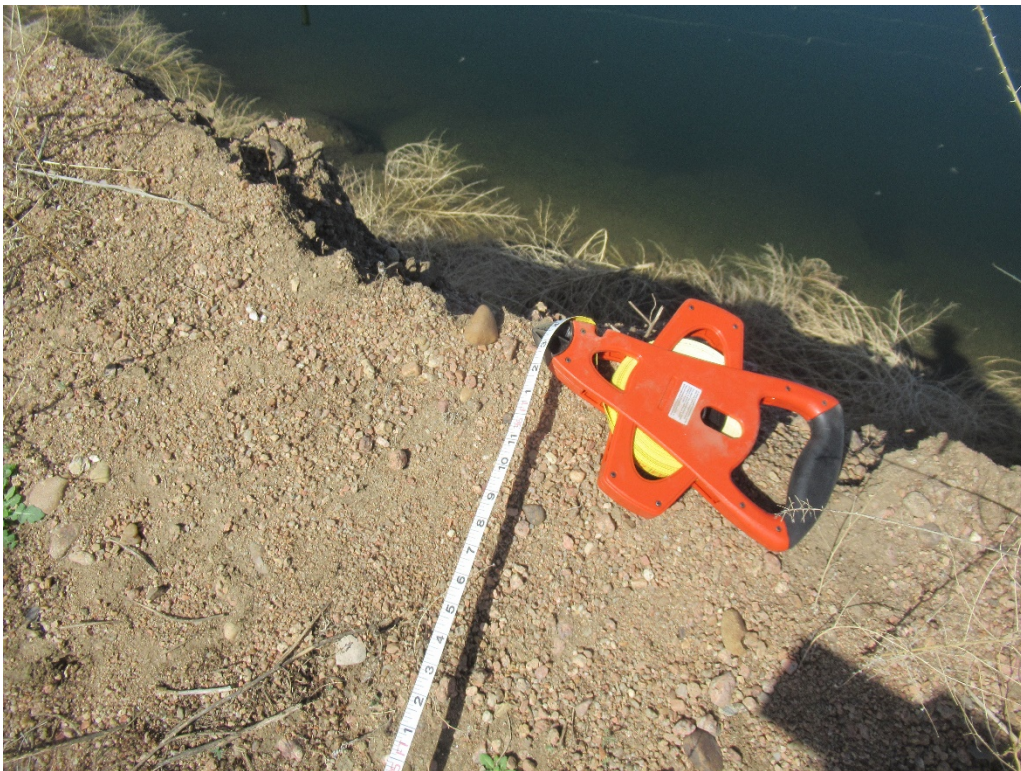
**PROBLEM:** The approved Mining Plan states a minimum 25 foot setback will be maintained from the permit boundary with at least a 40 foot offset from the permit boundary when slurry walls are installed or from county roads. The Operator has allowed the eastern shoreline of the Phase 2 / Pond 1 to erode into the required 40 foot setback. This a problem pursuant to CRS 34-32.5-116(4)(j) for failure to stabilize the affected area and failure to effectively control erosion.

The Division and the Operator measured the current offsets from the permit boundary to the edge of slope at four (4) of the survey locations. The offsets were measured at 36 feet, 25 feet, 30 feet and 55 feet, therefore

three (3) of the four (4) offsets are out of compliance with the approved Mining Plan. No evidence of instability which could potentially effect CR 32 ¾ was observed during the inspection.

View of the 36 foot offset measurement along the east shoreline of Phase 2 / Pond 1 Mining Area

As cited as a problem above, the Division will require the Operator to backfill and grade the Phase 2 / Pond 1 Mining Area to re-establish the required 40 foot offset from the eastern permit boundary / County Road 23 ¾ and provide evidence this has been corrected by the corrective action date. The Operator stated the discharge permit for the mining area is no longer valid. The Operator recently submitted a new discharge permit to dewater the mining area to allow the eastern shoreline to be backfilled to at least the minimum 40 feet offset. The Operator was informed by CDPHE the permit would take up to 60 days to review and issue. The material to backfill the mining area would be obtained on-site from the Phase 2 / Pond 2 Mining Area. The Phase 2 / Pond 1 Mining Area is approved to be converted into a reservoir with the installation of a slurry wall in the approved Reclamation Plan. The slurry wall is currently being designed by the Operator's consultant.

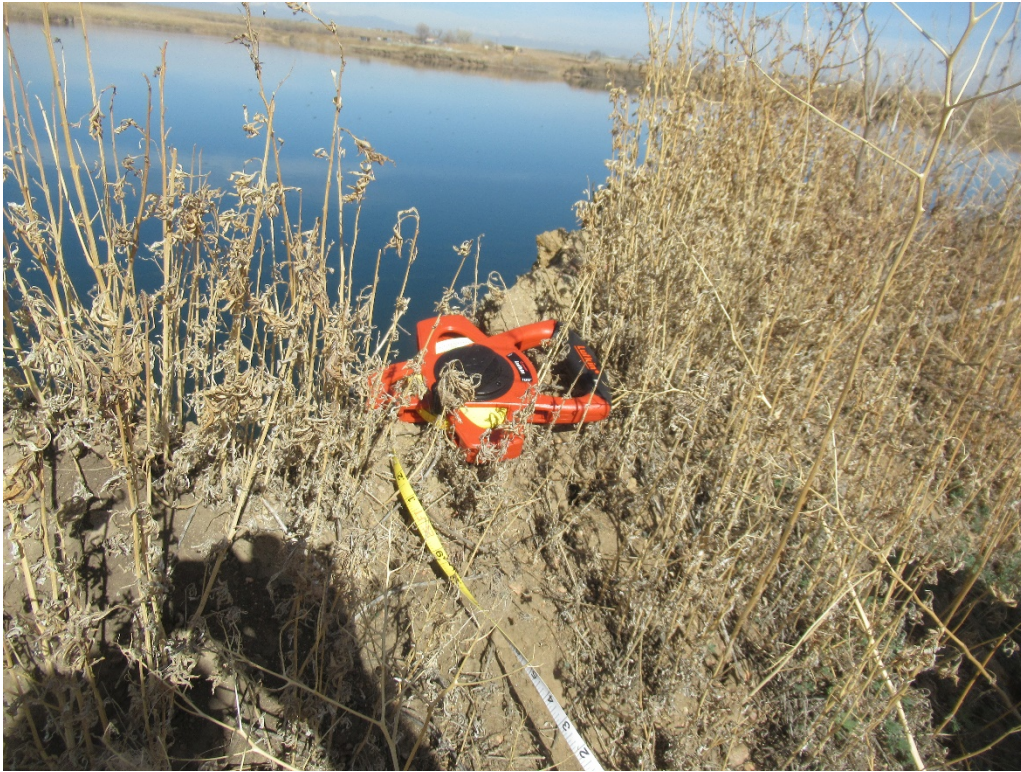
View of the 25 foot offset measurement along the east shoreline of Phase 2 / Pond 1 Mining Area

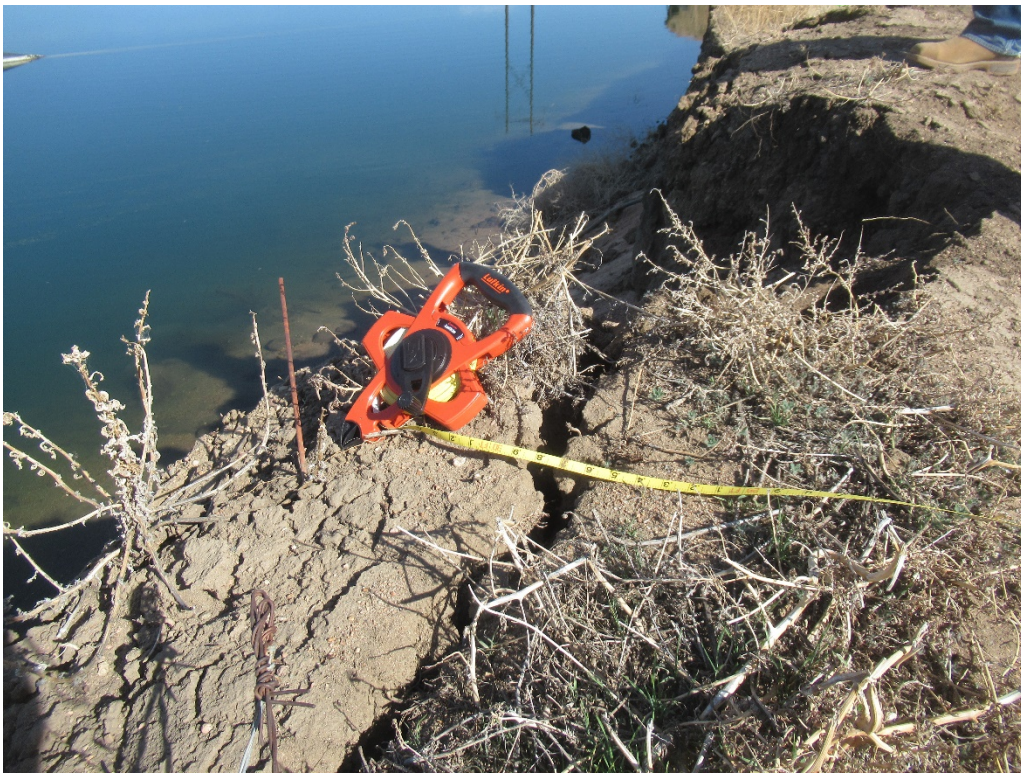
View of the 30 foot offset measurement along the east shoreline of Phase 2 / Pond 1 Mining Area

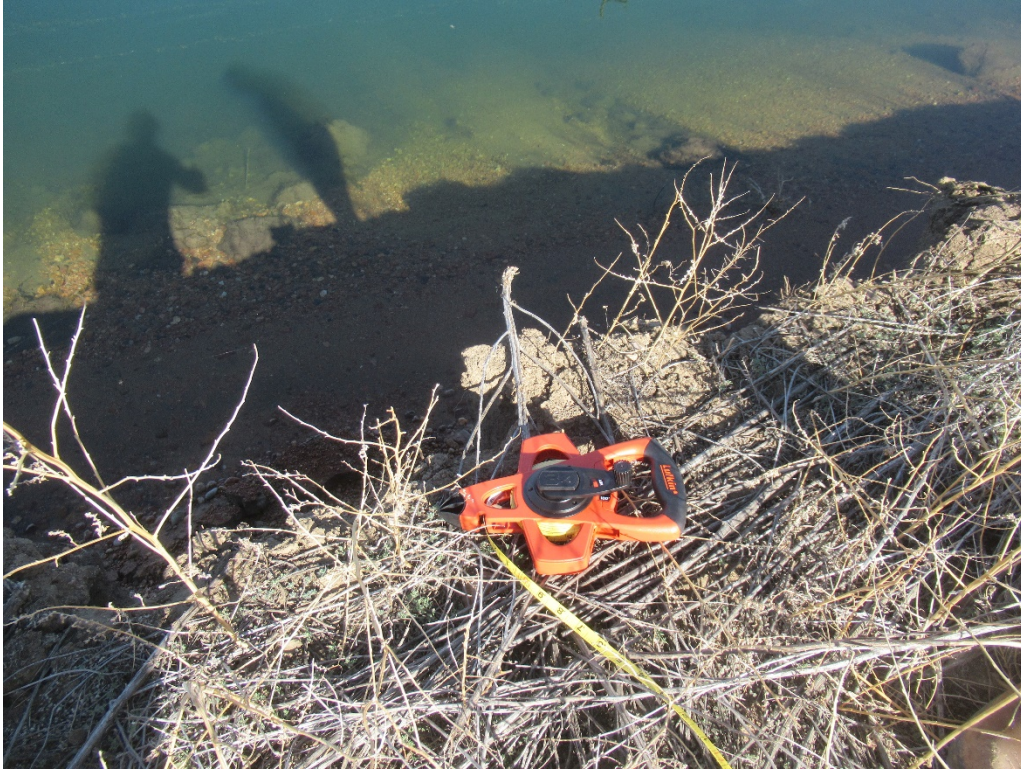
View of the 55 foot offset measurement along the east shoreline of Phase 2 / Pond 1 Mining Area

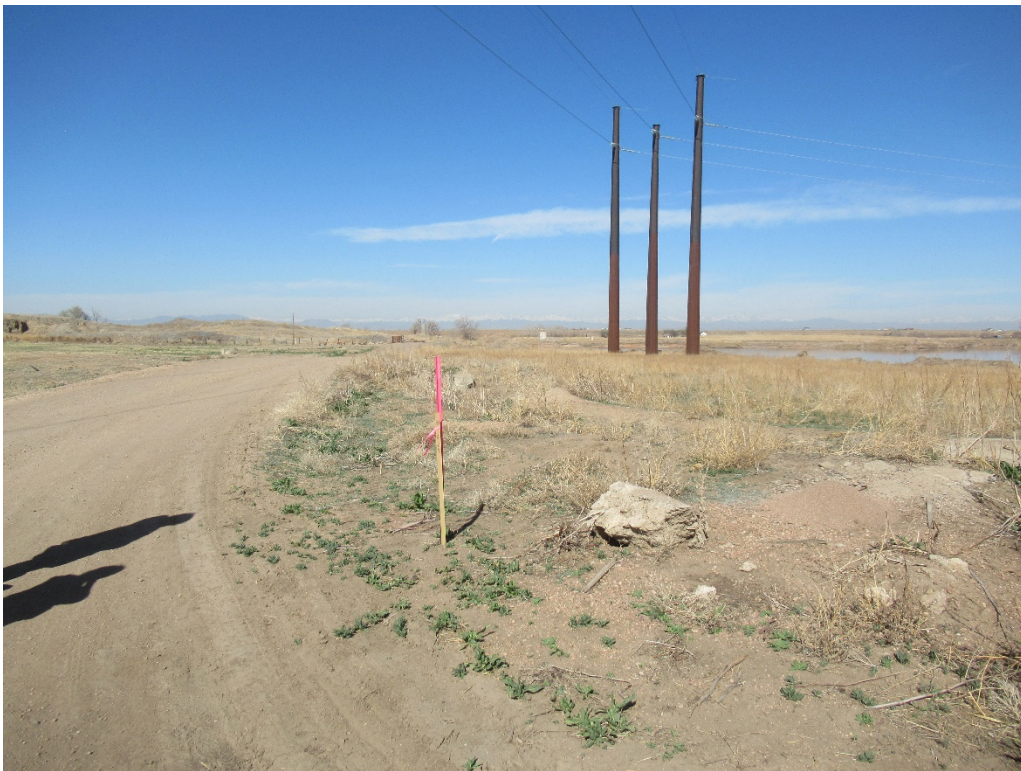
View of the site from the southeast corner of Phase 2 / Pond 1 Mining Area looking west

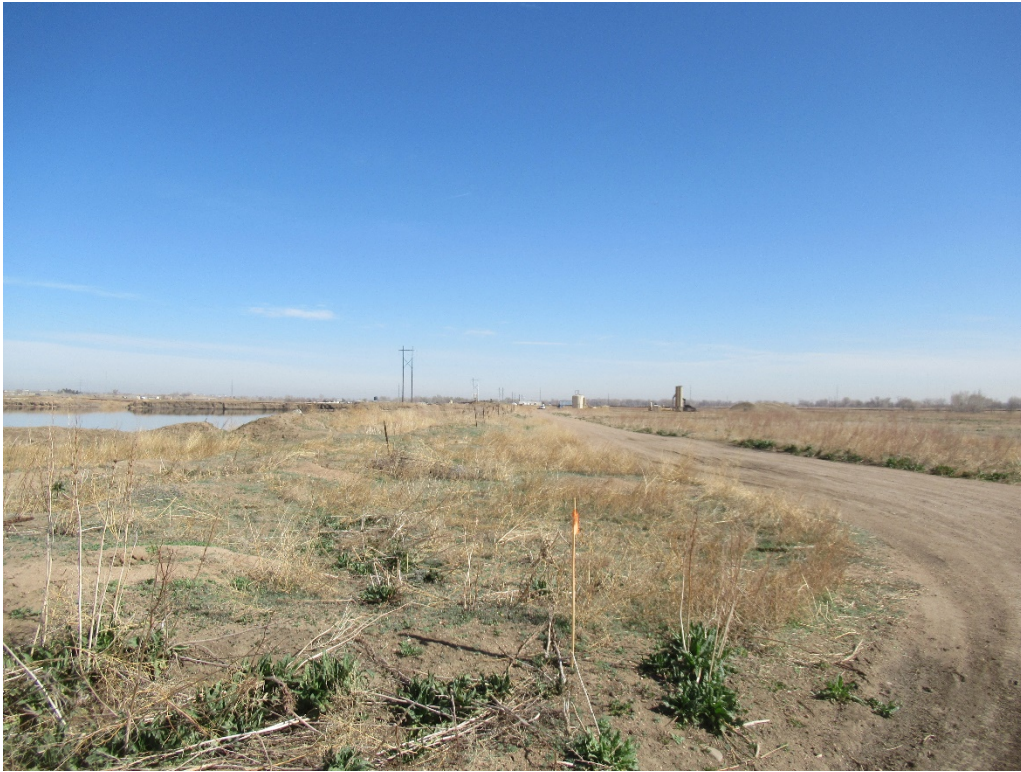
View of the site from the southeast corner of Phase 2 / Pond 1 Mining Area looking north

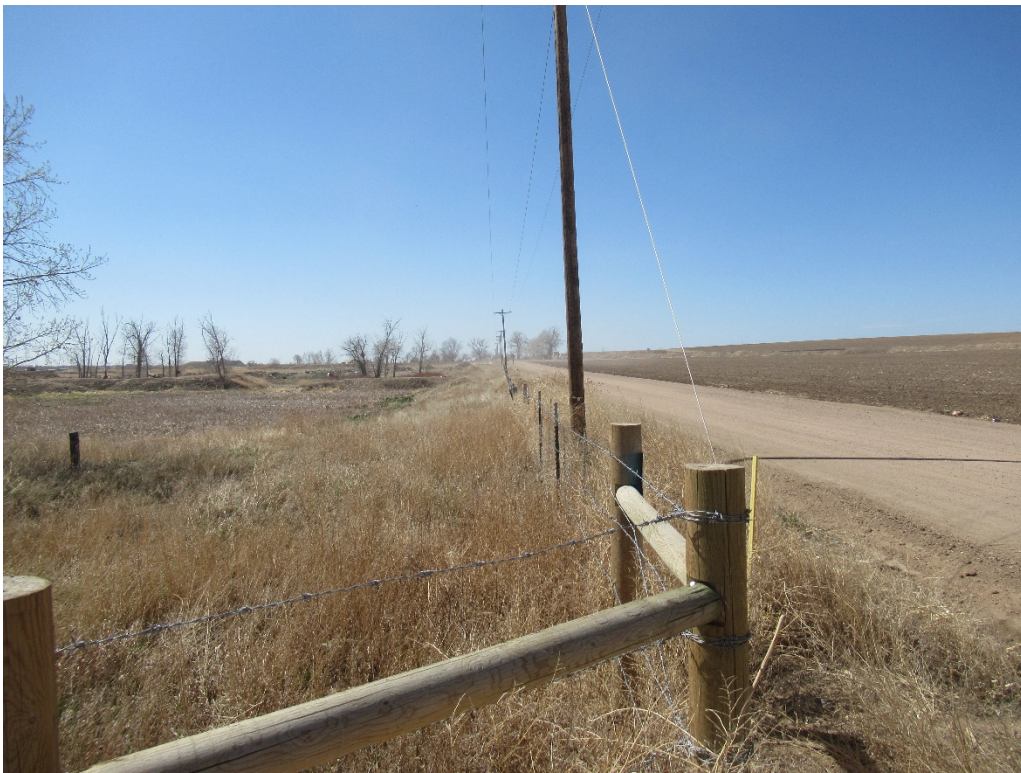
View of the site from the northwest corner of Phase 1 / Pond 2 Mining Area looking south. The area pictured has not been disturbed by the Operator and is the native ground.

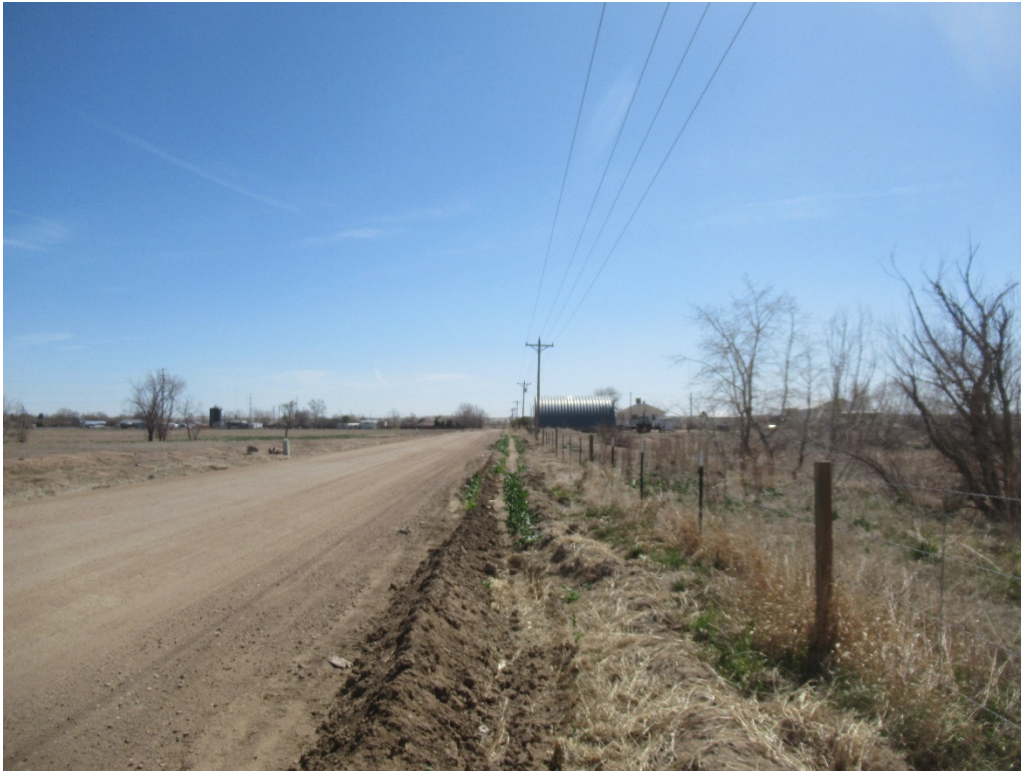
View of the site from the northwest corner of Phase 1 / Pond 2 Mining Area looking east
