MINERALS PROGRAM INSPECTION REPORT
PHONE: (303) 866-3567

MINE NAME: Wattenberg Lakes	MINE/PROSPECTING ID#: M-2004-051	MINERAL: Aggregate	COUNTY: Weld
INSPECTION TYPE: Monitoring	INSPECTOR(S): Peter Hays	INSP. DATE: April 22, 2022	INSP. TIME: 11:00
OPERATOR: Aggregate Industries - WCR, Inc.	OPERATOR REPRESENTATIVE: Neil Whitmer	TYPE OF OPERATION: 112c - Construction Regular Operation	
REASON FOR INSPECTION: Normal I&E Program	BOND CALCULATION TYPE: None	BOND AMOUNT: \$520,000.00	
DATE OF COMPLAINT: NA	POST INSP. CONTACTS: None	JOINT INSP. AGENCY: None	
WEATHER: Clear	INSPECTOR'S SIGNATURE:

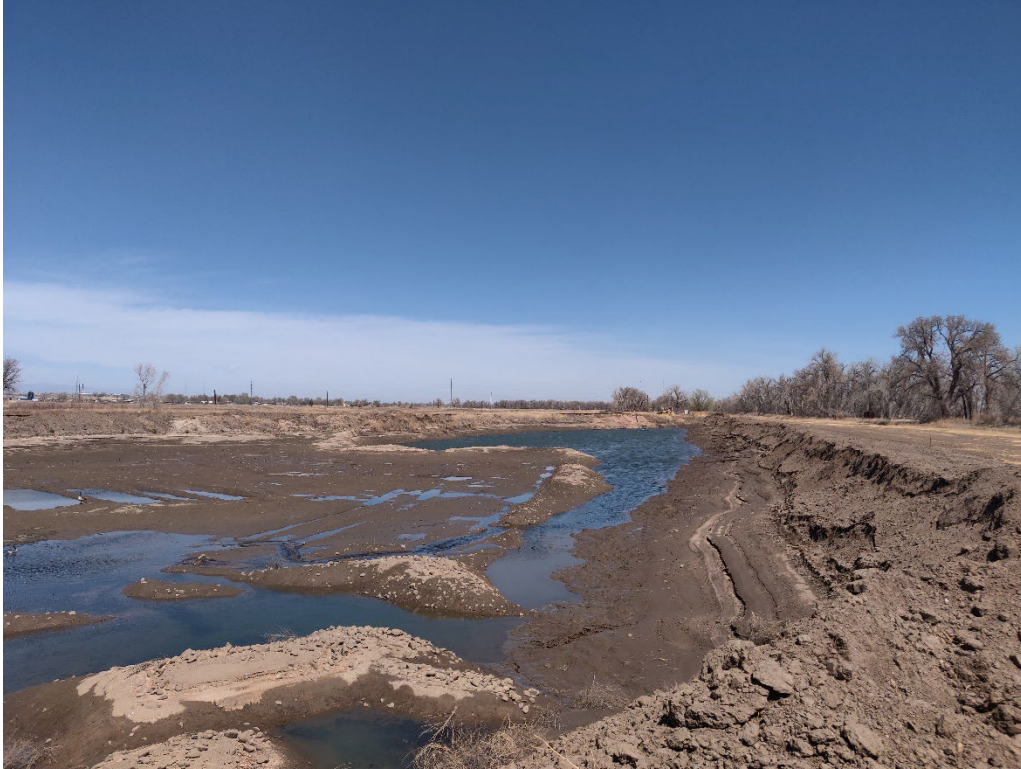
The Division required the Operator to backfill the Phase 2 / Mining Area 1 to establish the required 25 foot offset from the eastern permit boundary and provide evidence by the corrective action due date. The mining area will be backfilled to a wetland mitigation / riparian area in the approved Reclamation Plan. The Operator stated the timeframe to backfill the mining area was a couple of years. During the previous inspection, the Operator stated if the water in the mining area could be pumped out while equipment was on-site, the mining area would be backfilled to the required setback as soon as possible.

View of the backfilled slope from the south end looking north

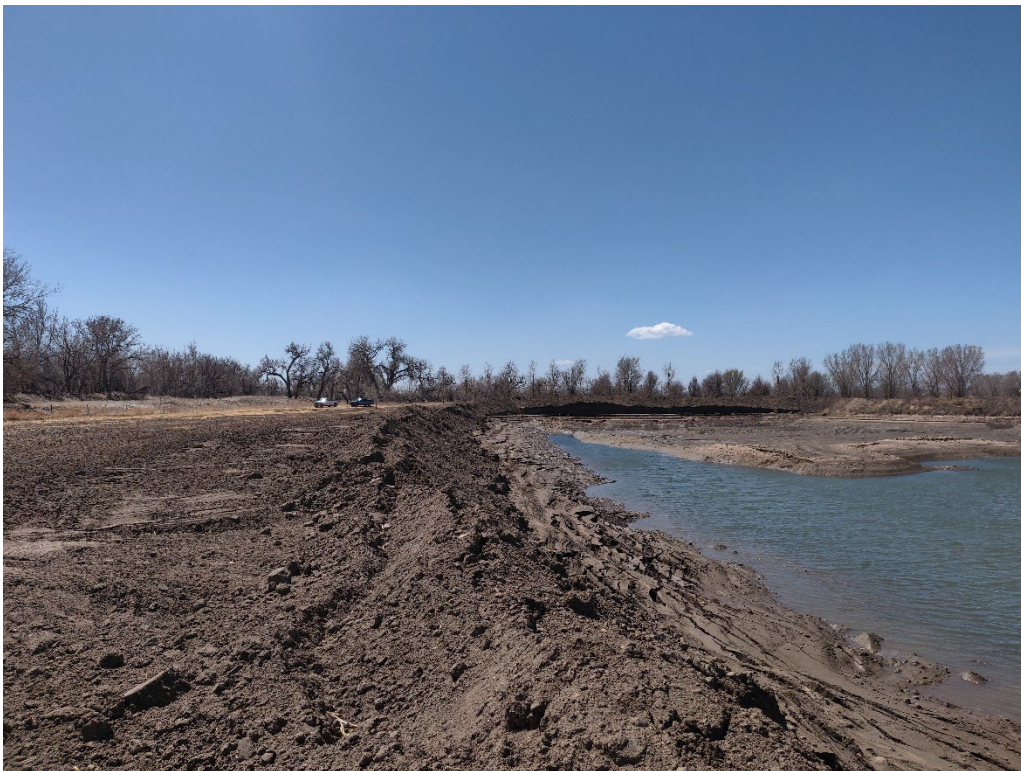
View of the backfilled slope from the north end looking south

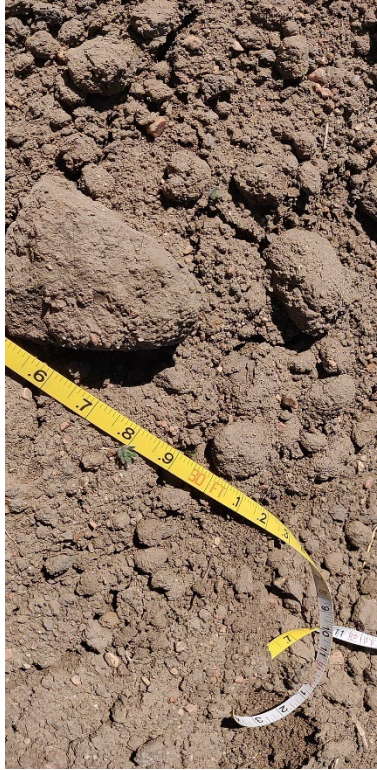
The offset from the permit boundary markers to the top of the eastern highwall for the Phase 2 / Mining Area 1 was measured at three (3) locations by the Division. The offsets measured thirty (30) feet, twenty-nine and a half (29.5) feet and twenty-nine (29) feet from south to north from the southeast permit boundary corner. A pump was observed in the northern portion of the area and the area was actively being dewatered during the inspection. The problem cited during the previous inspection for the Phase 2 / Mining Area 1 offset is considered resolved by the Division.

View of the first measured 30 feet offset

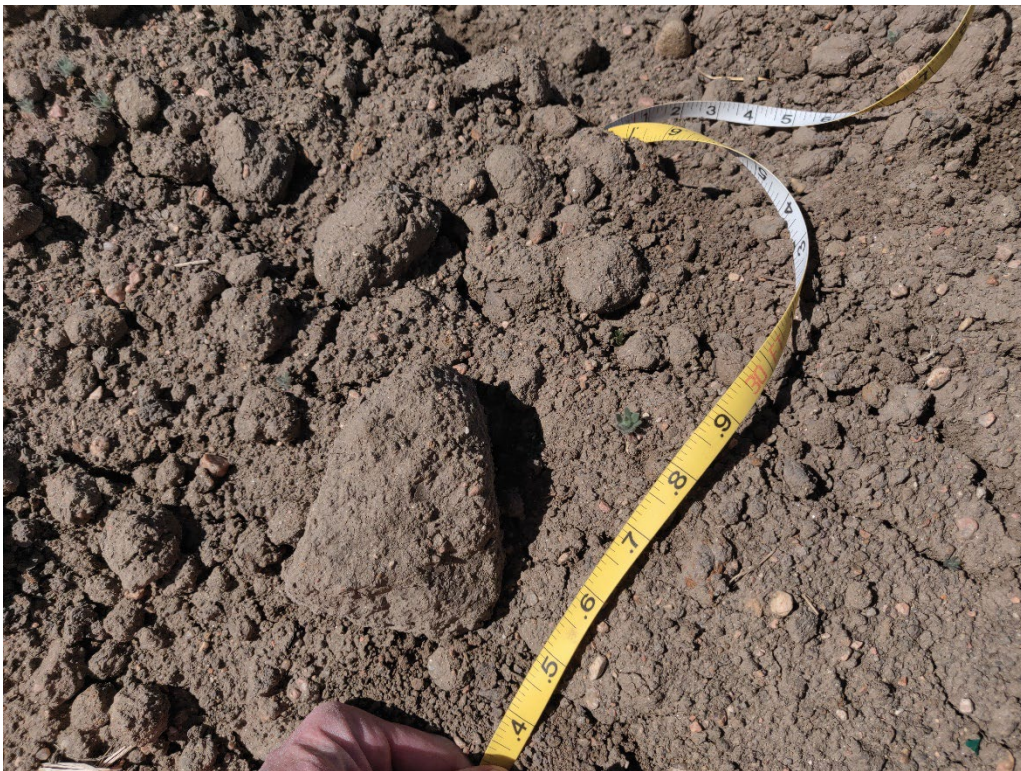
View of the second measured 29.5 feet offset

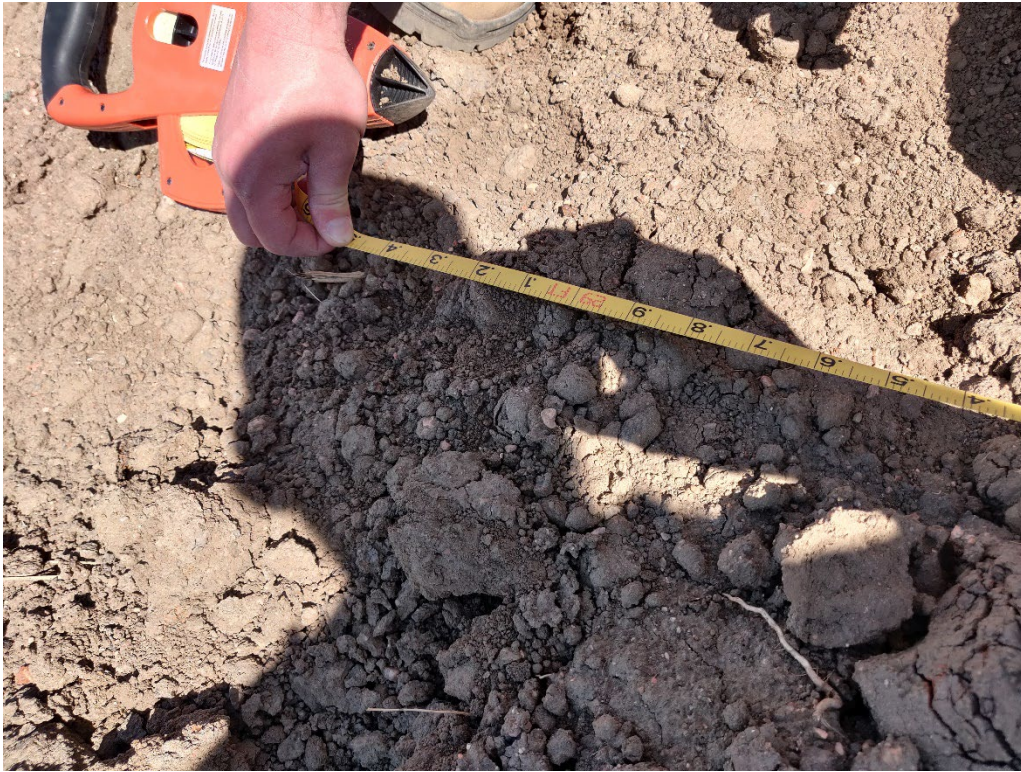
View of the third measured 29 feet offset
