MINERALS PROGRAM INSPECTION REPORT

MINE NAME: Wertz Pit	MINE/PROSPECTING ID#: M-2022-024	MINERAL: Aggregate & gravel	COUNTY: Bent
INSPECTION TYPE: Preoperation Inspection	INSPECTOR(S): Nikie Gagnon	INSP. DATE: July 14, 2022	INSP. TIME: 10:00
OPERATOR: All Rite Paving & Redi Mix	OPERATOR REPRESENTATIVE: Jodi Schreiber	TYPE OF OPERATION: 112c - Construction Regular Operation

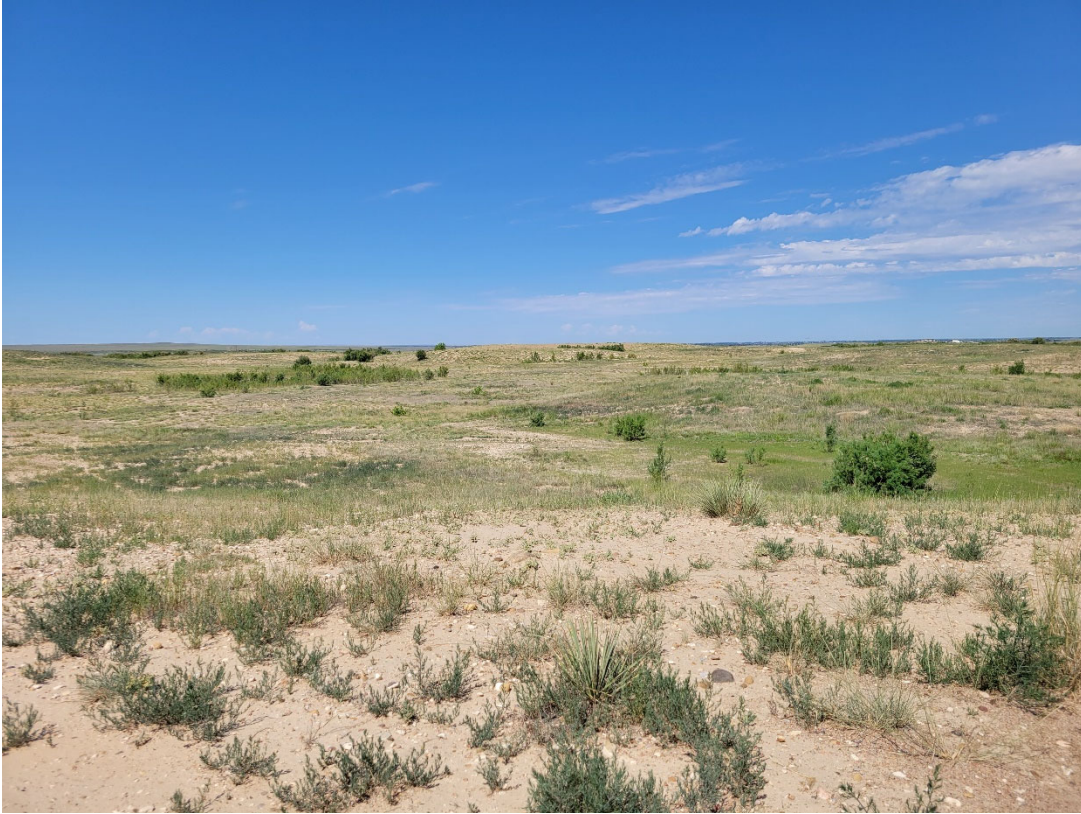
A gravel access road provides access to the site. During the inspection, the Division observed graded pit slopes around the central pit to be stable overall. Sparse vegetative cover exists across the pit, consisting of native grasses, forbs, and weeds (e.g. kochia, scotch thistle). Tamarisk trees are present in the bottom of the pit. Native grasses and forbs are denser east of the access road in reseeded areas.

Looking southwest across central pit.

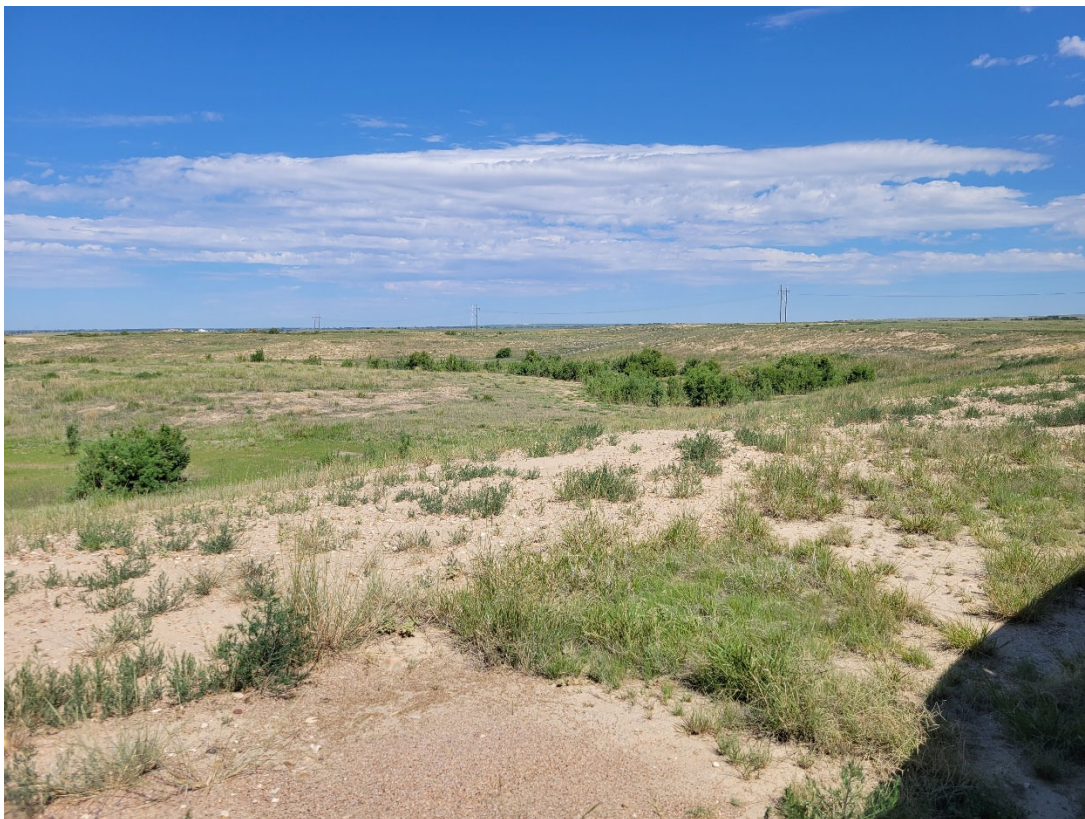
Looking northwest across central pit.

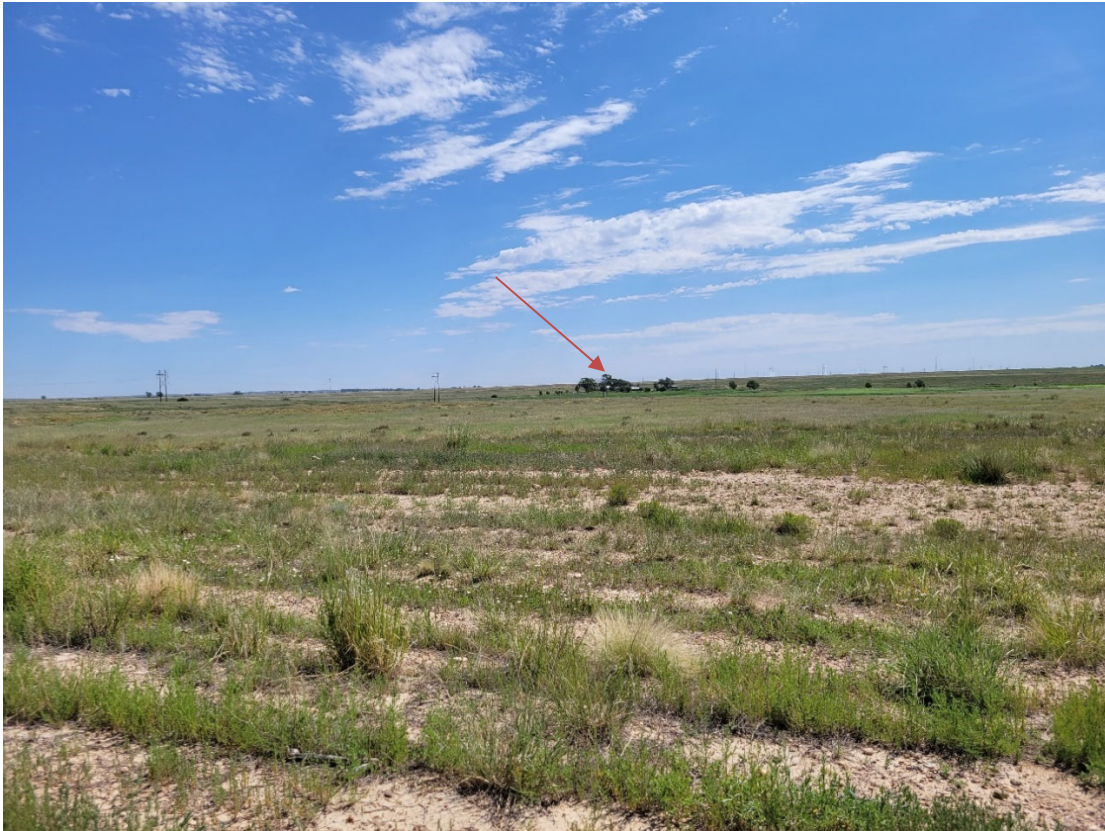
Reseeded area east of access road, within new permit boundary. Landowner home in the background.

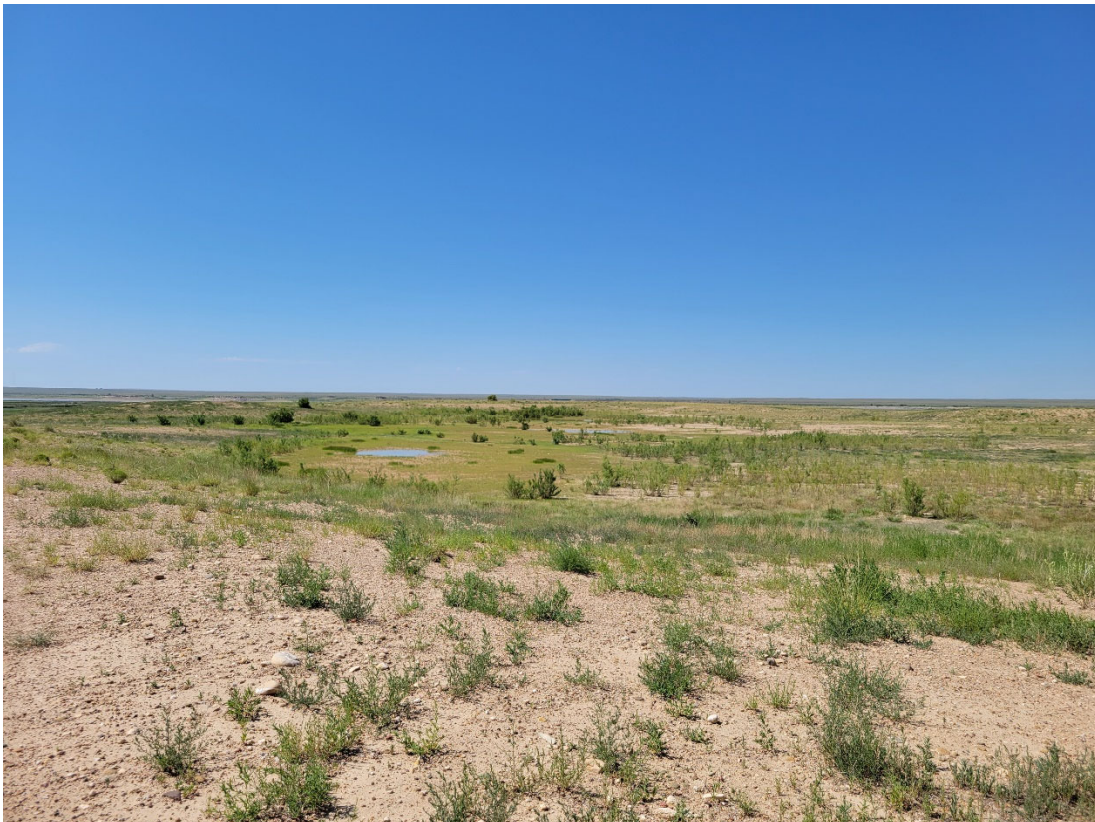
Southeastern corner of proposed permit boundary.
Looking south at former Hasty Pit permit area, outside proposed mining area.

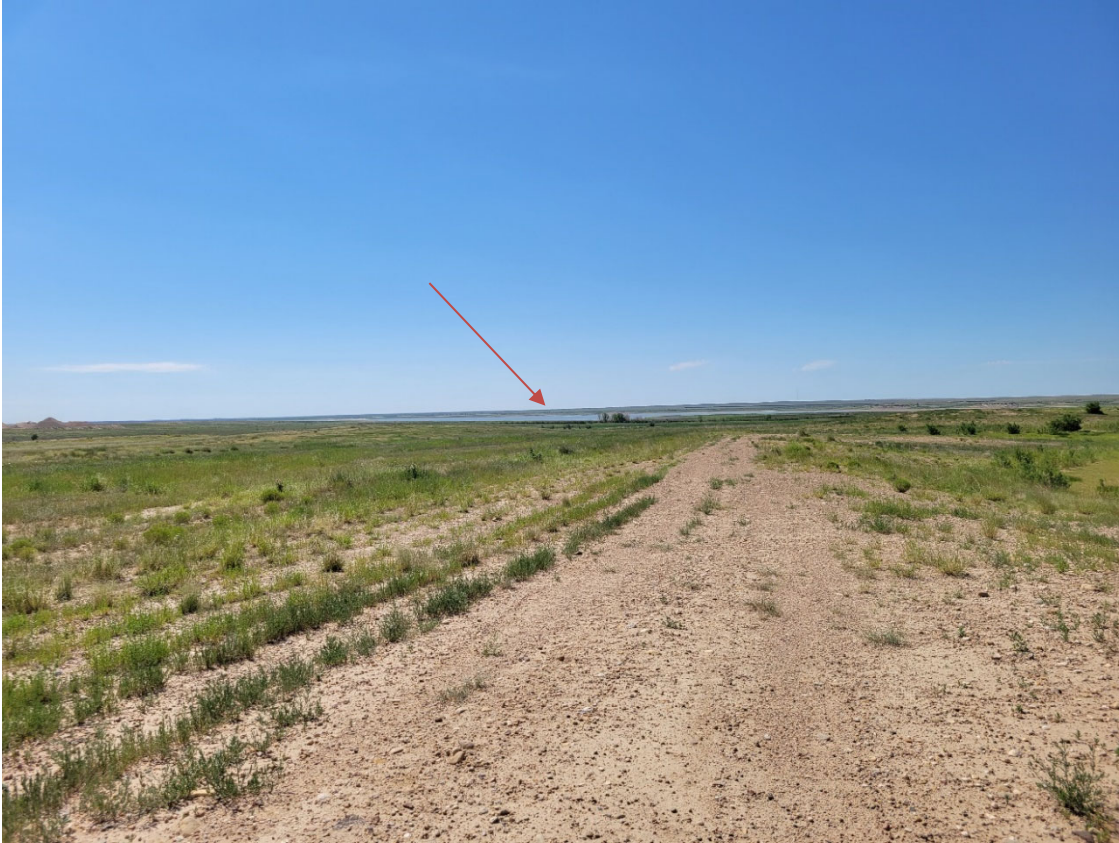
Looking south from access road. Reseeded area on the left. John Martin Reservoir in the background.

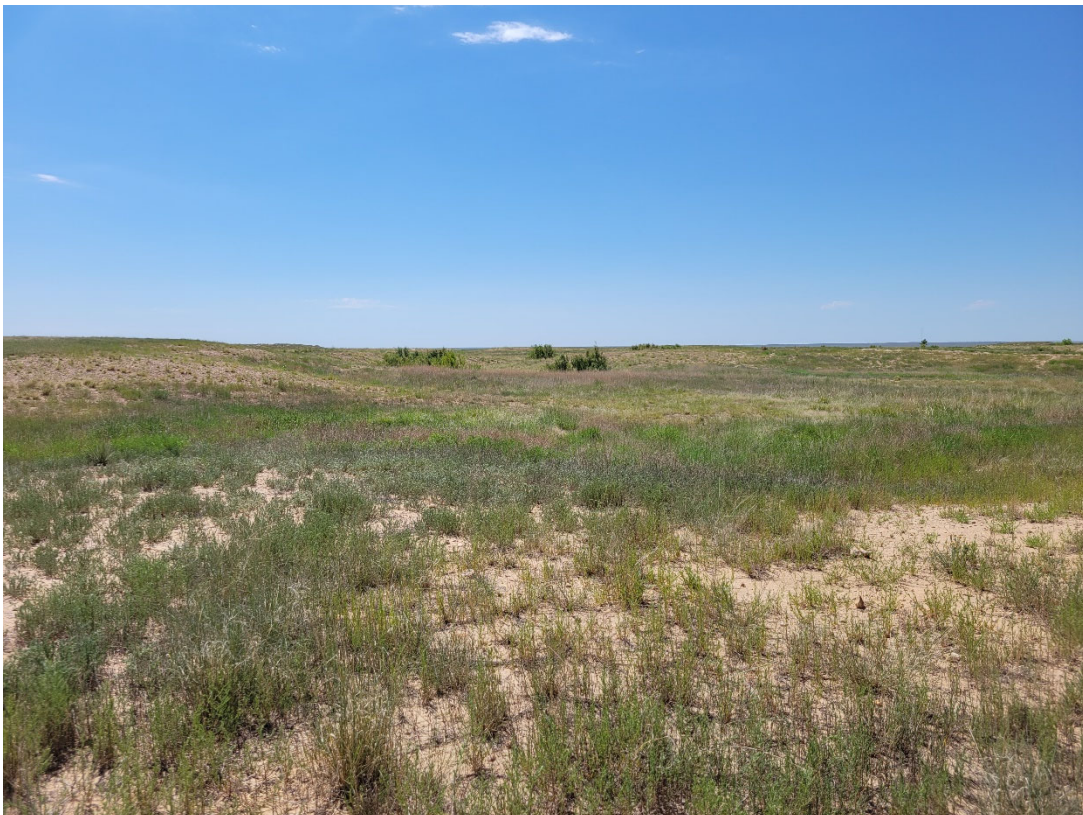
Looking south from northern section of the permit area.

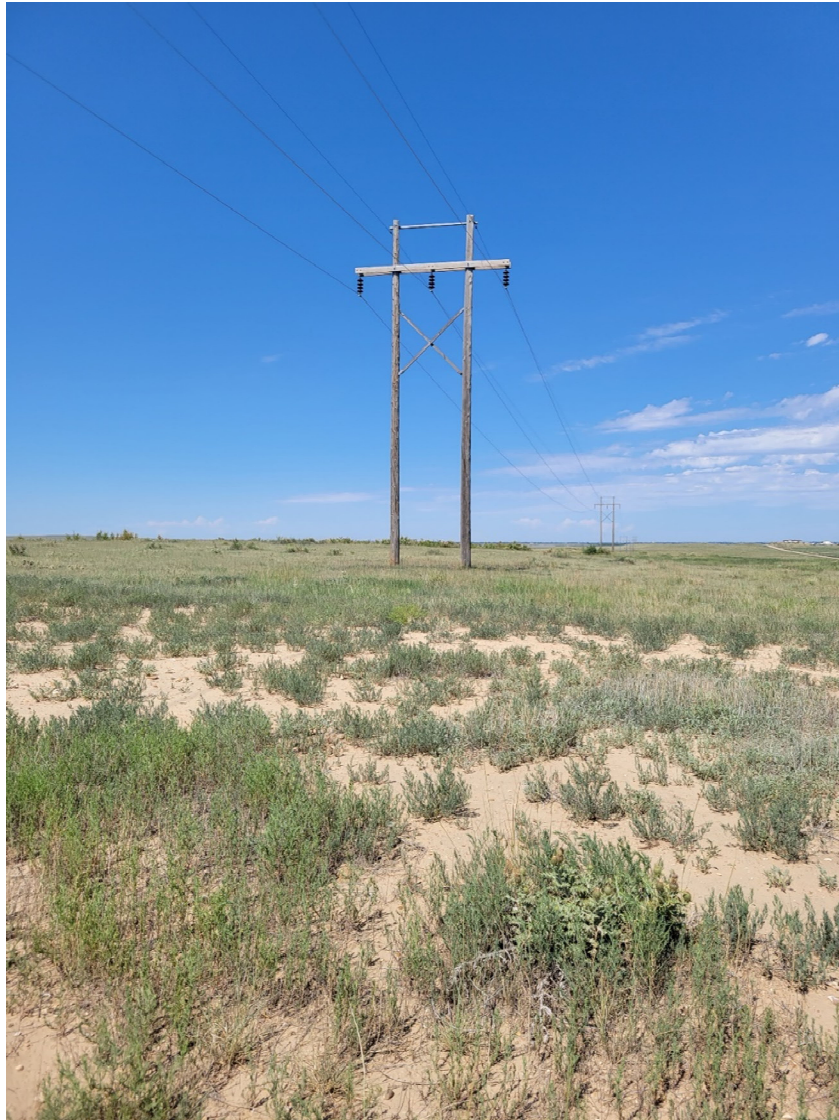
A high voltage electrical line owned by Lamar Light and Power (Lamar) runs through the middle of the area to be mined. Three power poles will likely be impacted by mining. During the inspection, Ms. Schreiber stated Lamar does not want to enter into a structure agreement with All Rite Paving and Redi Mix. Lamar opted to have an engineer give direction on how mining should occur around their structures in lieu of the structure agreement. The engineered drawing included in the application delineated a 25-foot buffer around the poles. Ms. Schreiber stated All-Rite is open to adjusting the buffer distance further out if the Division finds this necessary to protect the integrity of the power structures.

Looking west at transmission lines that cross proposed mining area.

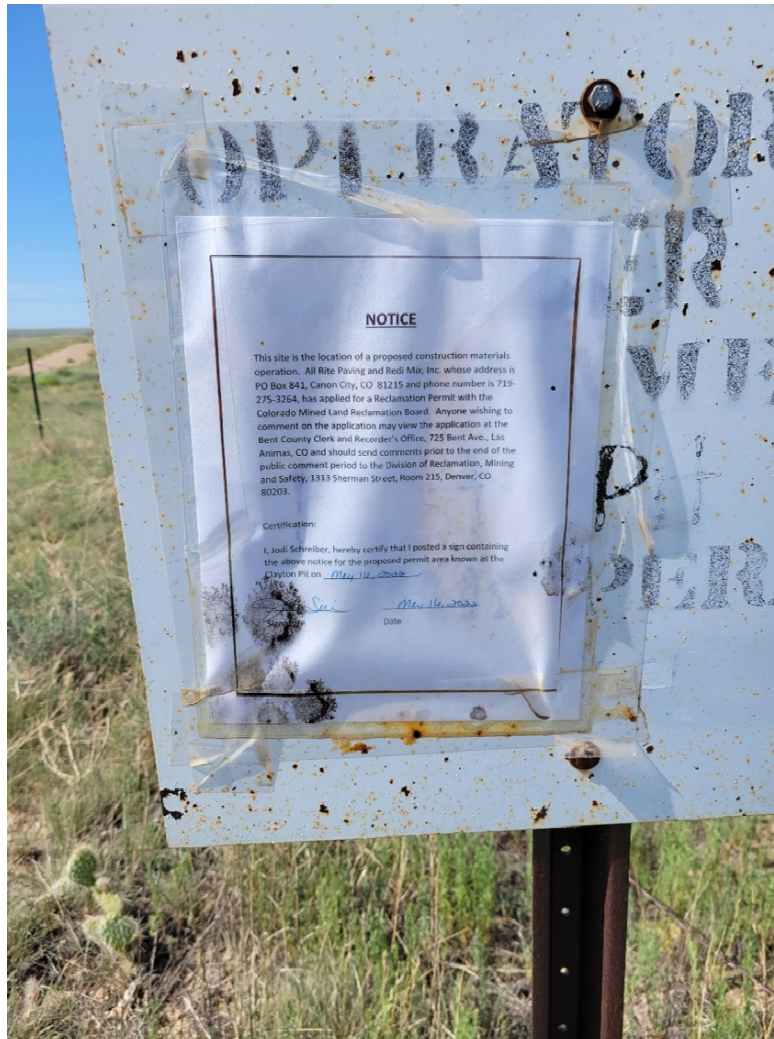
A notice was posted at the entrance to the site. Boundary markers have not been installed.

Notice posted at entrance to site.
