MINERALS PROGRAM INSPECTION REPORT
PHONE: (303) 866-3567

MINE NAME: Empire Pit	MINE/PROSPECTING ID#: M-1977-534	MINERAL: Sand and gravel	COUNTY: Clear Creek
INSPECTION TYPE: Monitoring	INSPECTOR(S): Peter Hays	INSP. DATE: July 22, 2022	INSP. TIME: 09:00
OPERATOR: City of Golden	OPERATOR REPRESENTATIVE: None	TYPE OF OPERATION: 112c - Construction Regular Operation	
REASON FOR INSPECTION: Normal I&E Program	BOND CALCULATION TYPE: None	BOND AMOUNT: \$0.00	
DATE OF COMPLAINT: NA	POST INSP. CONTACTS: None	JOINT INSP. AGENCY: None	
WEATHER: Clear	INSPECTOR'S SIGNATURE:

The Empire Pit was inspected by Peter Hays and Brock Bowles with the Division of Reclamation, Mining and Safety to observe the work associated with technical revision no 4. (TR4). The site was last inspected by the Division on June 30, 2022. A representative from the City of Golden was not present during the inspection.

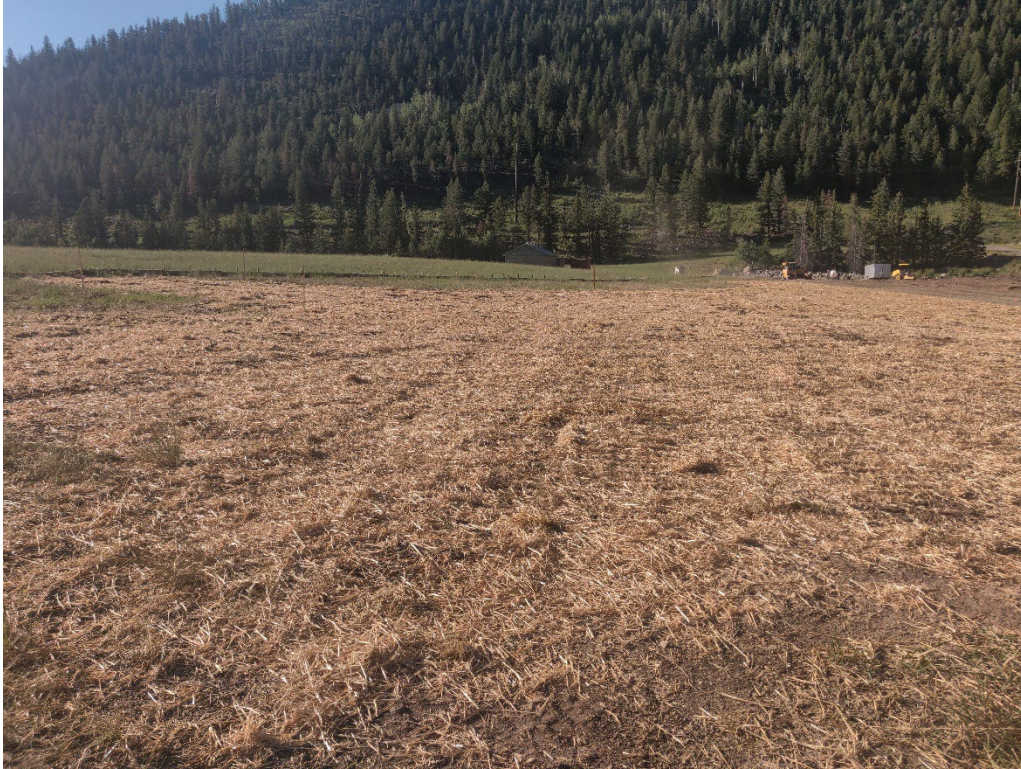
View of the project area from the north side looking south

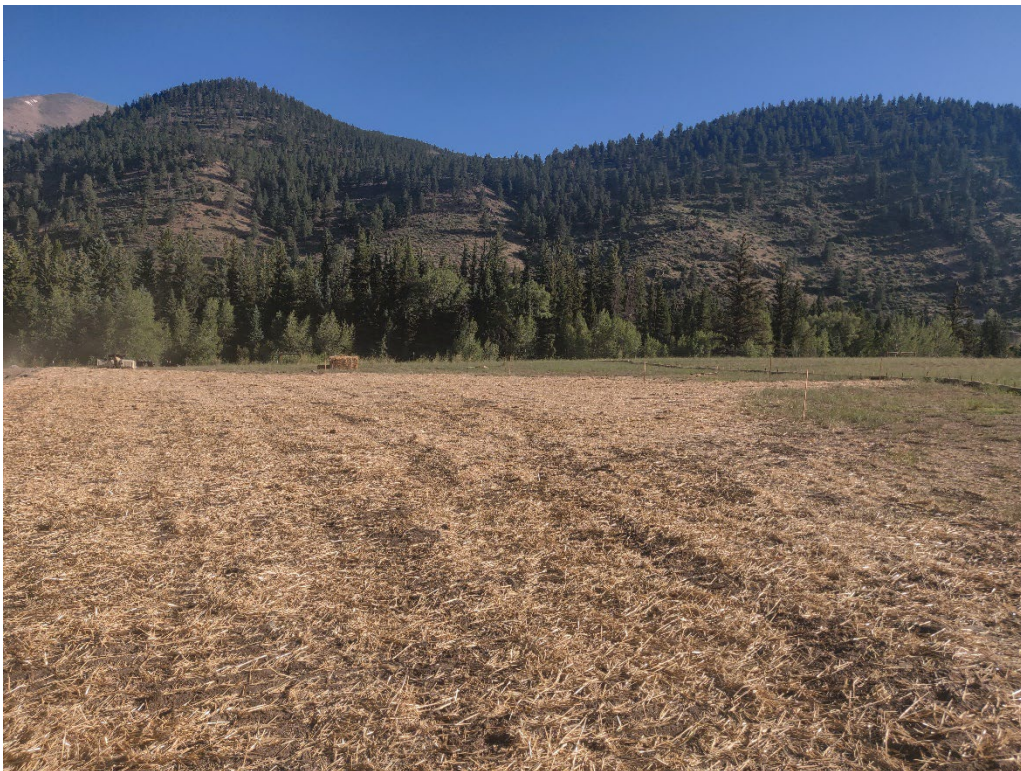
View of the project area from the south side looking north

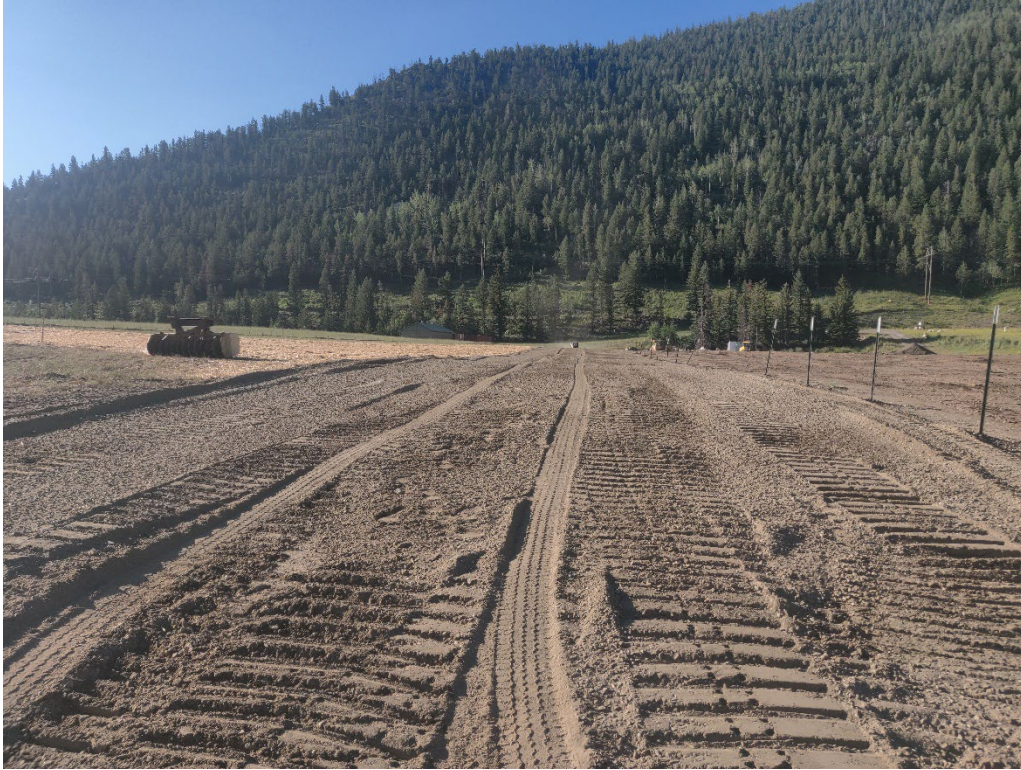
View of the access road from the north end looking south

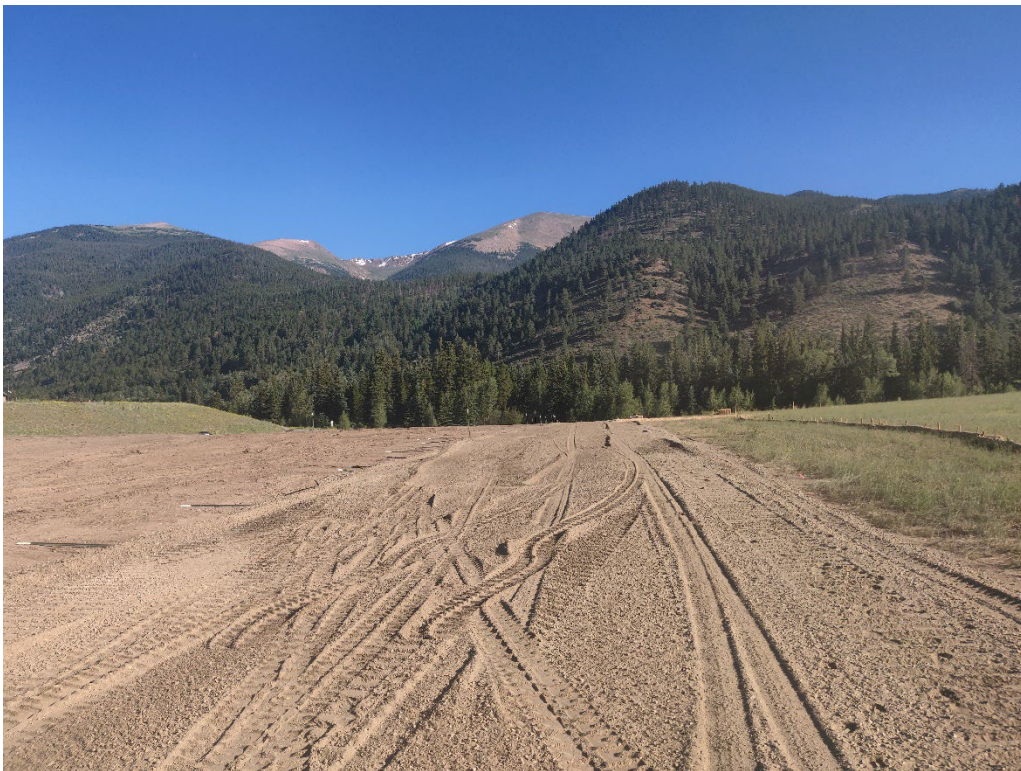
View of the access road from the south end looking north

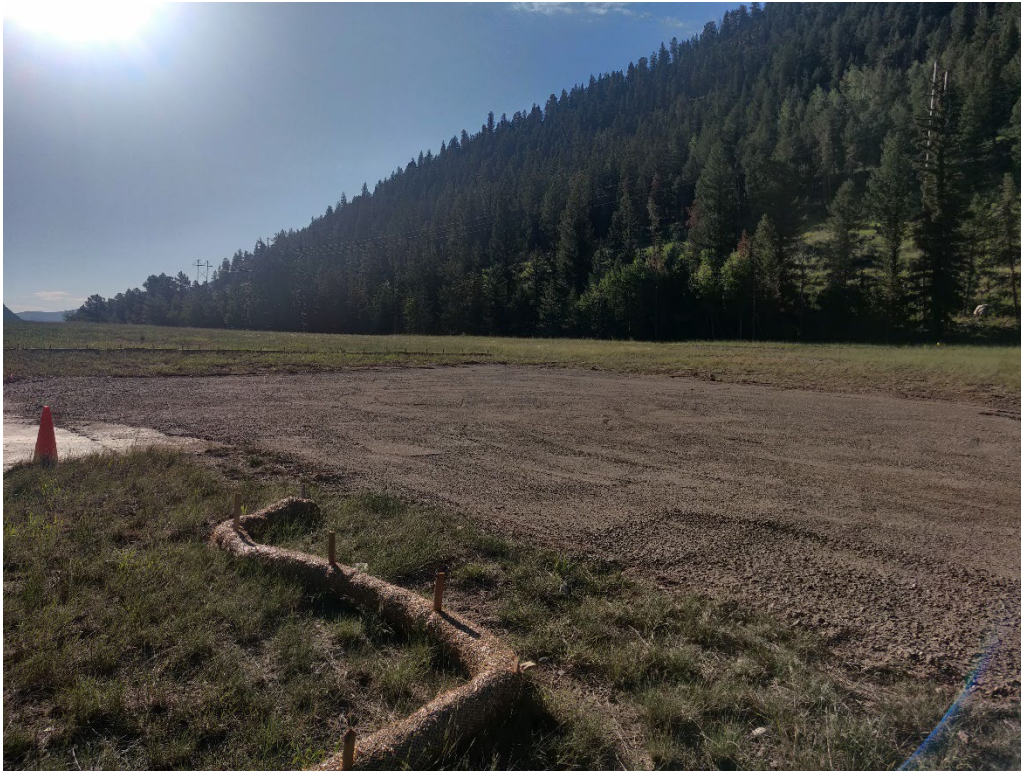
View of the turnaround area

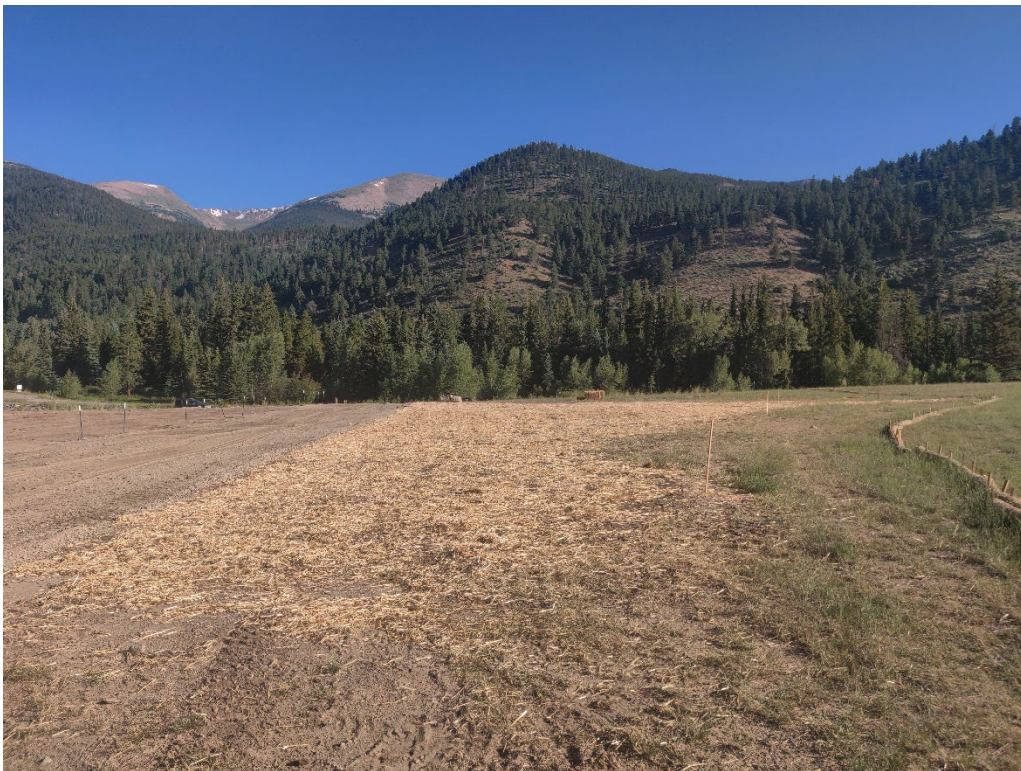
View of the project area and access road from the south side looking north
