MINERALS PROGRAM INSPECTION REPORT
PHONE: (303) 866-3567

MINE NAME: Henderson Mine - Puzzler Target	MINE/PROSPECTING ID#: P-2022-006	MINERAL: Molybdenum	COUNTY: Clear Creek
INSPECTION TYPE: Mineral Prospect Inspection	INSPECTOR(S): Peter Hays	INSP. DATE: July 22, 2022	INSP. TIME: 11:15
OPERATOR: Climax Molybdenum Company	OPERATOR REPRESENTATIVE: Geoff Niggeler	TYPE OF OPERATION: MP - Mineral Prospecting

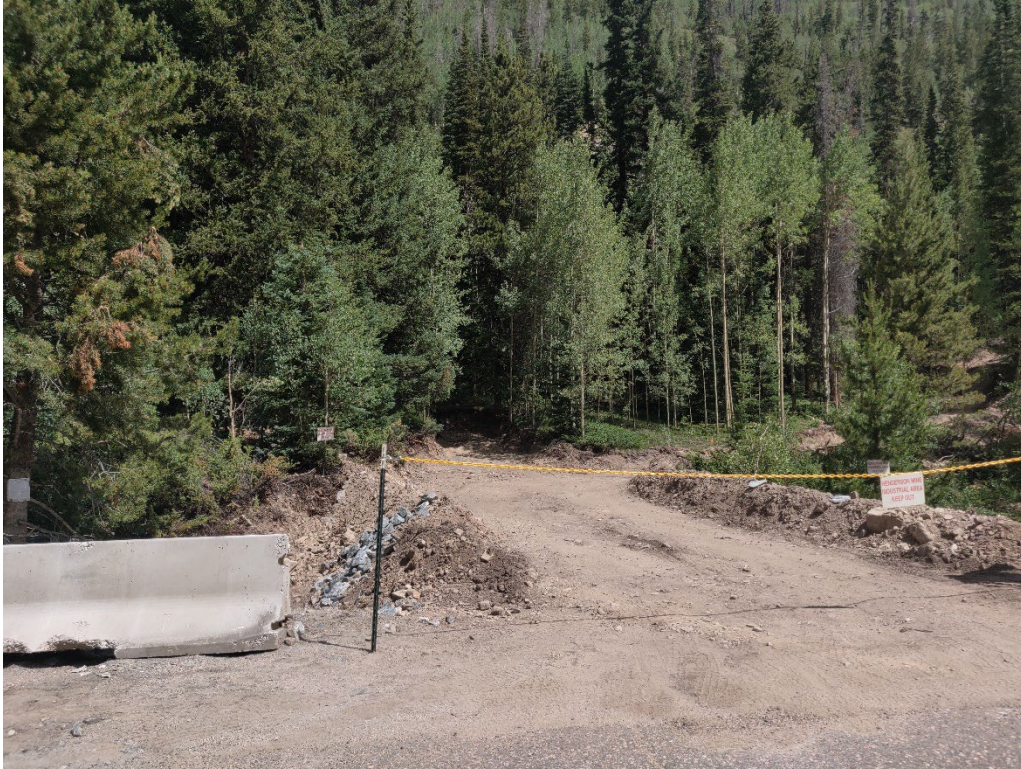
View of the access road from CR 202

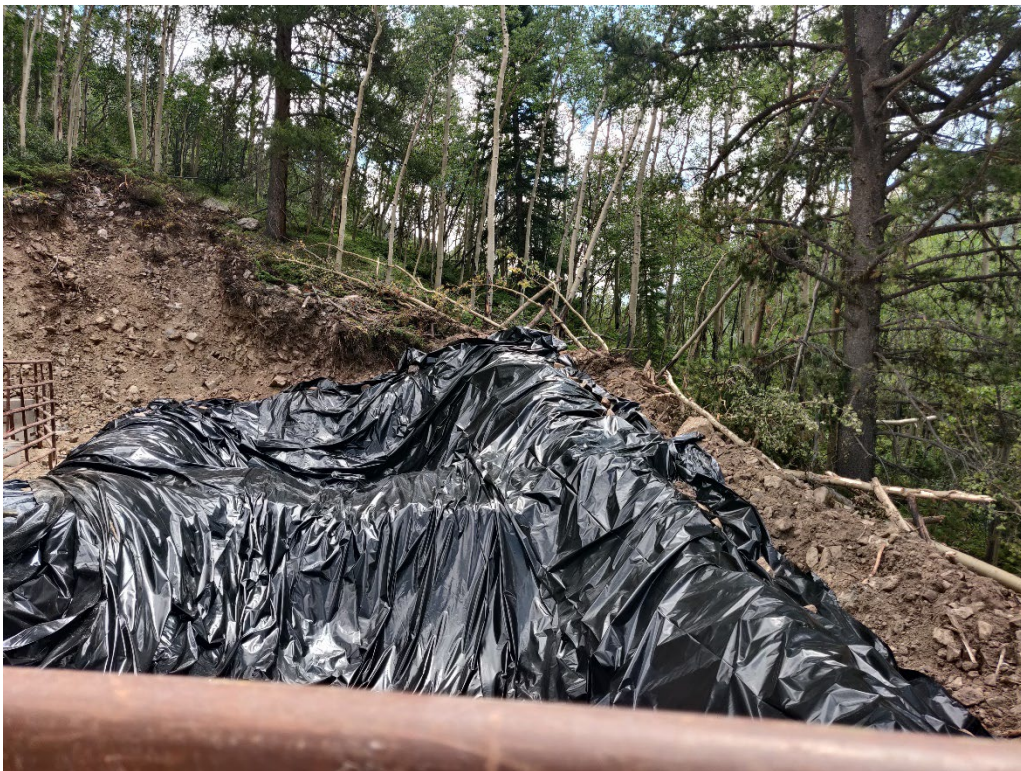
View of the triple lined mud pit

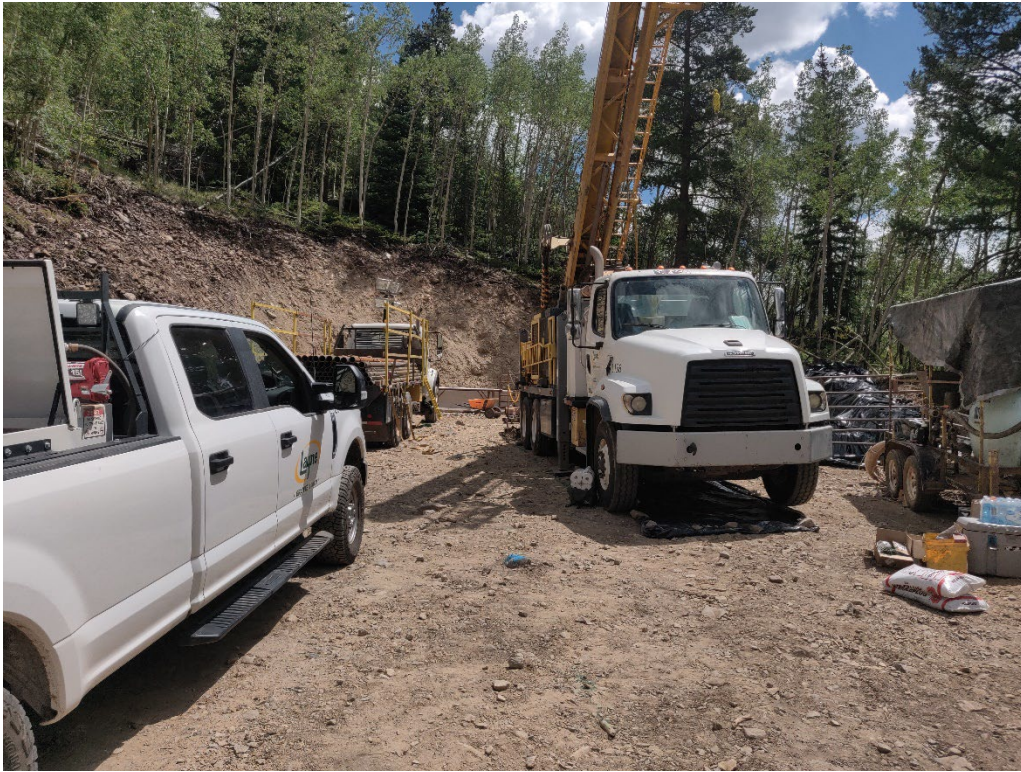
View of the drill rig, support vehicles and drill site

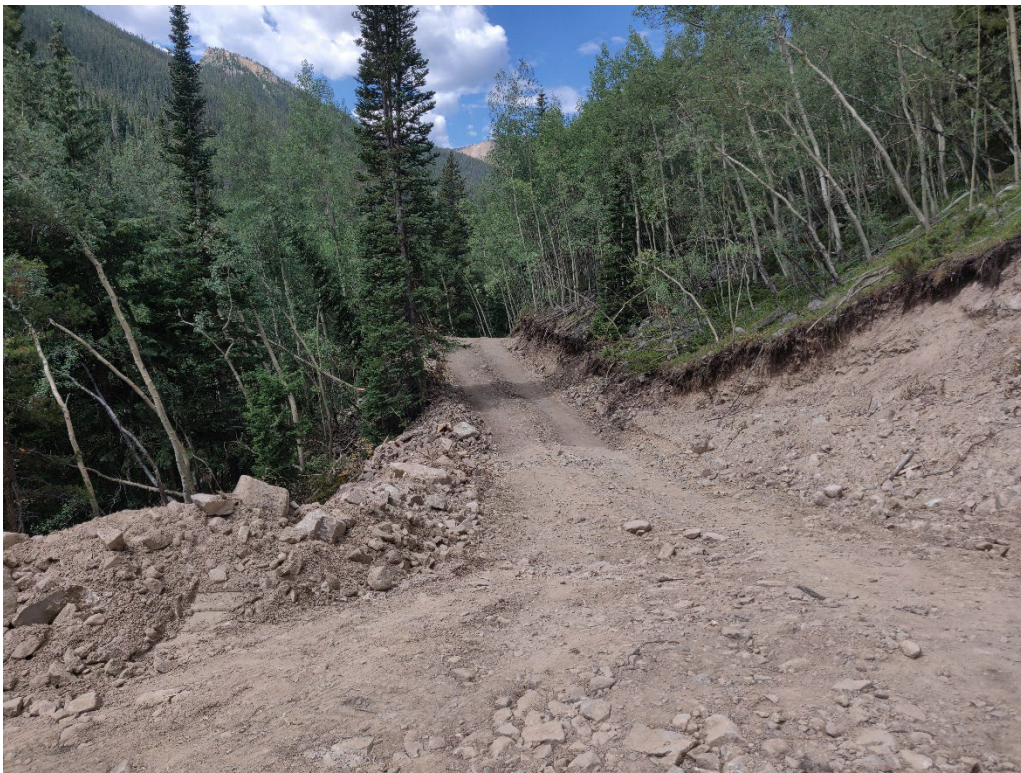
View of the access road from the drill pad
