MINERALS PROGRAM INSPECTION REPORT

MINE NAME: Fountain Pit	MINE/PROSPECTING ID#: M-1981-307	MINERAL: Sand and gravel	COUNTY: El Paso
INSPECTION TYPE: Surety Release Inspection	INSPECTOR(S): Timothy Cazier, P.E.	INSP. DATE: June 29, 2022	INSP. TIME: 13:30
OPERATOR: Martin Marietta Materials, Inc.	OPERATOR REPRESENTATIVE: Julie Mikulas	TYPE OF OPERATION: 112c - Construction Regular Operation

REASON FOR INSPECTION: Surety Release Requested	BOND CALCULATION TYPE: Partial Bond	BOND AMOUNT: \$1,369,462.00
DATE OF COMPLAINT: NA	POST INSP. CONTACTS: None	JOINT INSP. AGENCY: None
WEATHER: Clear	INSPECTOR'S SIGNATURE:

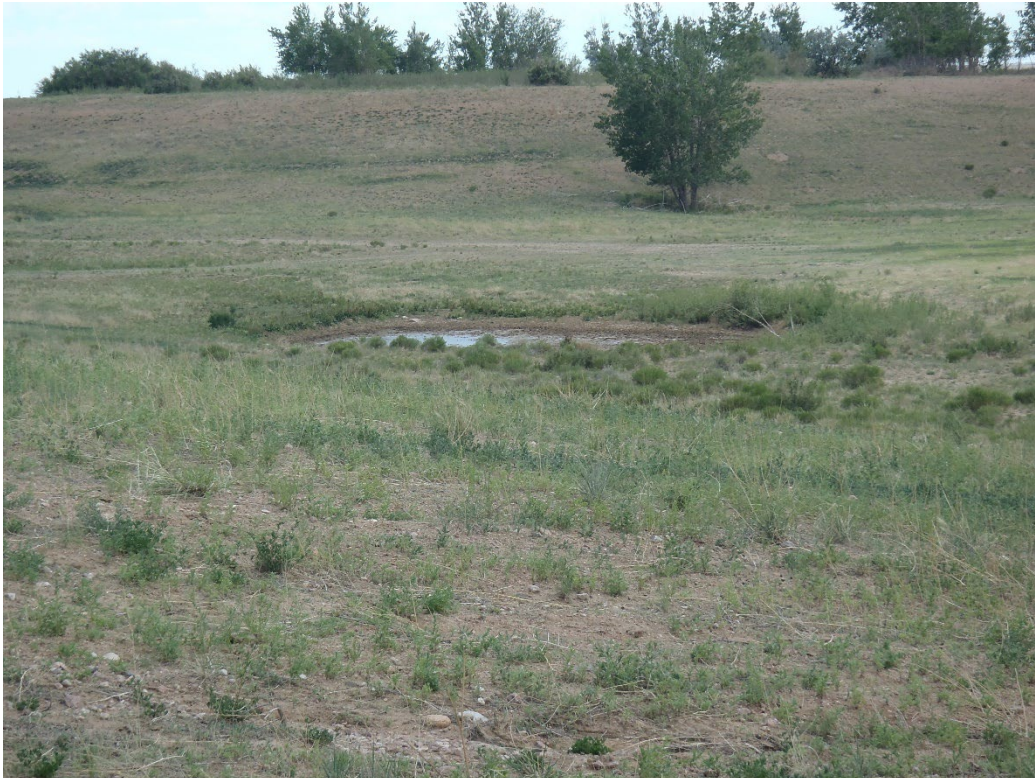
Hydrologic Balance: No standing water was observed in the west parcel. A small pond was observed in the east parcels (see **Photo 4**).

Photo 4. Small pond in east parcel (looking south).

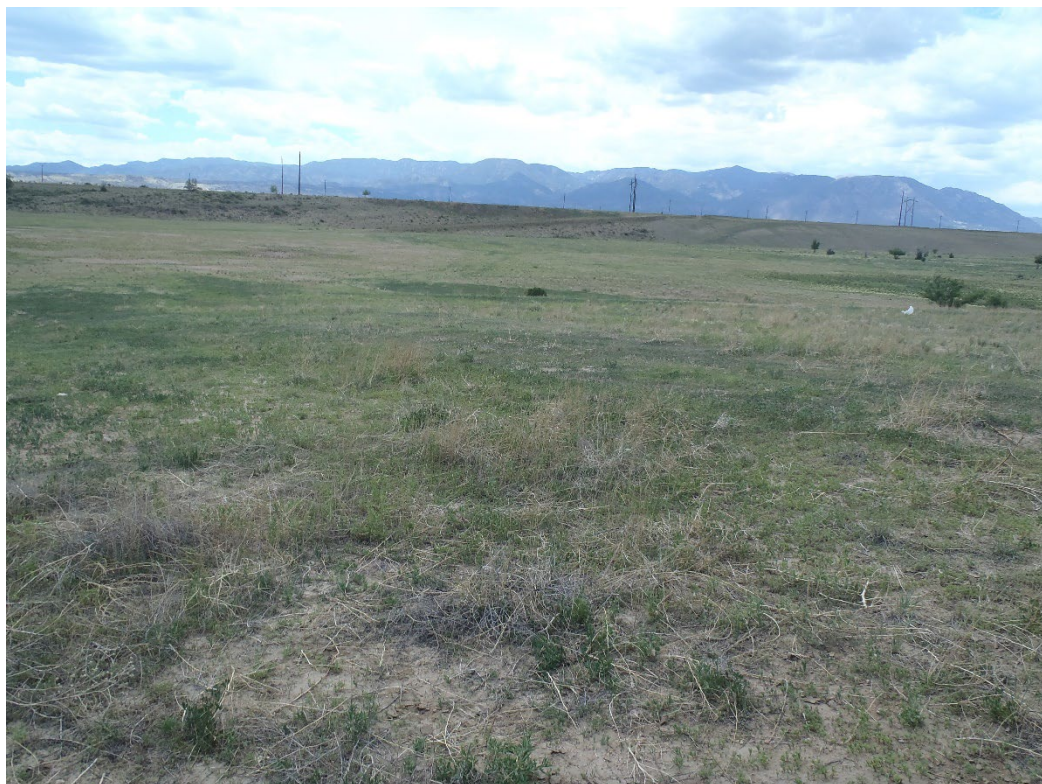
Photo 8. Typical revegetation (east parcel, looking SW towards transmission line).
