### MINERALS PROGRAM INSPECTION REPORT PHONE: (303) 866-3567

<b>MINE NAME:</b> Fountain Pit	<b>MINE/PROSPECTING ID#:</b> M-1981-307	<b>MINERAL:</b> Sand and gravel	<b>COUNTY:</b> El Paso
<b>INSPECTION TYPE:</b> Surety Release Inspection	<b>INSPECTOR(S):</b> Timothy Cazier, P.E.	<b>INSP. DATE:</b> June 29, 2022	<b>INSP. TIME:</b> 13:30
<b>OPERATOR:</b> Martin Marietta Materials, Inc.	<b>OPERATOR REPRESENTATIVE:</b> Julie Mikulas	<b>TYPE OF OPERATION:</b> 112c - Construction Regular Operation

<b>REASON FOR INSPECTION:</b> Surety Release Requested	<b>BOND CALCULATION TYPE:</b> Partial Bond	<b>BOND AMOUNT:</b> \$1,369,462.00
<b>DATE OF COMPLAINT:</b> NA	<b>POST INSP. CONTACTS:</b> None	<b>JOINT INSP. AGENCY:</b> None
<b>WEATHER:</b> Clear	<b>INSPECTOR'S SIGNATURE:</b>

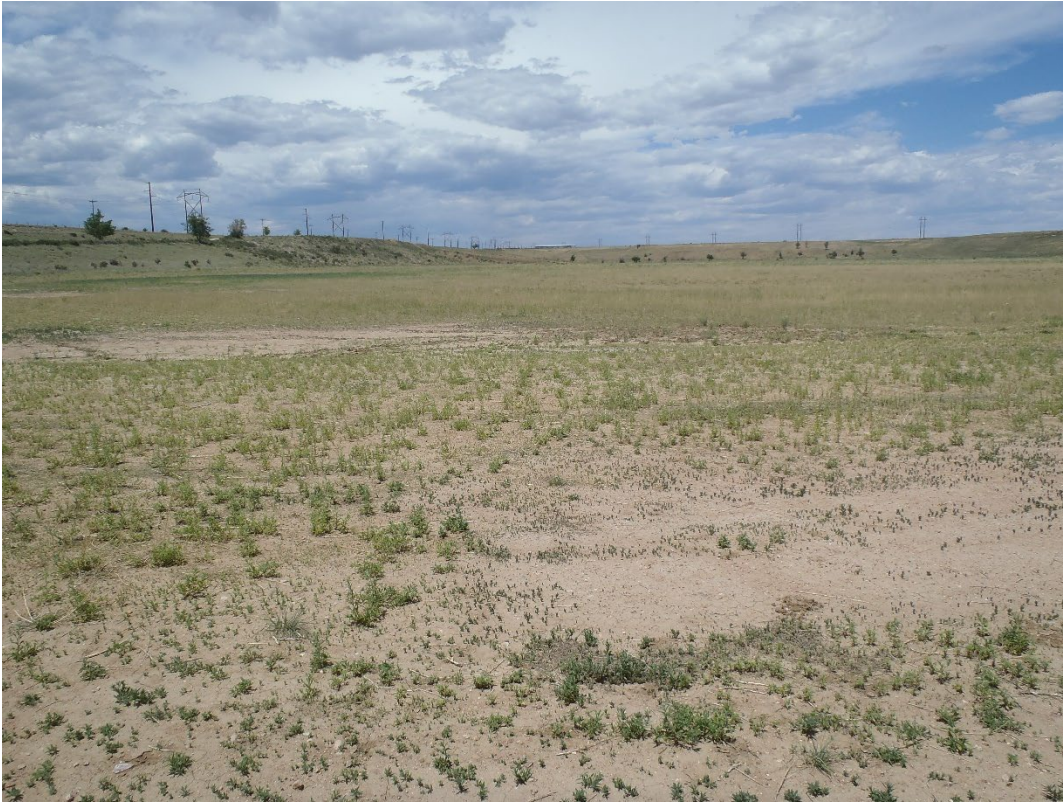
Backfilling and Grading: Ms. Mikulas stated the site grading had been completed. Previous highwalls appeared to be sloped to 3H:1V or flatter (see **Photo 1**). However, the approved mine plan commits to providing positive drainage to the south. A ridge supporting a transmission power line runs from the northwest to the southeast area of the site, separating the mined areas for which positive drainage is required by the approved permit. There is a sloped highwall at the south end of the west side (see **Photo 2**) that was never breached during the mining process, thereby preventing drainage to the south. The east side of the powerline ridge has more variable post mine topography (see **Photo 3**) making a visual assessment of positive drainage difficult. Mr. Murphy stated the City plans to use the two sides of the reclaimed mine area for water storage. As such, positive drainage would be contraindicated. [The DRMS will require a revision to the permit via the technical revision \(TR\) process to avoid having to provide positive southerly drainage prior to reclamation liability release.](#)

Photo 1. Recontoured highwalls (west parcel, looking north).

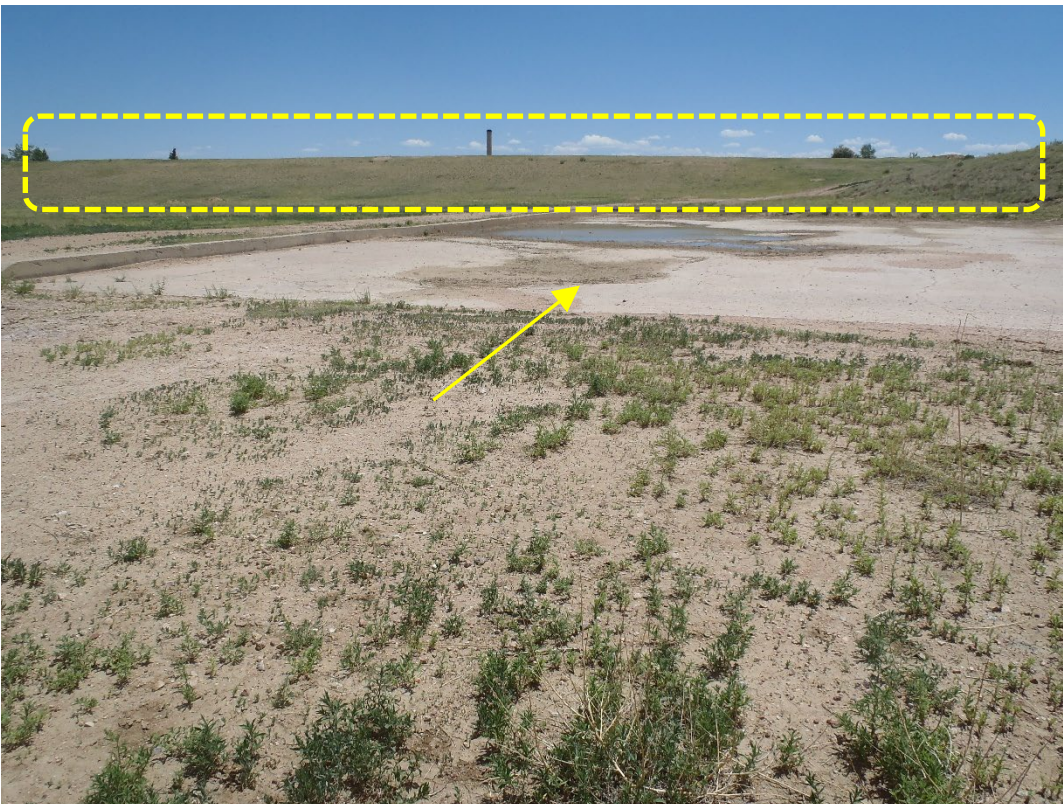
**Reclamation Success:** Highwall contouring, growth media placement and seeding appeared to be completed in accordance with the approved reclamation plan. However, a concrete pad (see **Photo 2**) was observed in the south end of the west parcel, and a stockpile of concrete rubble (see **Photo 7**) was observed in the southwest corner. Mr. Murphy indicated the City was ok with leaving this concrete on site. [If the concrete pad and the rubble stockpile are to remain, they will need to be included in the TR discussed under "Backfilling and Grading" above. A letter from the landowner expressing interest in these facilities to remain must be included in the TR.](#)

Photo 2. Sloped highwall on south end of west parcel (looking south, concrete pad in foreground).

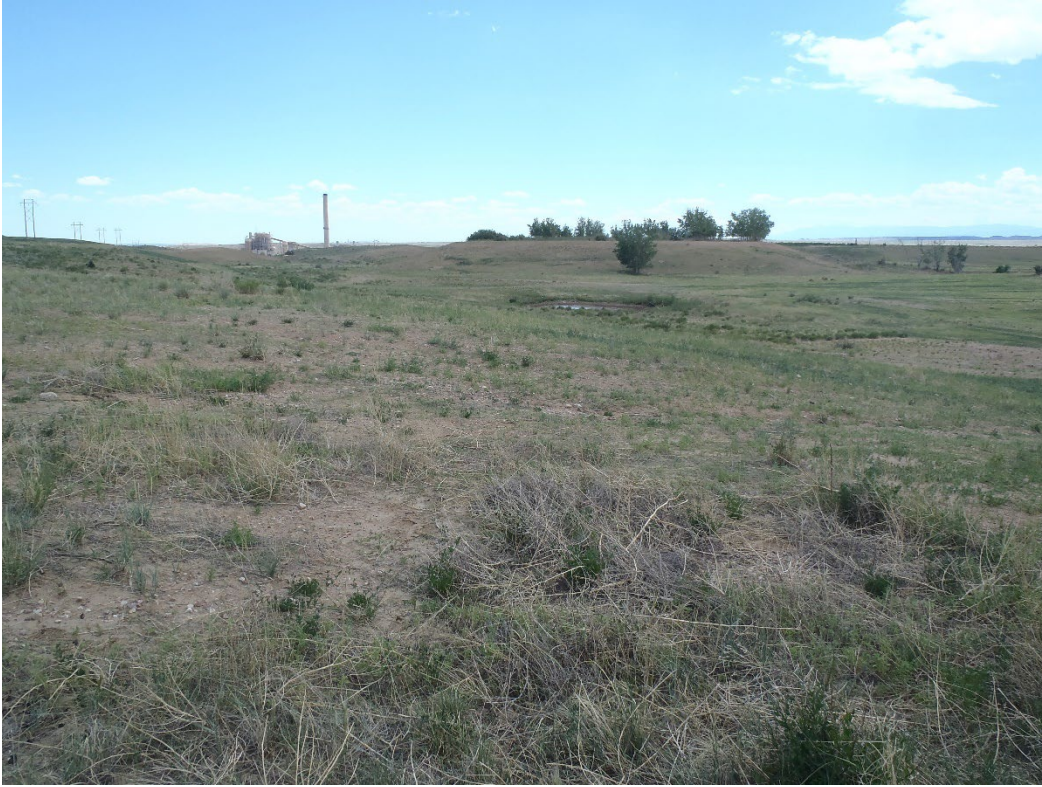
Photo 3. East parcel variable topography (looking SE).

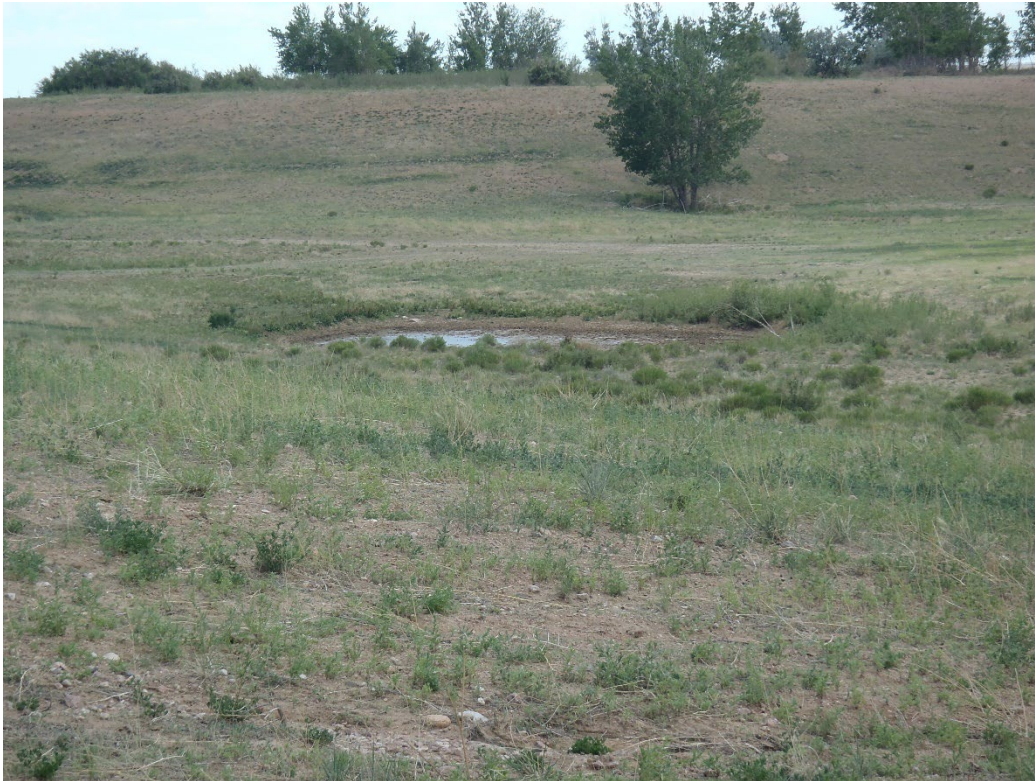
Hydrologic Balance: No standing water was observed in the west parcel. A small pond was observed in the east parcels (see **Photo 4**).

Photo 4. Small pond in east parcel (looking south).

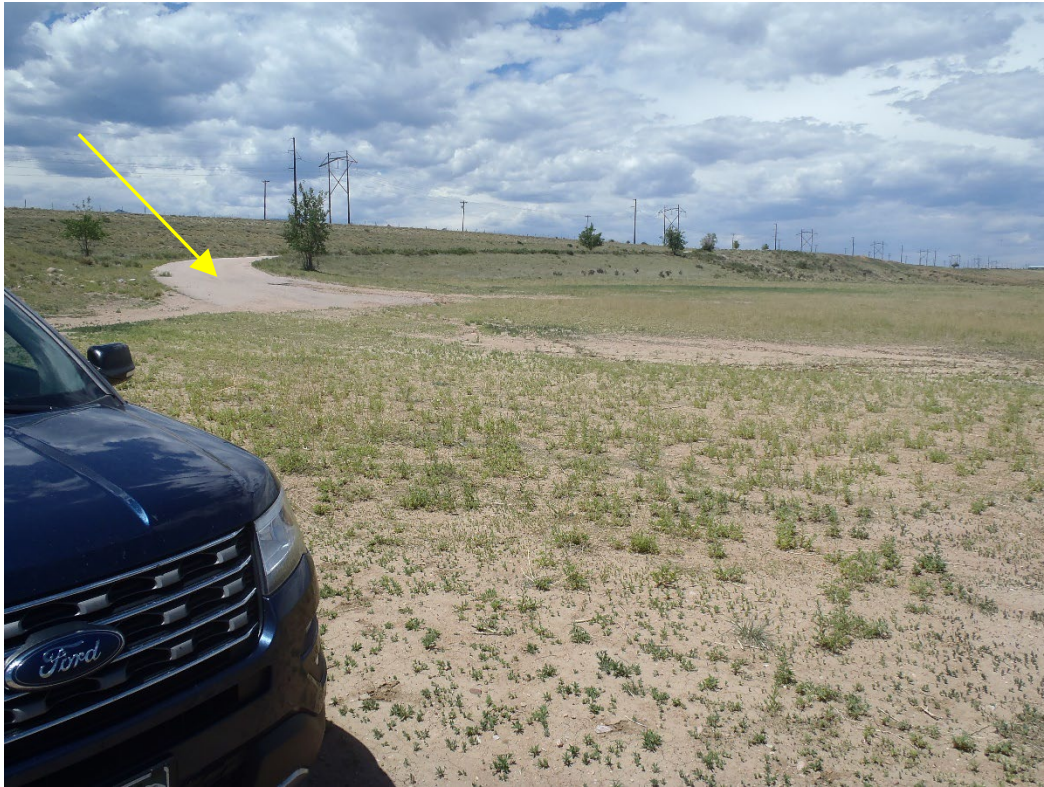
Roads: Non paved access roads appeared to be reclaimed. Only the paved access road along the west side of the site remains (see **Photos 5 and 6**).

**Revegetation:** The observed revegetation of the site is acceptable for release (see **Photos 5 and 8**). However, there is a considerable amount of tamarisk/salt cedar in the central portion of the east parcel (see **Photo 9**). The DRMS cannot release a site with significant List B noxious weeds. **Problem No. 2 is cited on page 1 of this report for the observed tamarisk.** These must be treated prior to a release request approval.

Photo 5. Paved access road to south end of west parcel & pit floor reveg (looking NW).

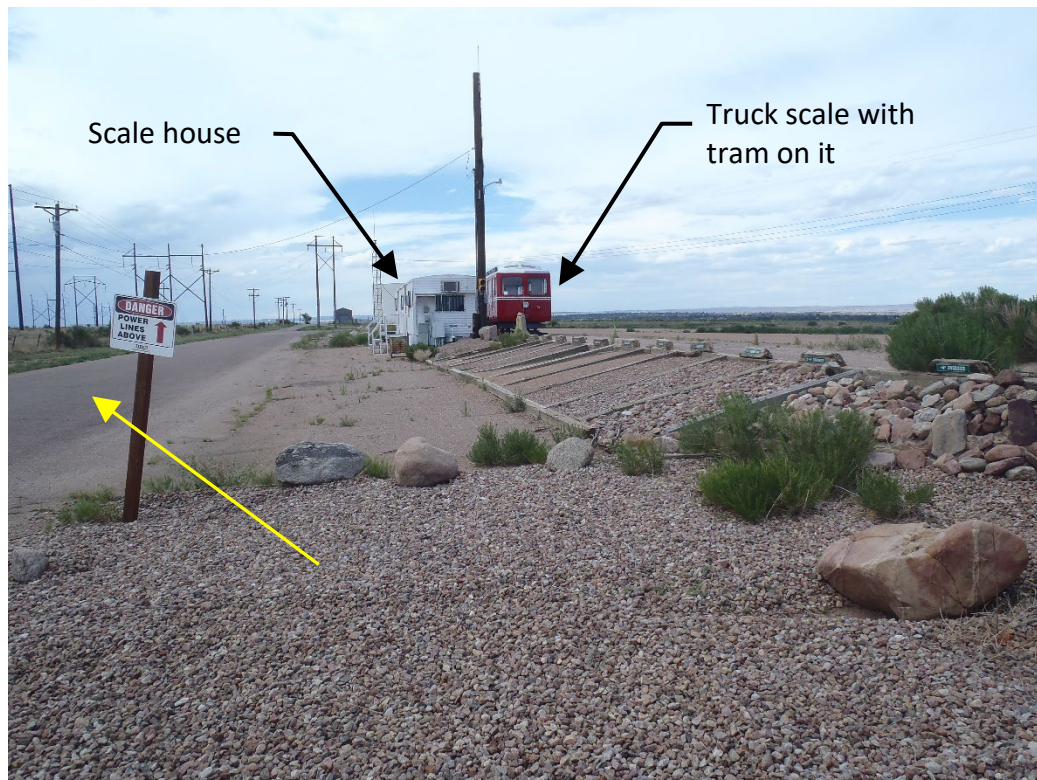
**Support Facilities On-site:** The only facilities observed were the truck scale and scale house (see **Photo 6**). [If these are to remain, they will need to be included in the TR discussed under "Backfilling and Grading" above. A letter from the landowner expressing interest in these facilities to remain must be included in the TR.](#)

Photo 6. Paved access road on west side of permit area (north of City Building, looking north).

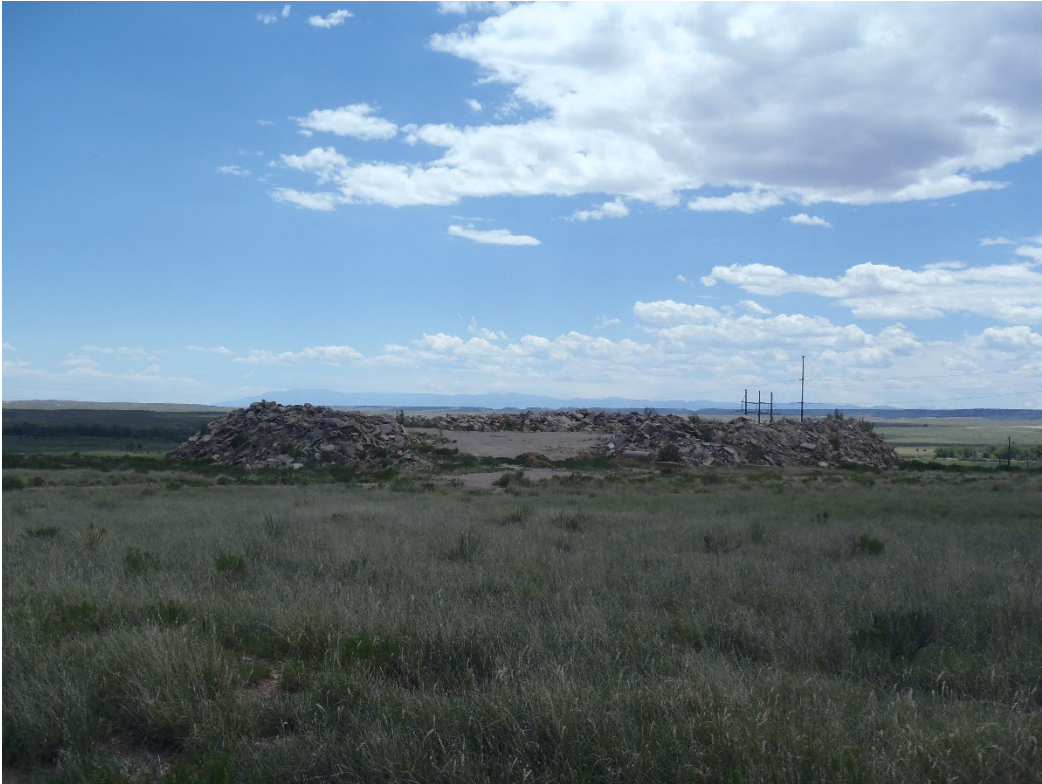
Photo 7. Concrete rubble stockpile in SW corner of permit area (Looking SW).

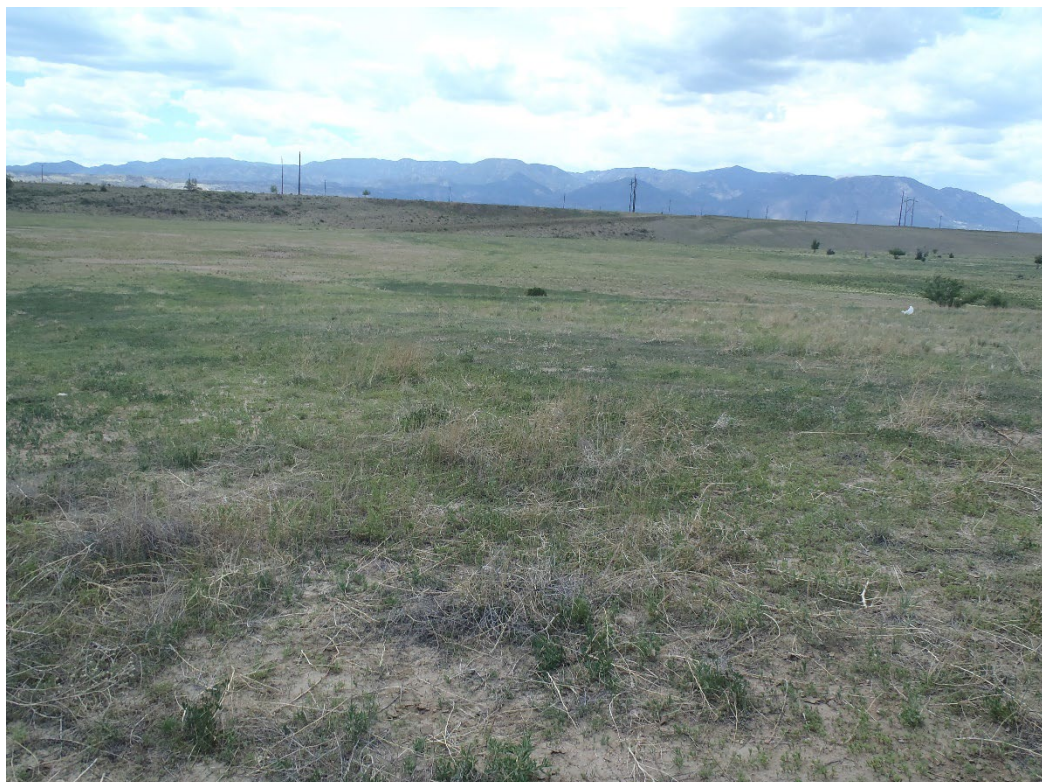
Photo 8. Typical revegetation (east parcel, looking SW towards transmission line).

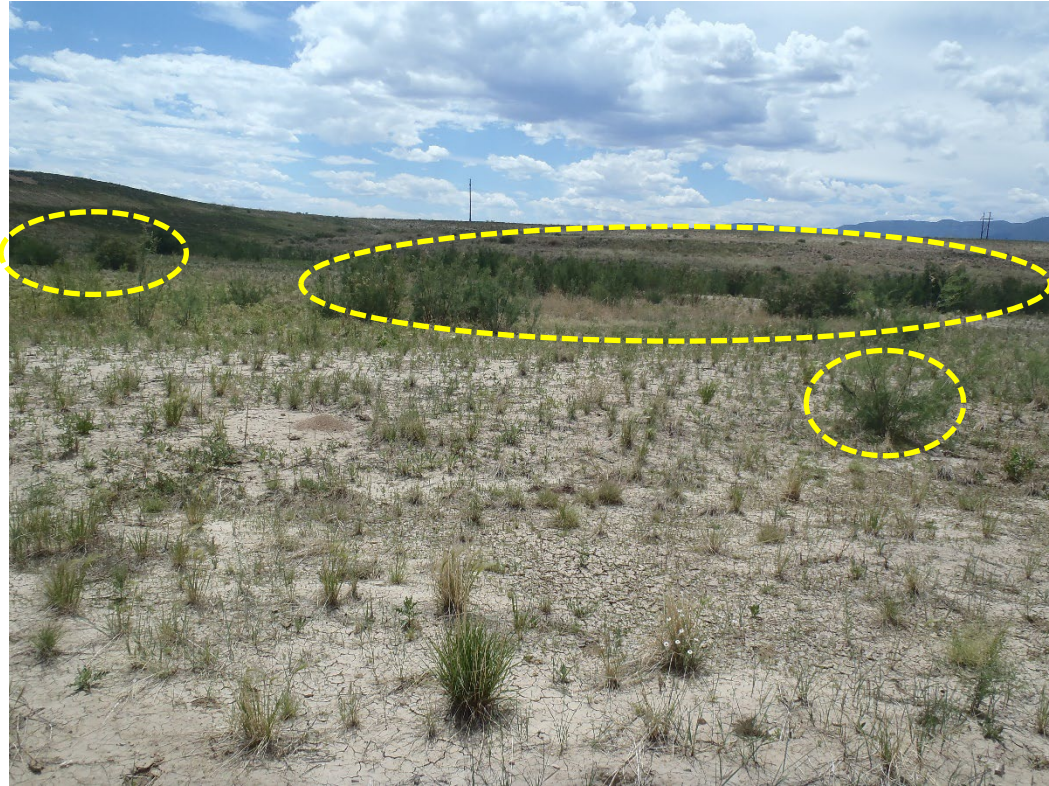
**PROBLEM/POSSIBLE VIOLATION No. 2:** Problem: Tamarisk (salt cedar) trees are present within or have volunteered into the permit area and are becoming established. This is a problem for failure to employ weed control methods for a state listed noxious weed species within the permitted area, and to reduce the spread of weeds to nearby areas as required by Section 3.1.10 (6) of the rule.

Photo 9. Tamarisk in north central east parcel (Looking west).

**CORRECTIVE ACTIONS:** The operator shall either implement the existing weed control plan, or develop a weed control and management plan in accordance with Section 3.1.10 (6) of the Rule. This plan should be developed in consultation with the county extension agency, or weed control district office and should include specific

control measures to be applied, a schedule for when control measures will be applied and a post-treatment monitoring plan. The operator shall provide documentation of having treated the tamarisk by the corrective action due date.
