MINERALS PROGRAM INSPECTION REPORT

| MINE NAME: Suzanne Marie | MINE/PROSPECTING ID#: M-2009-093 | MINERAL: Anhydrite, gypsum | COUNTY: Larimer |
| INSPECTION TYPE: Monitoring | INSPECTOR(S): Brock Bowles | INSP. DATE: June 30, 2022 | INSP. TIME: 10:00 |

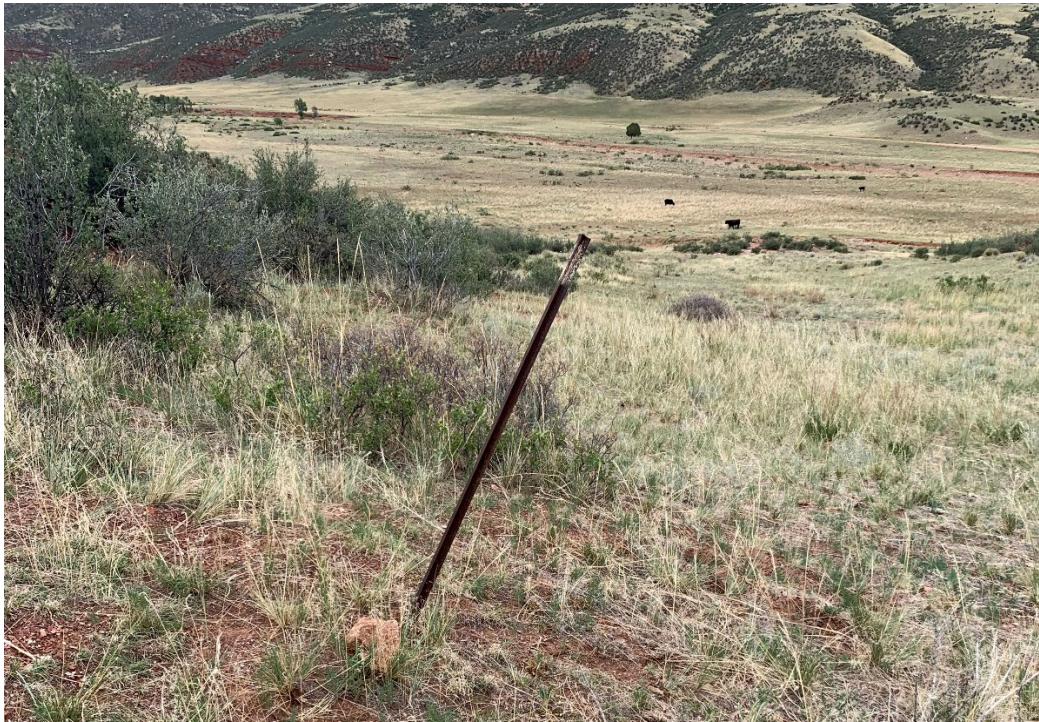
The permit boundary markers were in place (photo 1). The west end of the permit boundary is the fenceline.

Photo 1 – Permit boundary marker

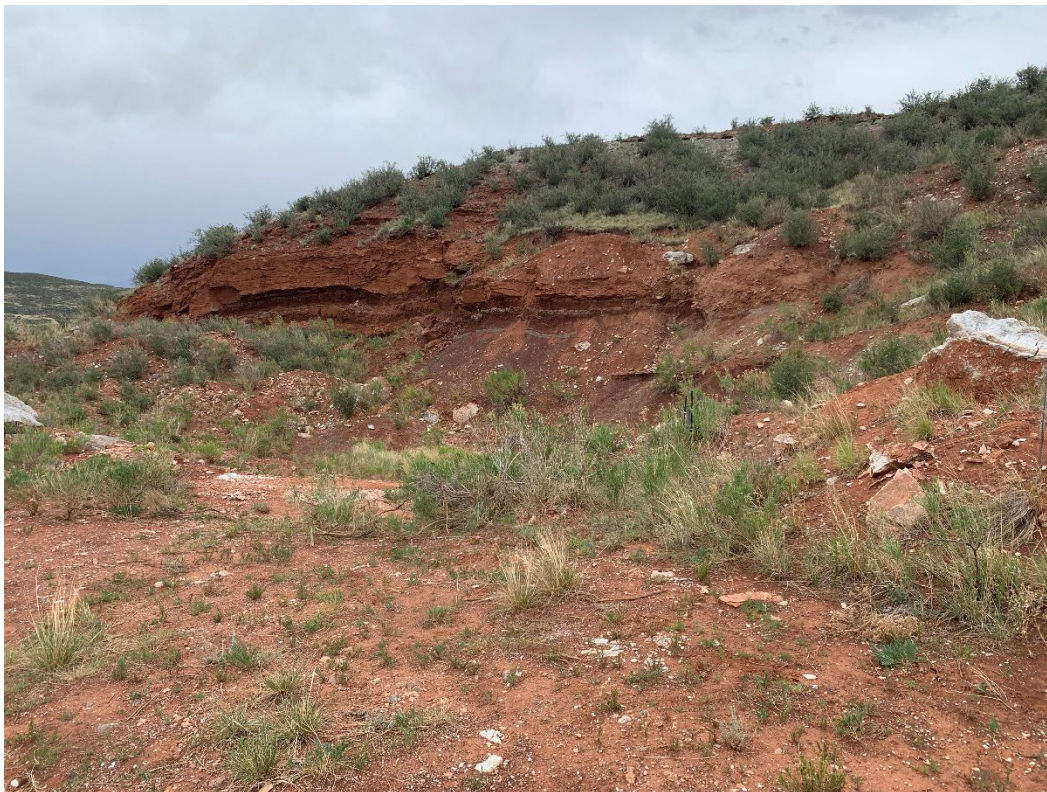
About ¼ acre is disturbed on the east end of the permitted area (photo 2). No mining was taking place and no mining equipment was on site. The highwall is approximately 15 feet high and 75 feet long.

Photo 2 – Disturbed area on east side of permit

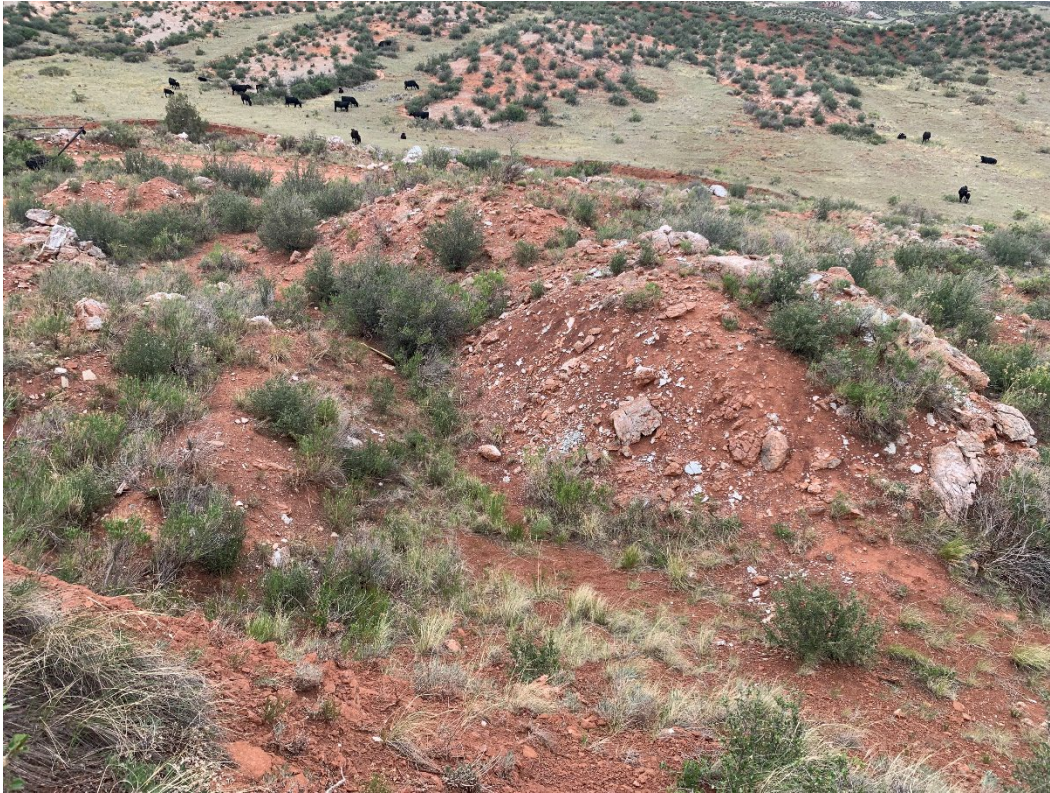
Topsoil/overburden piles were in place east of the pit area (photo 3). The site appears to be stable. No erosion features were seen and no noxious weeds were noted.

Photo – Topsoil/overburden stockpiles east of pit area
