MINERALS PROGRAM INSPECTION REPORT
PHONE: (303) 866-3567

MINE NAME: Newett Quarry	MINE/PROSPECTING ID#: M-1978-093	MINERAL: Limestone (general)	COUNTY: Chaffee
INSPECTION TYPE: Monitoring	INSPECTOR(S): Lucas West	INSP. DATE: June 22, 2022	INSP. TIME: 09:00
OPERATOR: Pete Lien & Sons, Inc.	OPERATOR REPRESENTATIVE: Dana Mellage	TYPE OF OPERATION: 112c - Construction Regular Operation	
REASON FOR INSPECTION: Normal I&E Program	BOND CALCULATION TYPE: Complete Bond	BOND AMOUNT: \$132,228.00	
DATE OF COMPLAINT: NA	POST INSP. CONTACTS: None	JOINT INSP. AGENCY: None	
WEATHER: Clear	INSPECTOR'S SIGNATURE:

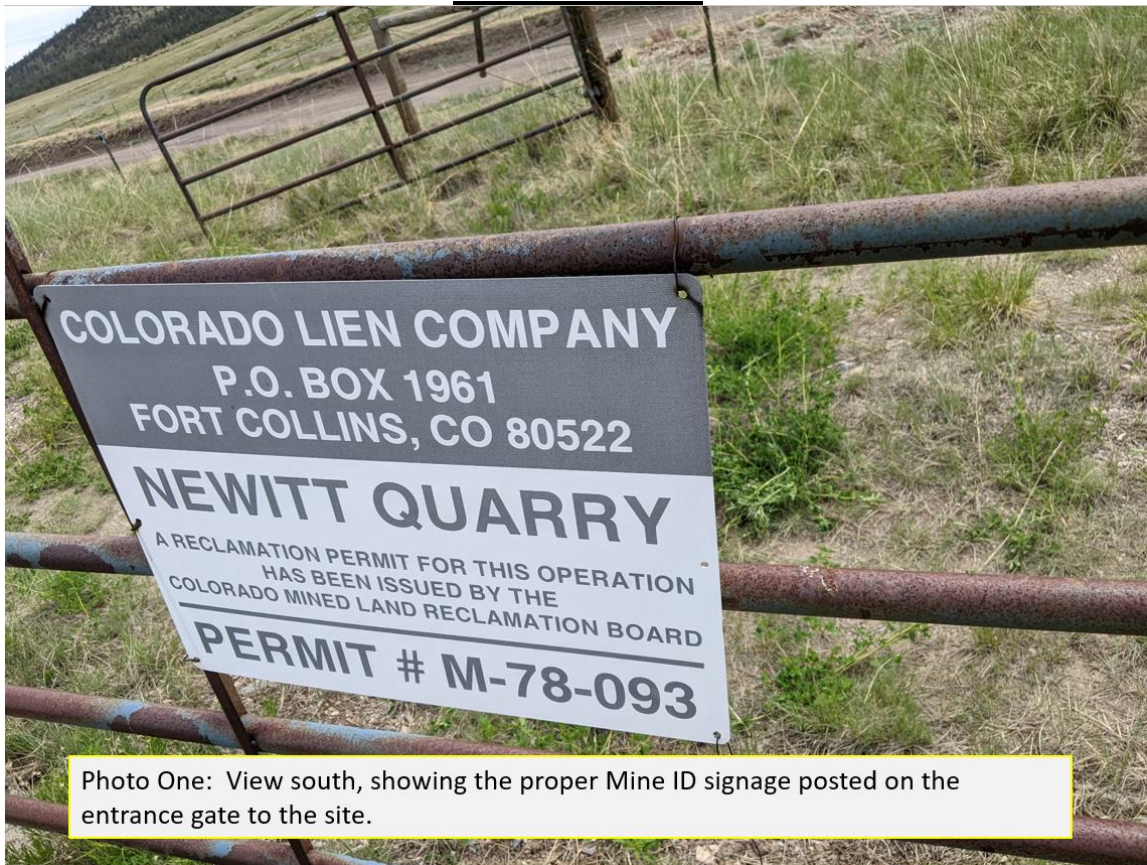
The site was not active at the time of the inspection and no mining equipment was located on site as the operation is currently in Temporary Cessation. The proper Mine Identification signage was posted at the entrance to the site and can be seen in Photo One. The affected areas are clearly marked by T-Posts and all disturbances are within the affected area boundaries. The lower permit area contains stockpiled of various materials that were all observed to be stable and in good condition. No evidence of recent hauling activity was noted, and the floor of the stockpile area appears to exhibit positive drainage. Examples of the stockpiles and stockpile area can be seen in Photos Two and Three. An access road connects the stockpile area from the mining area. Along the access road several storm water control structures were observed. At the time of the inspection they were all in good condition and able to function as designed. The Operator is reminded that even in times of Temporary Cessation, storm water maintenance is required. The access road is in good condition and no significant erosion was noted.

Photo One: View south, showing the proper Mine ID signage posted on the entrance gate to the site.

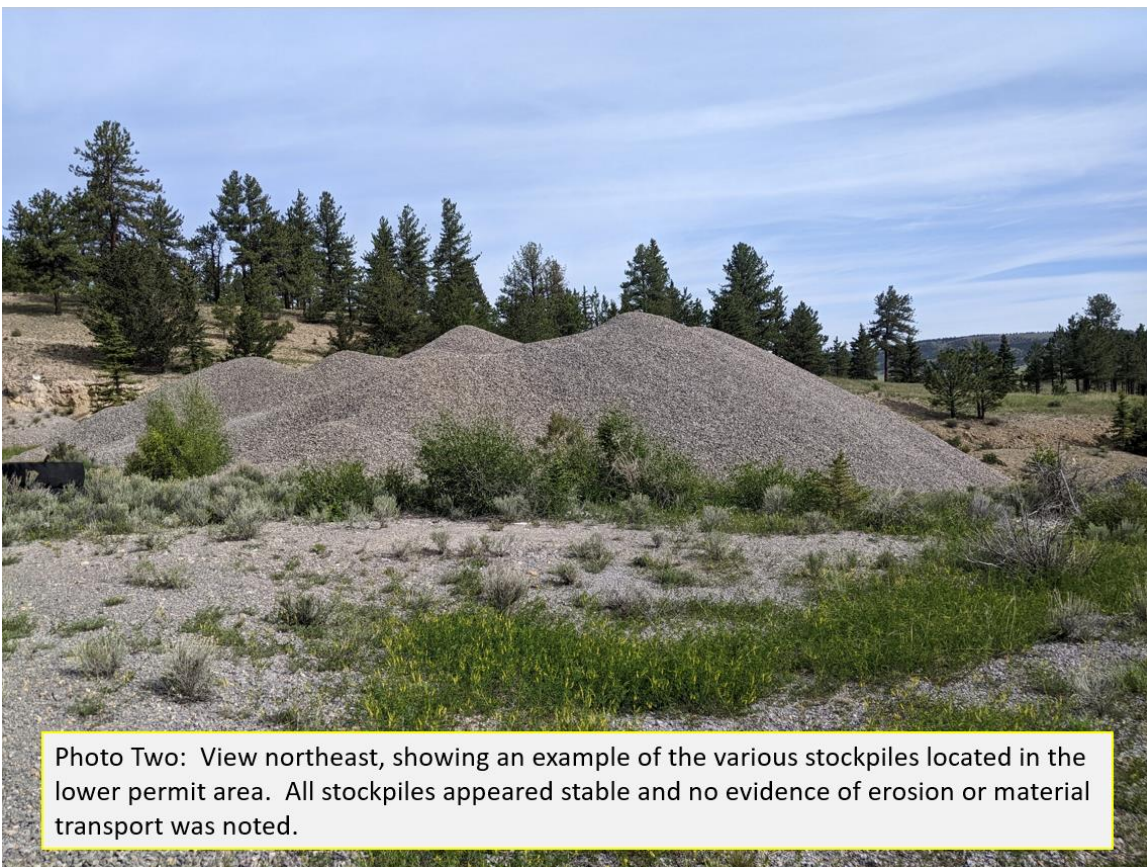
Photo Two: View northeast, showing an example of the various stockpiles located in the lower permit area. All stockpiles appeared stable and no evidence of erosion or material transport was noted.

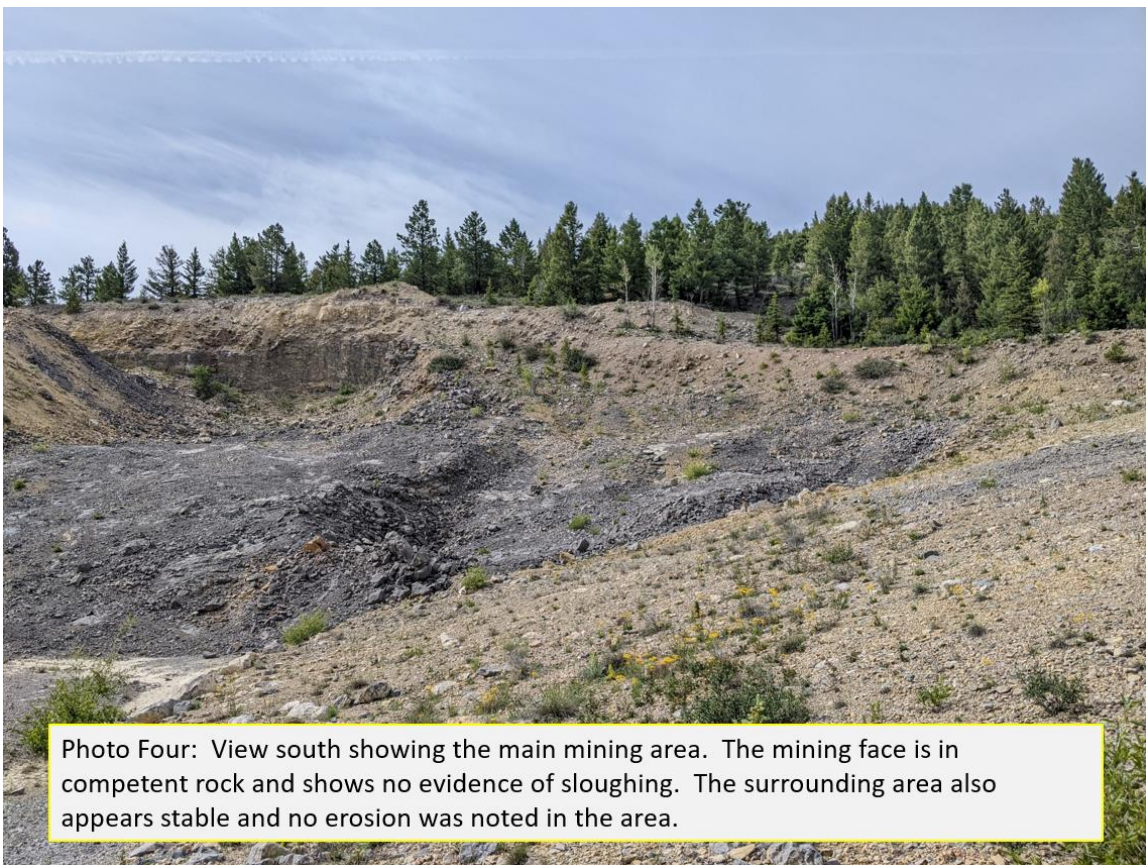
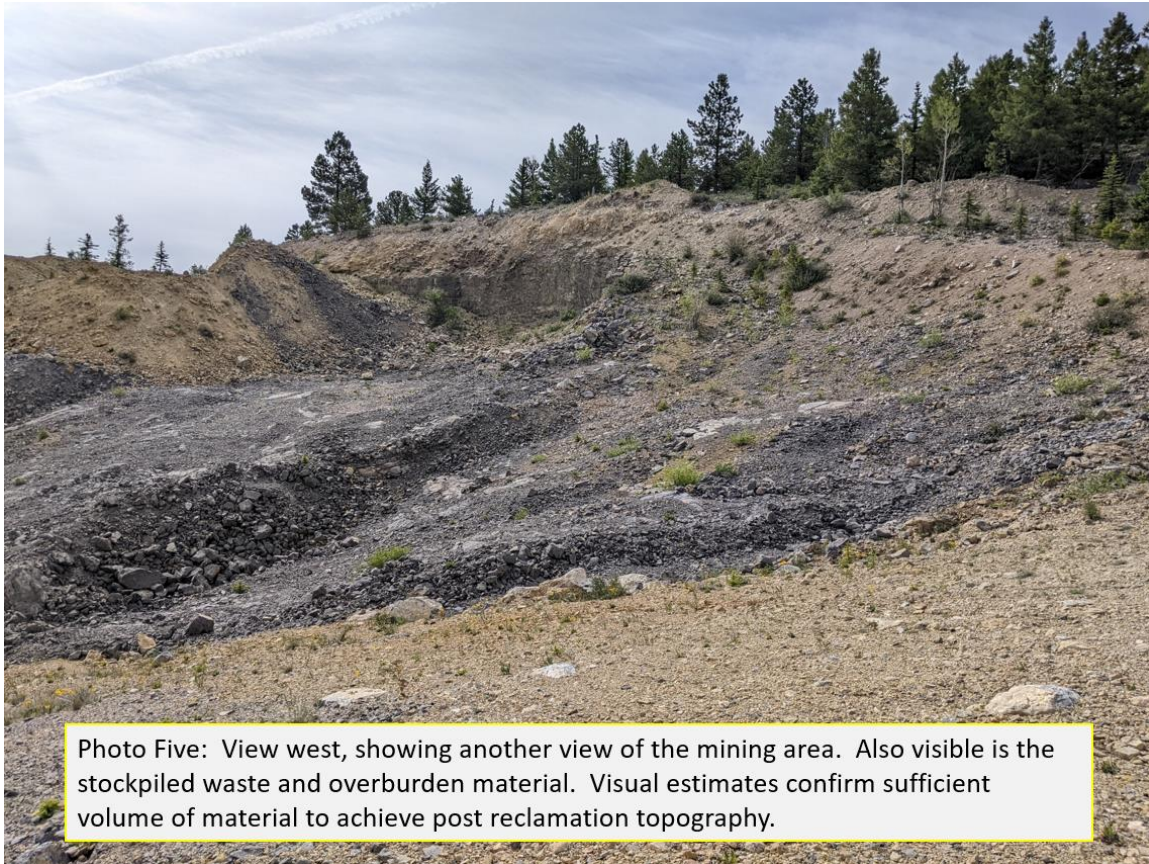
The main mining area consists of a highwall approximately 20 feet tall and spans nearly 100 Linear Feet of exposed competent rock. No evidence of sloughing or instability was noted. The highwall can be seen in Photos four and five. Adjacent to the highwall, various stockpiles of overburden and waste material is staged. The piles were stable at the time of the inspection and appear to be of sufficient volume to achieve the post reclamation topography.
