MINERALS PROGRAM INSPECTION REPORT
PHONE: (303) 866-3567

MINE NAME: Riverbend Operation	MINE/PROSPECTING ID#: M-2000-016	MINERAL: Sand and gravel	COUNTY: Weld
INSPECTION TYPE: Monitoring	INSPECTOR(S): Peter Hays	INSP. DATE: June 22, 2022	INSP. TIME: 13:00
OPERATOR: Martin Marietta Materials, Inc.	OPERATOR REPRESENTATIVE: Julie Mikulas	TYPE OF OPERATION: 112c - Construction Regular Operation

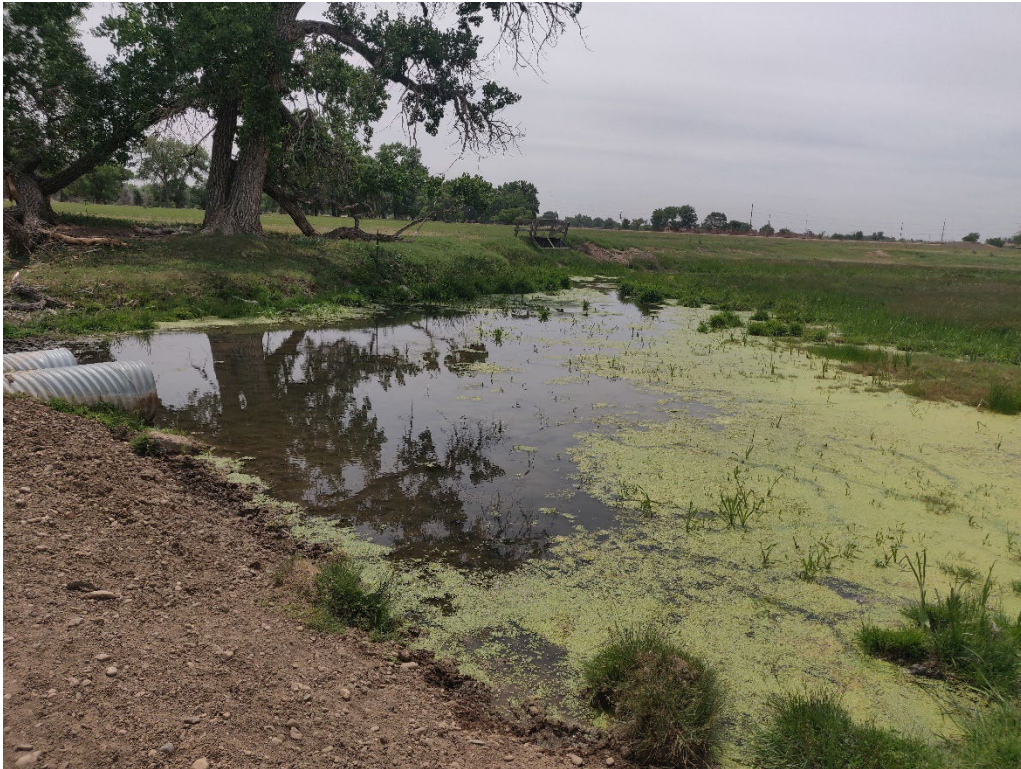
View of the complainant's creek looking south from the culverts

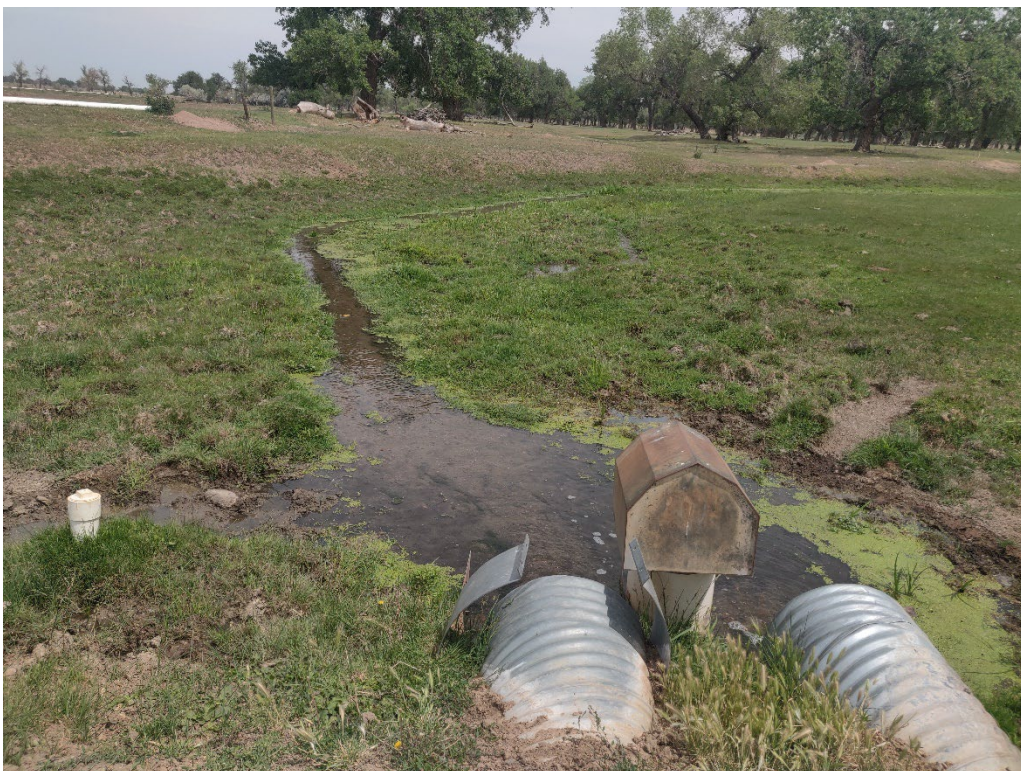
View of the complainant's creek looking north from the culverts

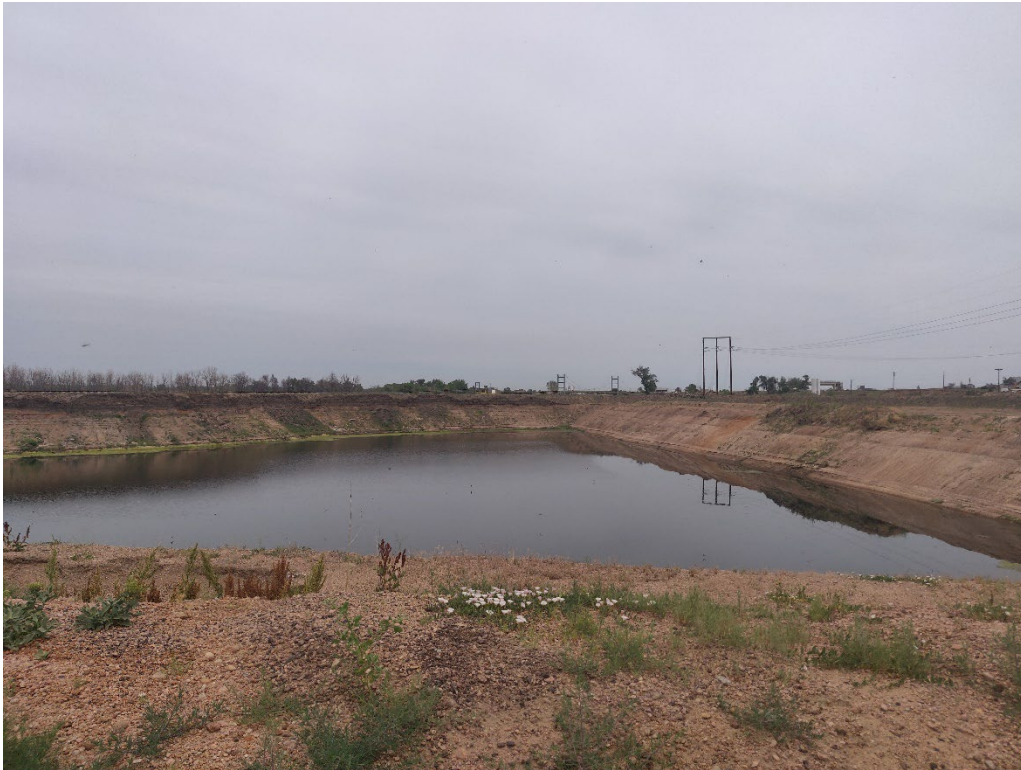
View of the southern portion of Cell 1 looking north

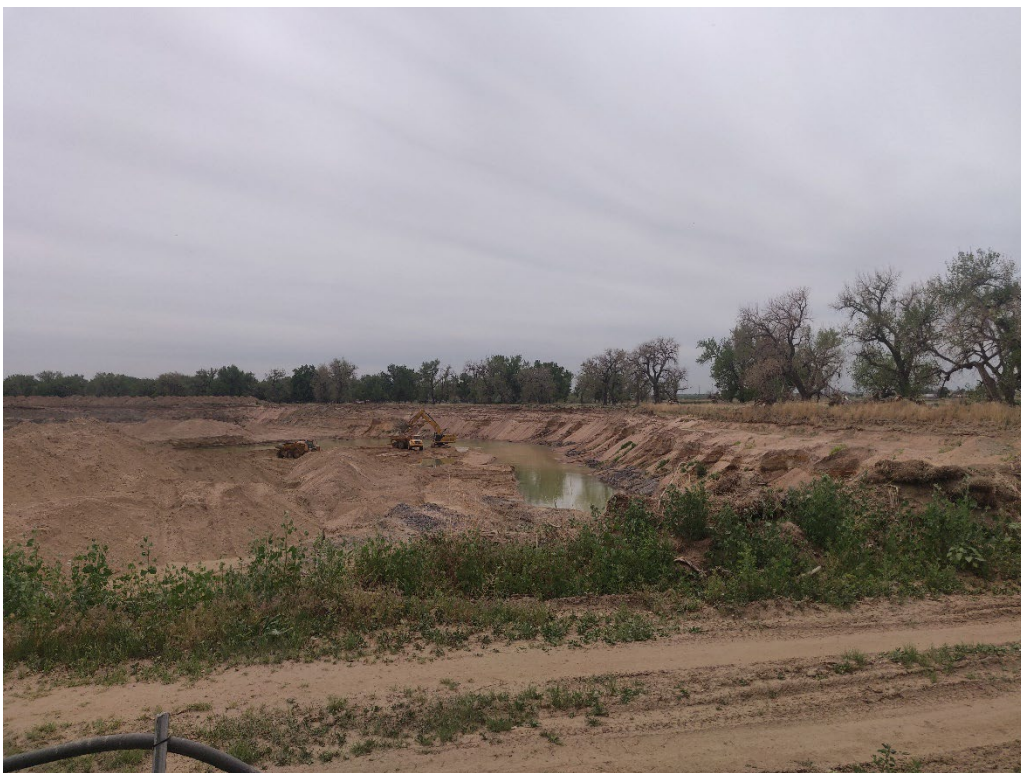
View of Cell 1 / Phase 2 from WCR 8 looking south
