MINERALS PROGRAM INSPECTION REPORT

MINE NAME: Ranch Land Rock Pit #2	MINE/PROSPECTING ID#: M-2003-021	MINERAL: Gravel	COUNTY: Fremont
INSPECTION TYPE: Surety-Related Inspection	INSPECTOR(S): Timothy Cazier, P.E.	INSP. DATE: July 27, 2022	INSP. TIME: 09:30
OPERATOR: Ranch Land LLC dba Pioneer Sand Co Inc	OPERATOR REPRESENTATIVE: Angela Bellantoni & Jason Ulmer	TYPE OF OPERATION: 112c - Construction Regular Operation	
REASON FOR INSPECTION: Surety Related	BOND CALCULATION TYPE: None	BOND AMOUNT: \$192,337.00	
DATE OF COMPLAINT: NA	POST INSP. CONTACTS: None	JOINT INSP. AGENCY: None	
WEATHER: Clear	INSPECTOR'S SIGNATURE:

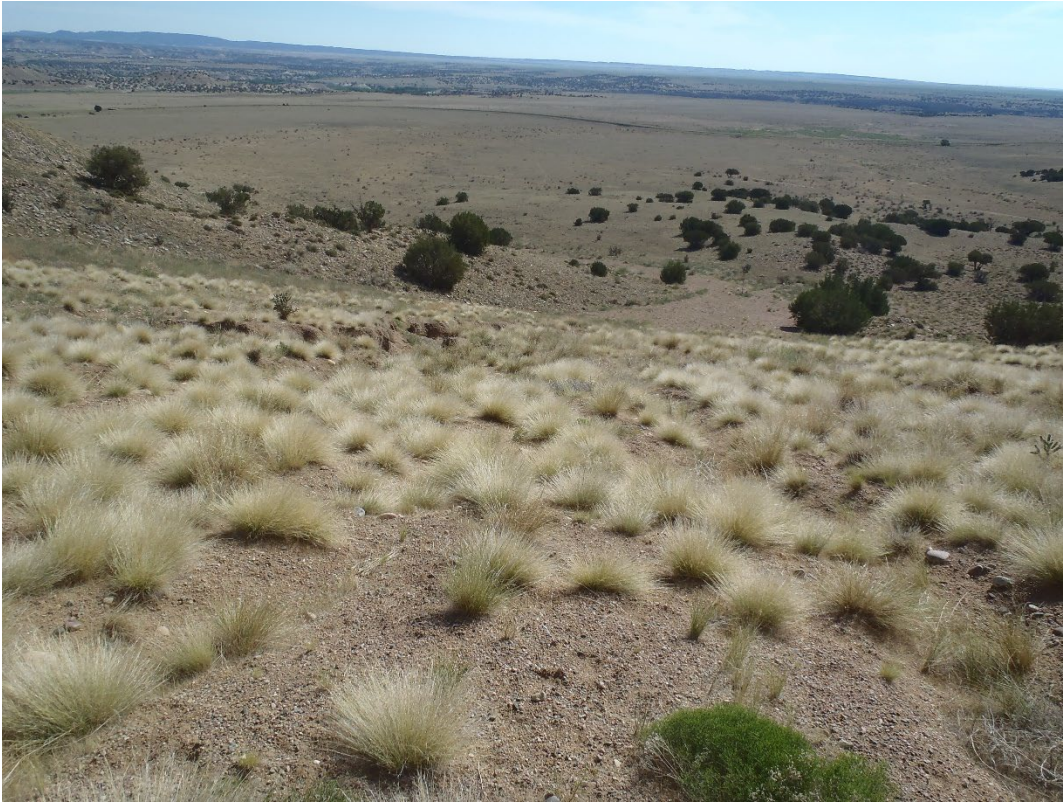
The focus of this inspection was the assessment of the reclamation effort for Phase 1 on the east end of the permit area. The outslope (see **Photo 1**) on the east side of the phase 1 pit floor was observed. The vegetation on this slope was voluntarily established as Mr. Ulmer stated they had not seeded it. Although some gullies were present, vegetation was observed in the gullies and the surrounding surface was well vegetated and appeared to now be stable. The Phase 1 pit floor and sloped highwall (see **Photo 2**), which were seeded by the Permittee, were also deemed to have adequate vegetation for the acreage reduction.

Photo 1. Phase 1 reclaimed outslope (looking east).

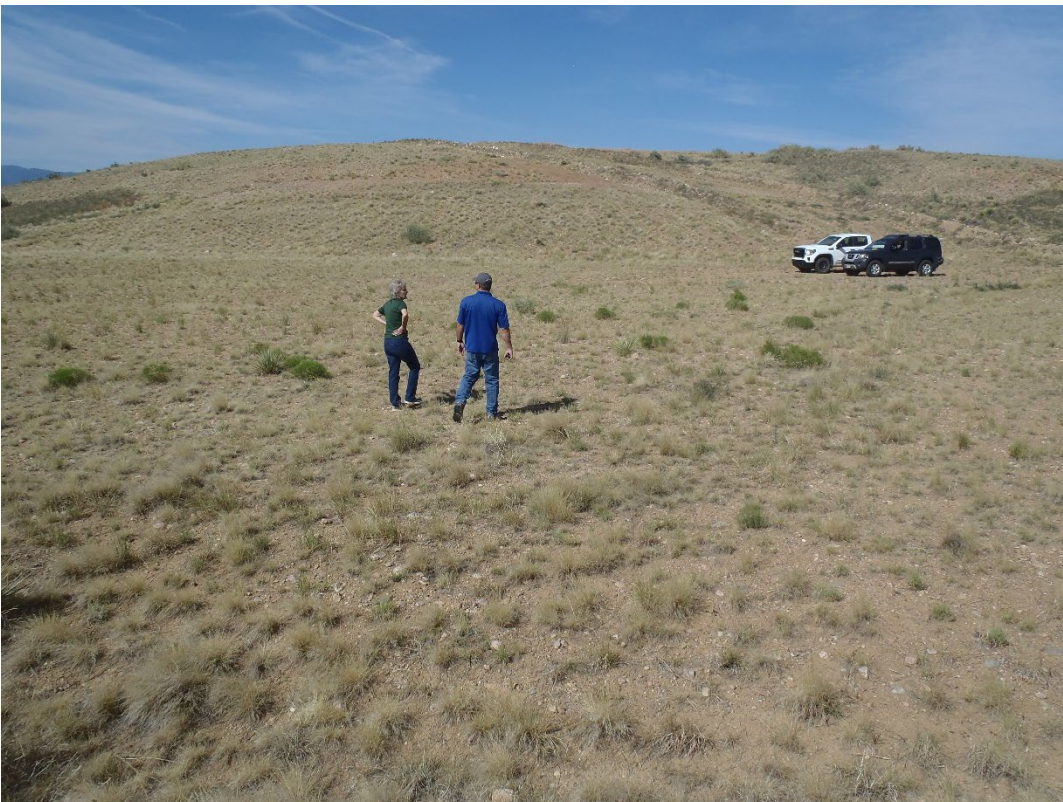
Photo 2. Phase 1 reclaimed pit floor and highwall (looking west).
