New Elk Mine, C-1981-012, Inspection Report

PERMIT INFORMATION

Permit Number: C-1981-012 Mine Name: New Elk Mine Operator: New Elk Coal Company, LLC Operator Address: Mr. Mark Gray 12250 Highway 12 Weston, CO 81091	County: Las Animas Operation Type: Underground Permit Status: Active Ownership: Private
	Operator Representative Present: Nick Mason
Operator Representative Signature: (Field Issuance Only)

INSPECTION INFORMATION

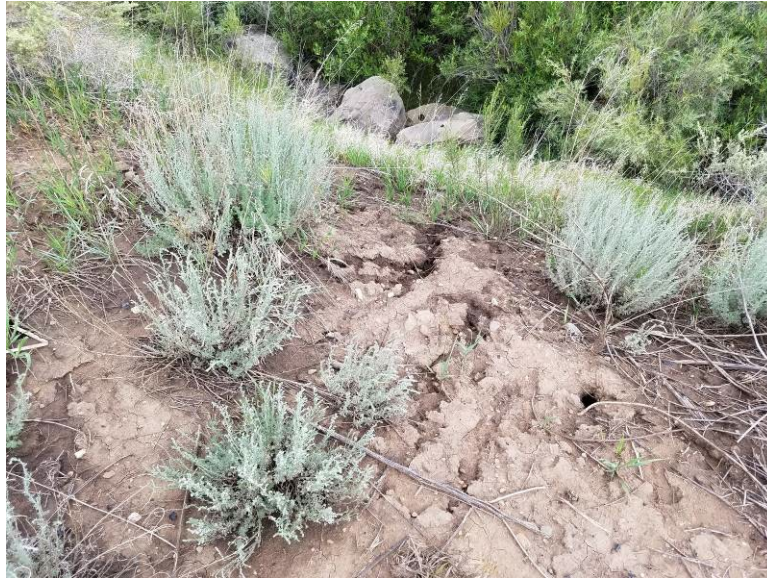
Pond 007a was holding water but was not discharging. The embankment was stable and vegetated overall. However a small rill has formed on the north pond embankment upslope of the river. **NECC should stabilize this area.** The primary spillway appears clear and functional.

Figure 1. Pond 007a northern embankment, rill forming.

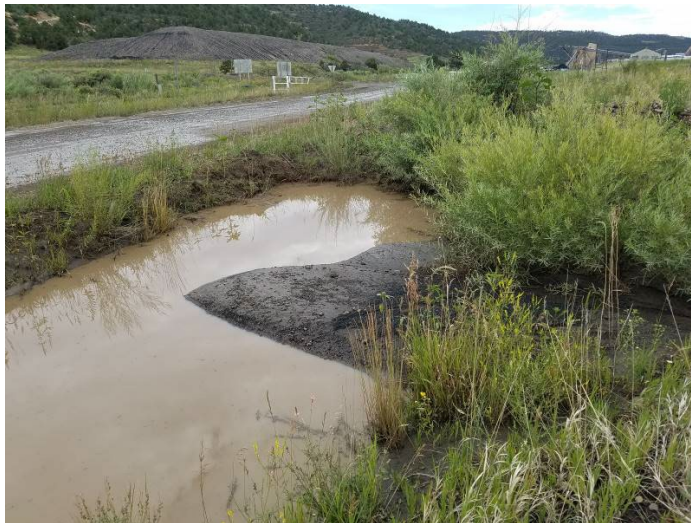
Culvert C9 that goes under the access road to the topsoil and subsoil stockpile was plugged with sediment and water has backed up the roadside ditch. **NECC will need to clear this culvert.**

Figure 2. Culvert C-19 inlet.

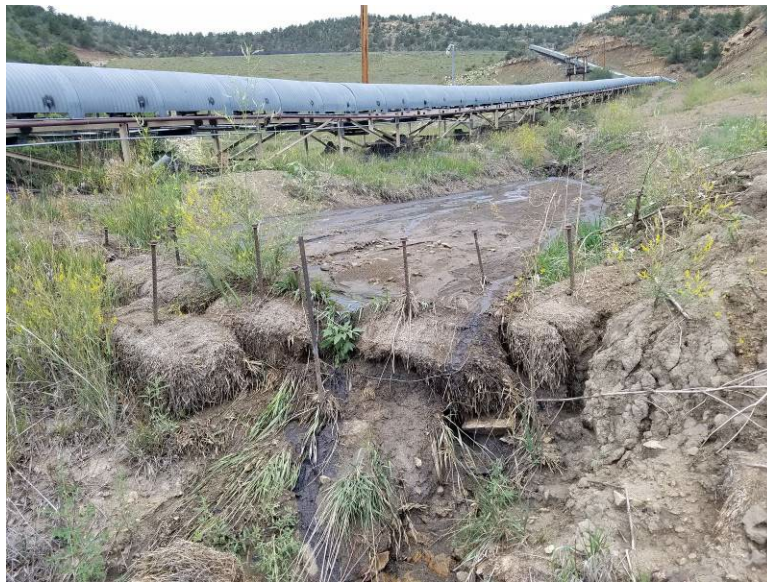
As noted in previous DRMS inspection reports, a check dam on the east side of the conveyor located within the ditch that leads to Containment Area #5 south of Pond 008 is in need of maintenance. **NECC has built a straw check dam that is holding back a large amount of sediment. This straw check dam is beginning to fail, NECC will need to clean out the sediment from behind the check dam and rebuilt/replace the check dam.** Nick Mason observed this check dam and agreed this feature needed maintenance.

Figure 3. Straw check dam in drainage above Containment Area #5, east of the Conveyor.

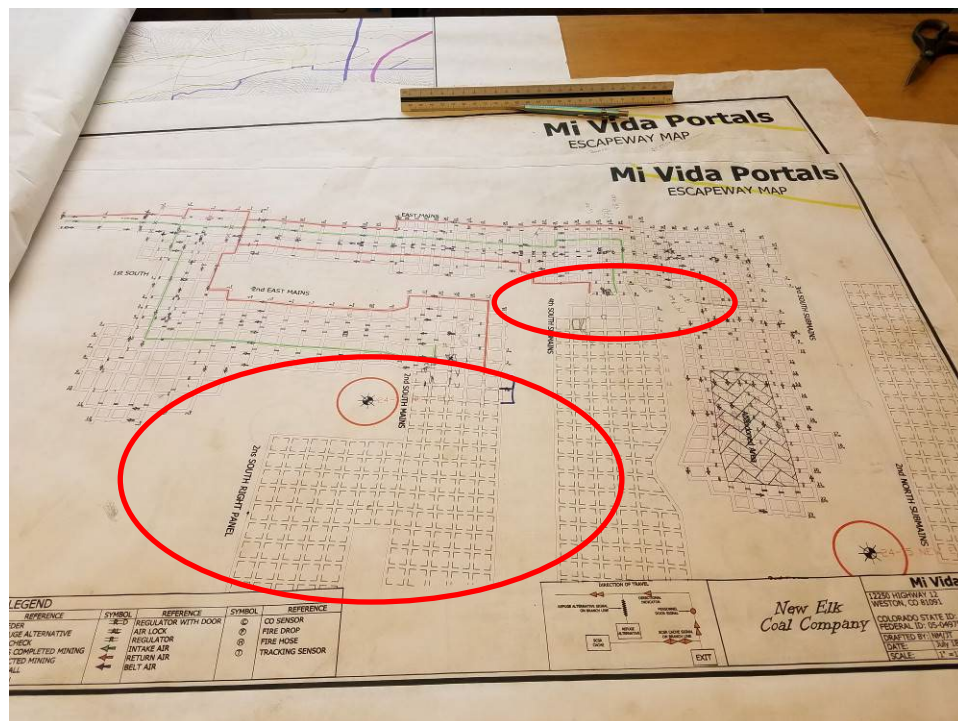
Mr. Mason showed me a map they keep at the mine office titled “Mi Vida Portals, Escapeway Map,” dated July 18, 2022. This map shows completed and projected future underground workings. There appears to be some differences in the actual underground workings and the future workings shown on this July 18, 2022 map and the approved mining plan map “Map 03”. It appears NECC is modifying their proposed mine plan; these differences can be seen below:

Figure 4. Mi Vida Portals, Escapeway Map, July 18, 2022. Approximate location of differences in working than what is approved in Map 3.

NECC will need to submit a minor revision to update the timing and sequence and aerial extent of the underground workings in accordance with Rule 2.05.3(2)(b).
