To: Jerald Schnabel
Continental Materials Corp.
File: June 2022 Monitoring Summary

Reference: June 2022 Geotechnical Monitoring Summary Pikeview Quarry

Client/Project
CONTINENTAL MATERIALS
CORP.
PIKEVIEW QUARRY SLOPE
MONITORING

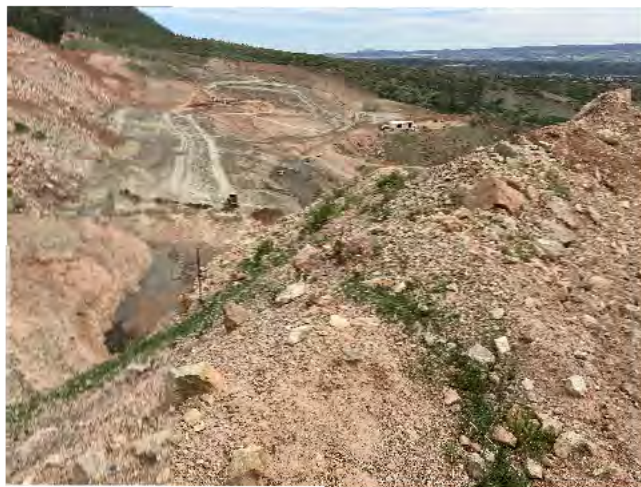
- Offsite fill was placed near the reclamation benches. The material was spread by dozers and compacted in one-foot lifts in accordance with the project specifications. (Photo 6)

6. Compacted area in the pit looking north.

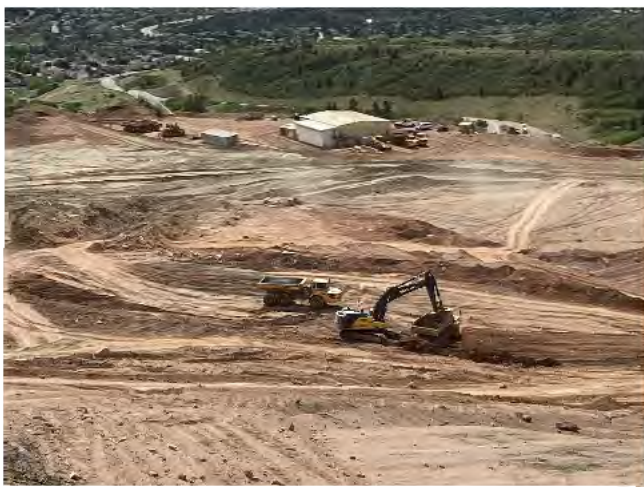
- Reclamation grading began in February 2022 and continued throughout June.
- Operators are moving material from the North Borrow Area to the pit floor for compaction in one-foot lifts. Note that the North Borrow Area is a separate project associated with the City's plans for the property; this grading was permitted by El Paso County. (Photo 5 and 7)

5. Excavator loading haul trucks in the pit area.

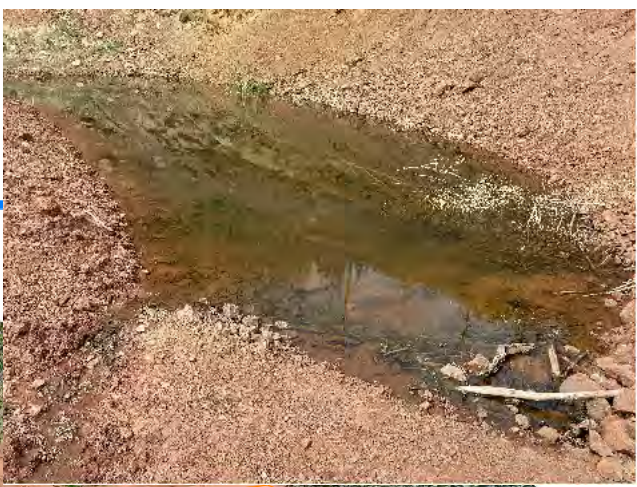
4. Pond along top of haul road with notch for drain.

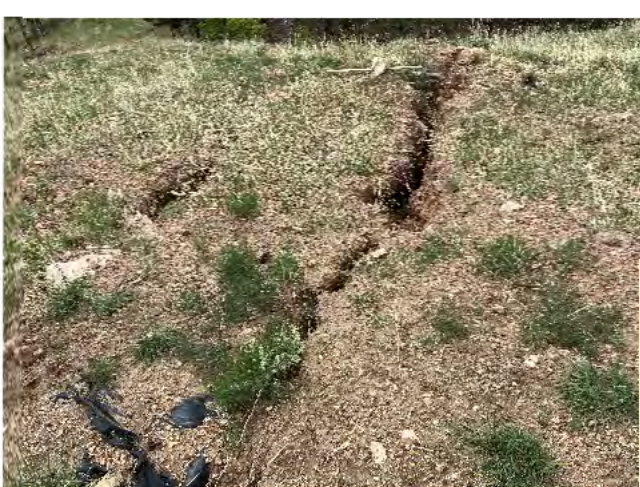
- Known cracks were monitored for changes. Currently the cracks are not growing in any of the areas on the slopes of the site. The hummocky field in the area immediately above the southern extent of the slide shows evidence of cracking but they are not fresh or active. No new or open cracks were found immediately inside or next to the slide area. (Photo 3)

3. Cracking on south end of the site - no change.

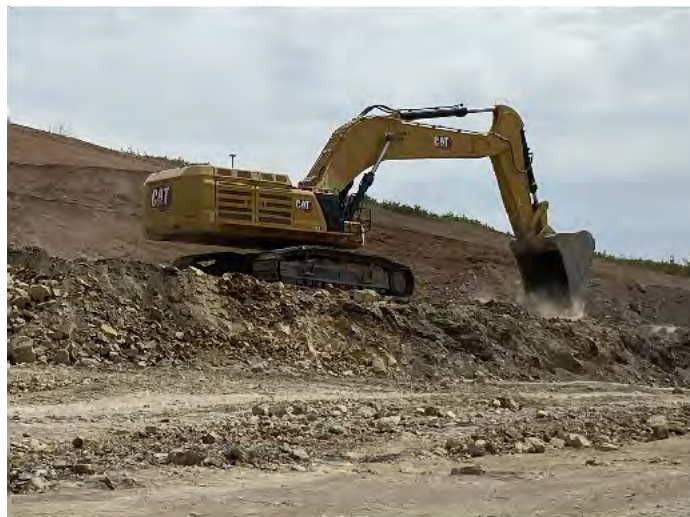
7. Excavator working in the North Borrow Area.

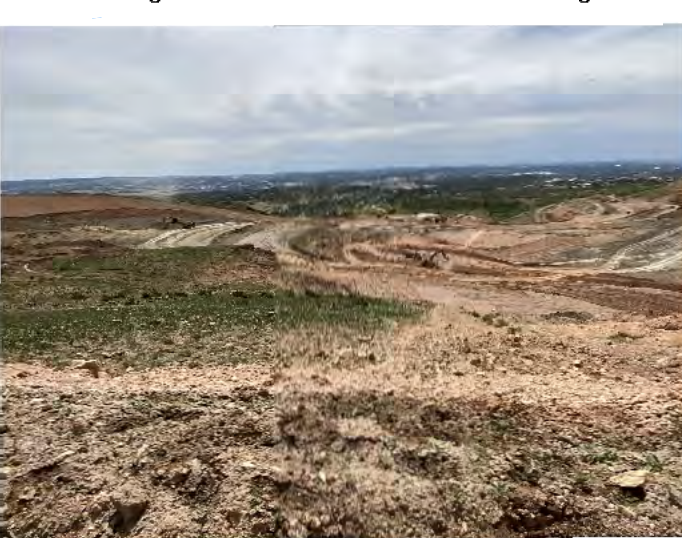
2. View of the North Borrow Area.

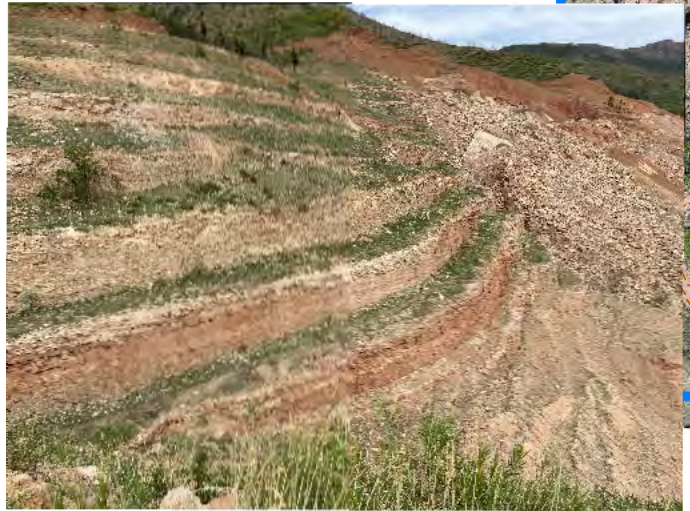
8. Reclamation benches at the south end of the site.

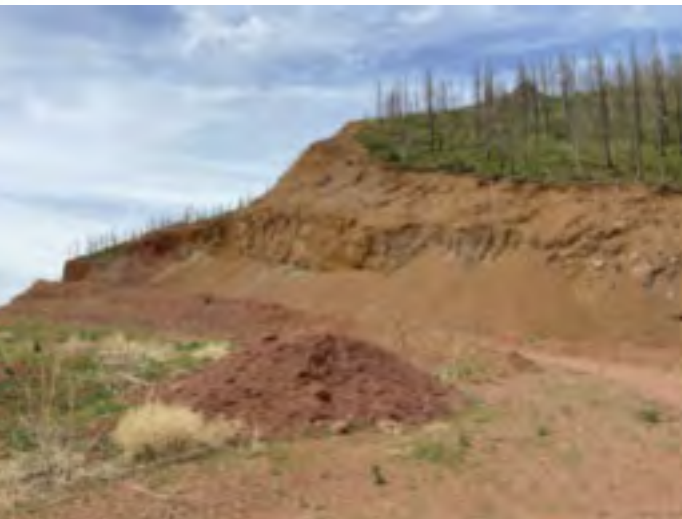
1. View of South Peak from top of haul road.

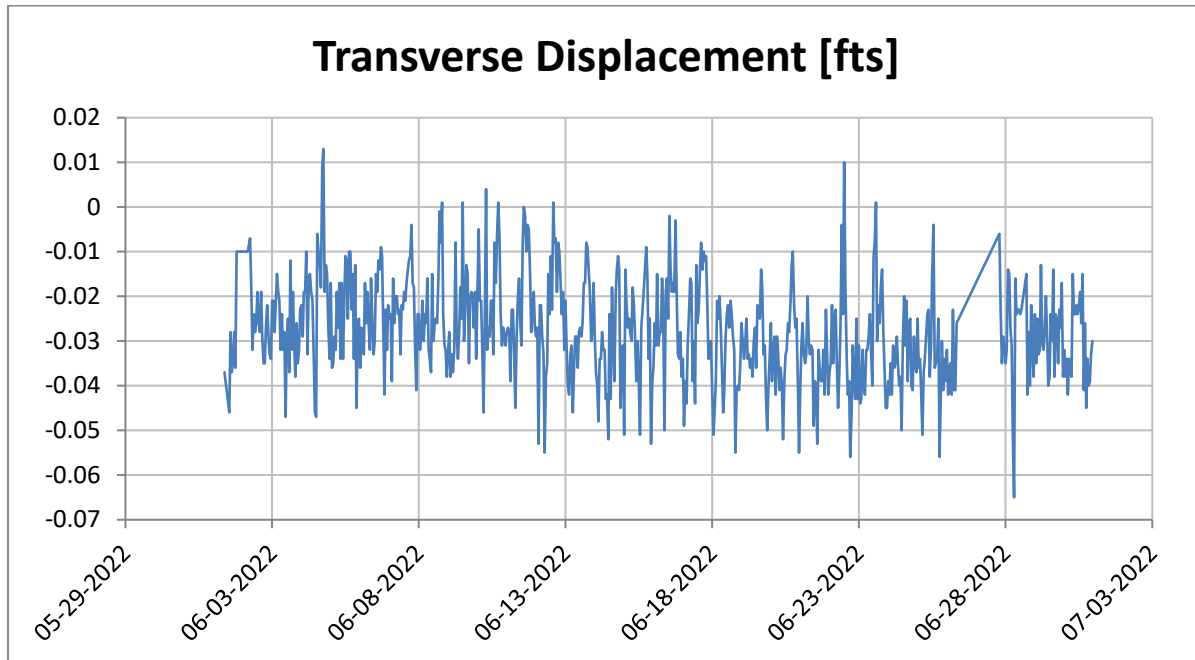
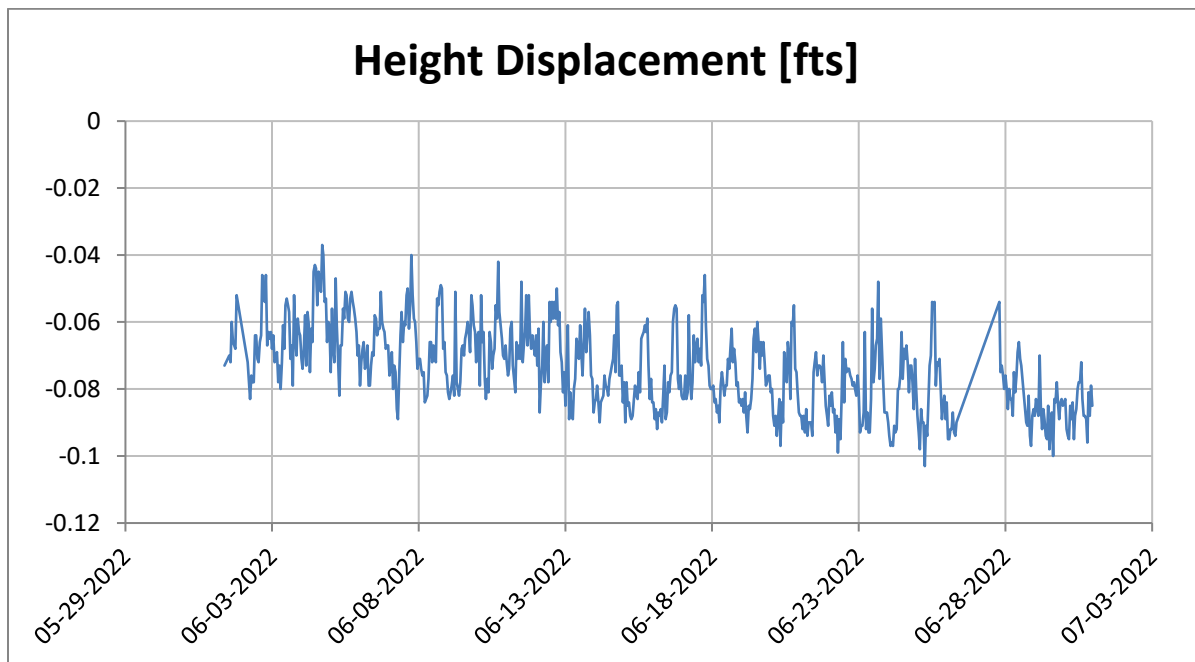
Prism BR1

1. Survey accuracy is ± 0.016 feet.
2. Alarm threshold is ± 0.35 feet.
3. Transverse displacement is in the horizontal direction. Positive direction means closer to the robotic station.
4. Height displacement is in the vertical direction. Positive direction means higher in elevation.
5. Prism records slope creep movements with slow velocity.

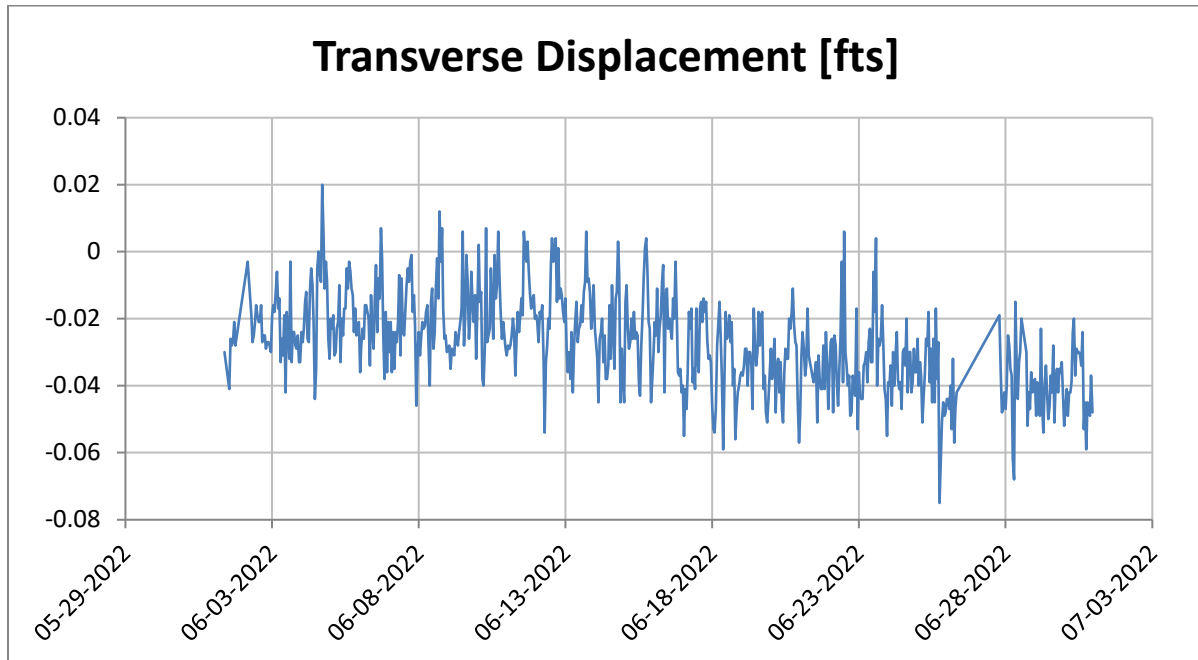
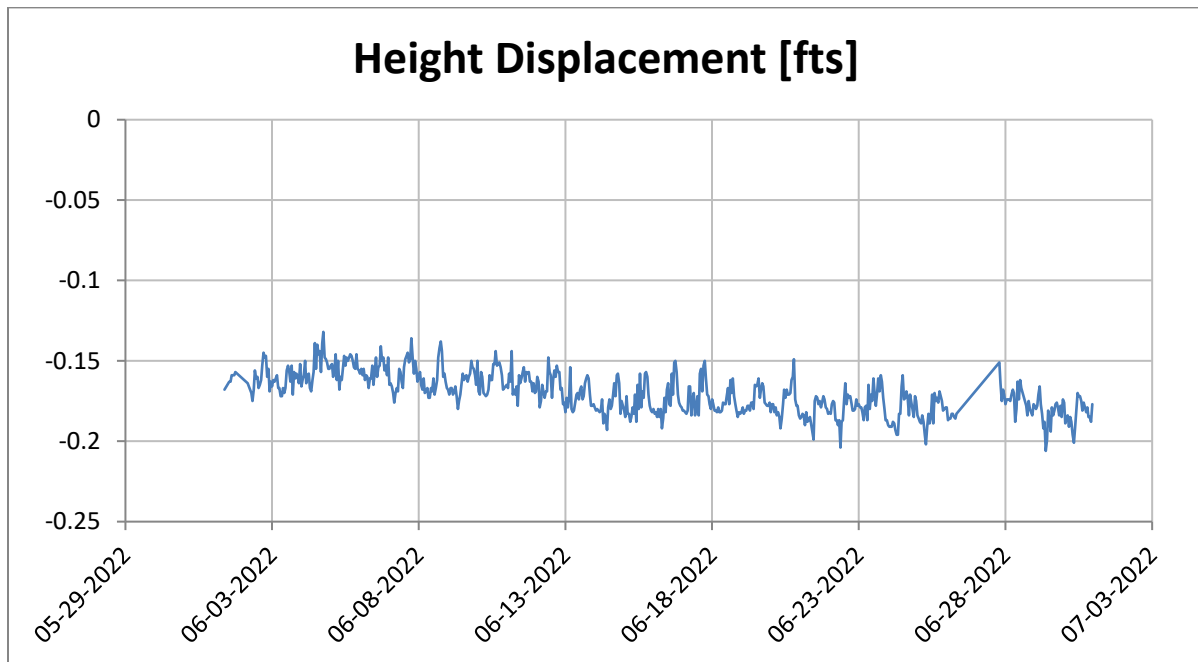
Prism BR2

1. Survey accuracy is ± 0.016 feet.
2. Alarm threshold is ± 0.35 feet.
3. Transverse displacement is in the horizontal direction. Positive direction means closer to the robotic station.
4. Height displacement is in the vertical direction. Positive direction means higher in elevation.
5. Prism is located in an area where ongoing movements are expected. The prism records slope creep movements with slow velocity.

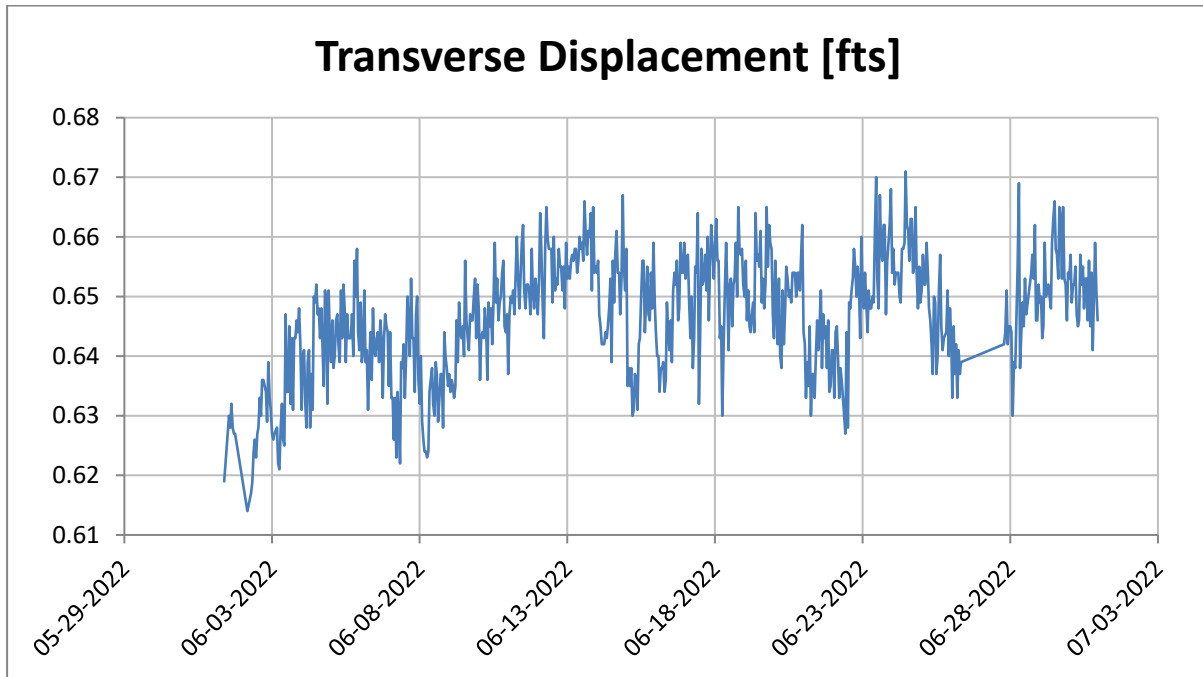
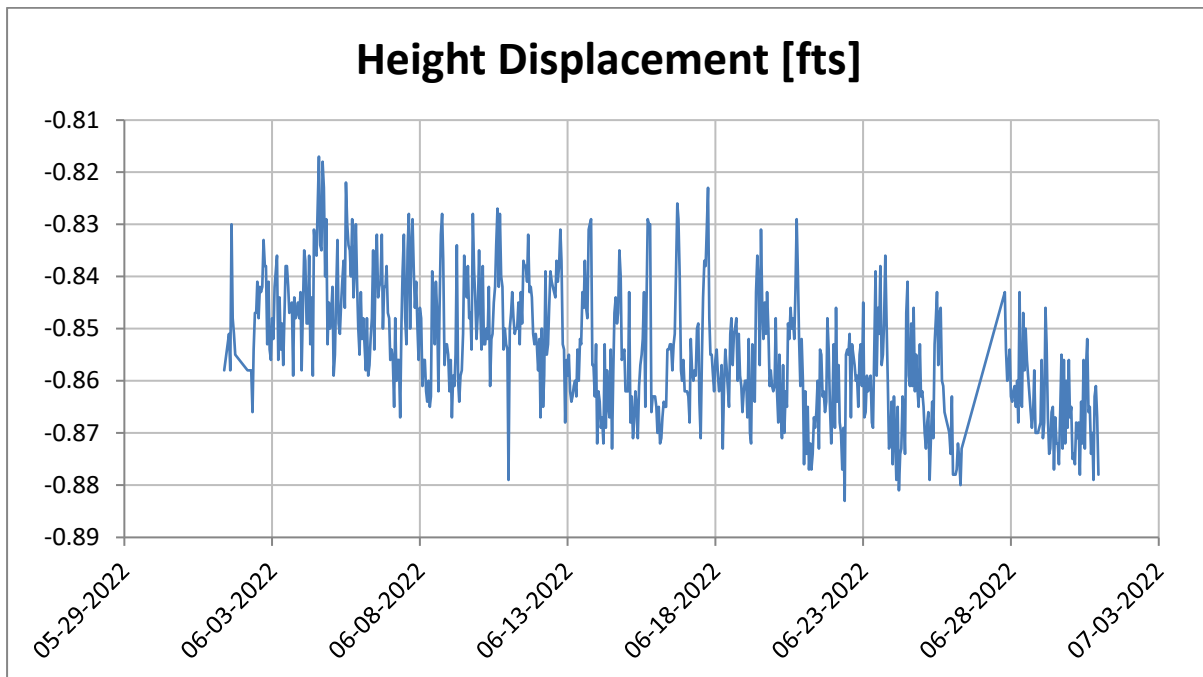
Prism NP66

1. Survey accuracy is ± 0.016 feet.
2. Alarm threshold is ± 0.35 feet.
3. Transverse displacement is in the horizontal direction. Positive direction means closer to the robotic station.
4. Height displacement is in the vertical direction. Positive direction means higher in elevation.
5. Prism records slope creep movements with slow velocity.

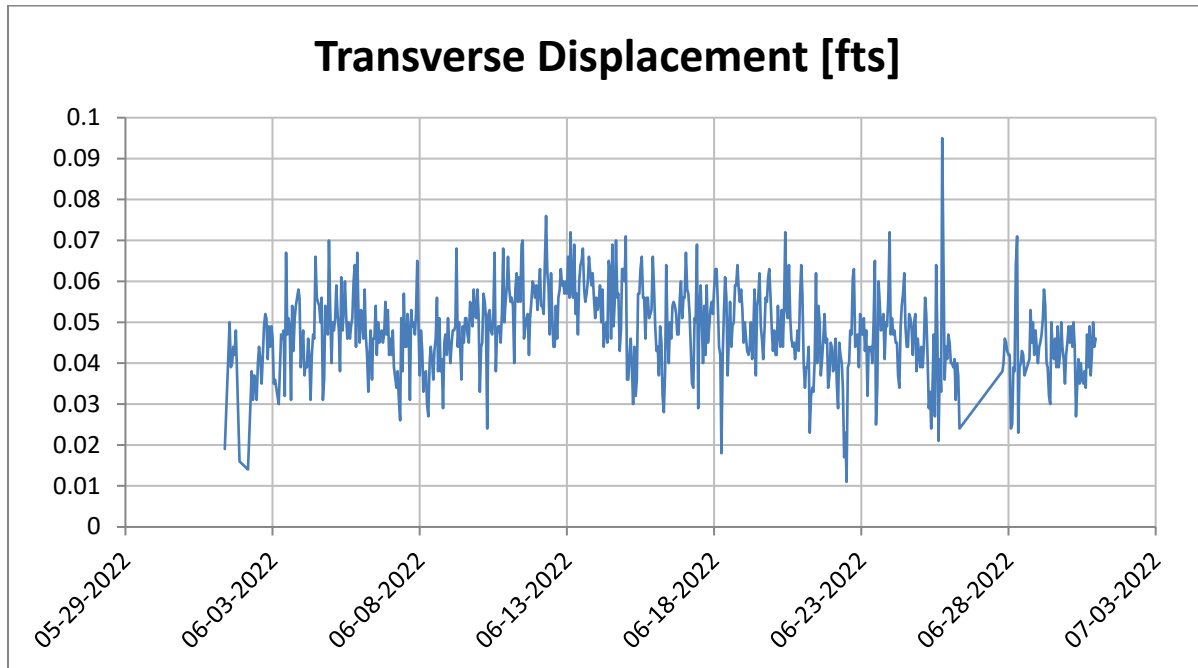
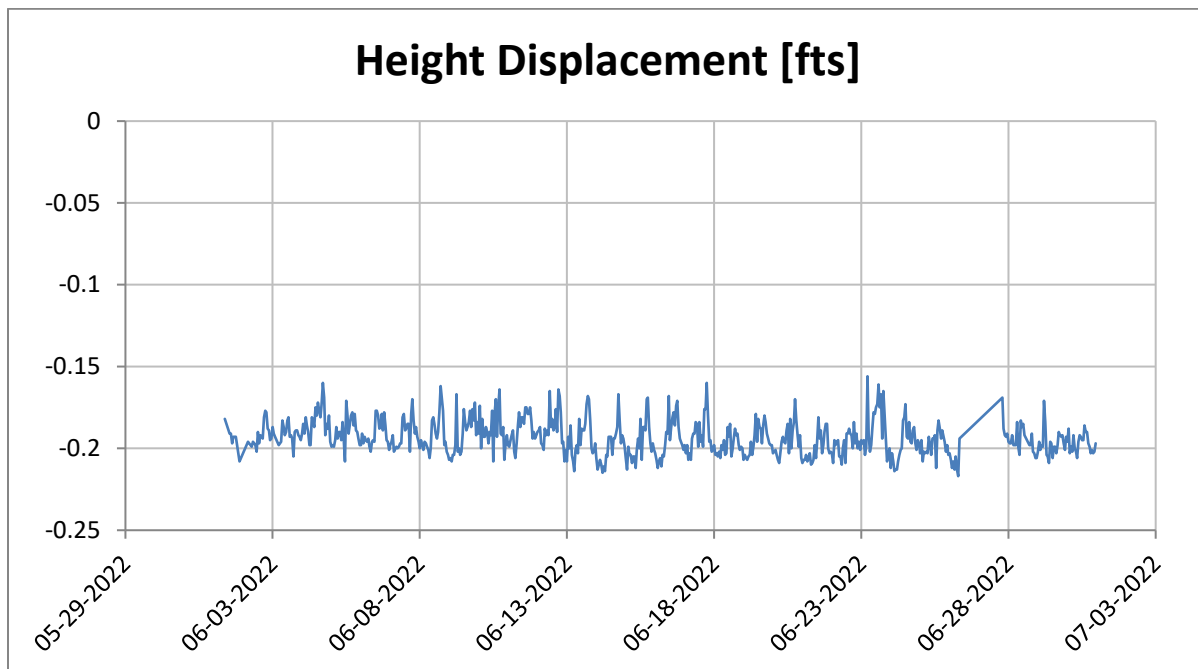
Prism P35

1. Survey accuracy is ± 0.016 feet.
2. Alarm threshold is ± 0.35 feet.
3. Transverse displacement is in the horizontal direction. Positive direction means closer to the robotic station.
4. Height displacement is in the vertical direction. Positive direction means higher in elevation.
5. Regression limit alarm was received on June 25.

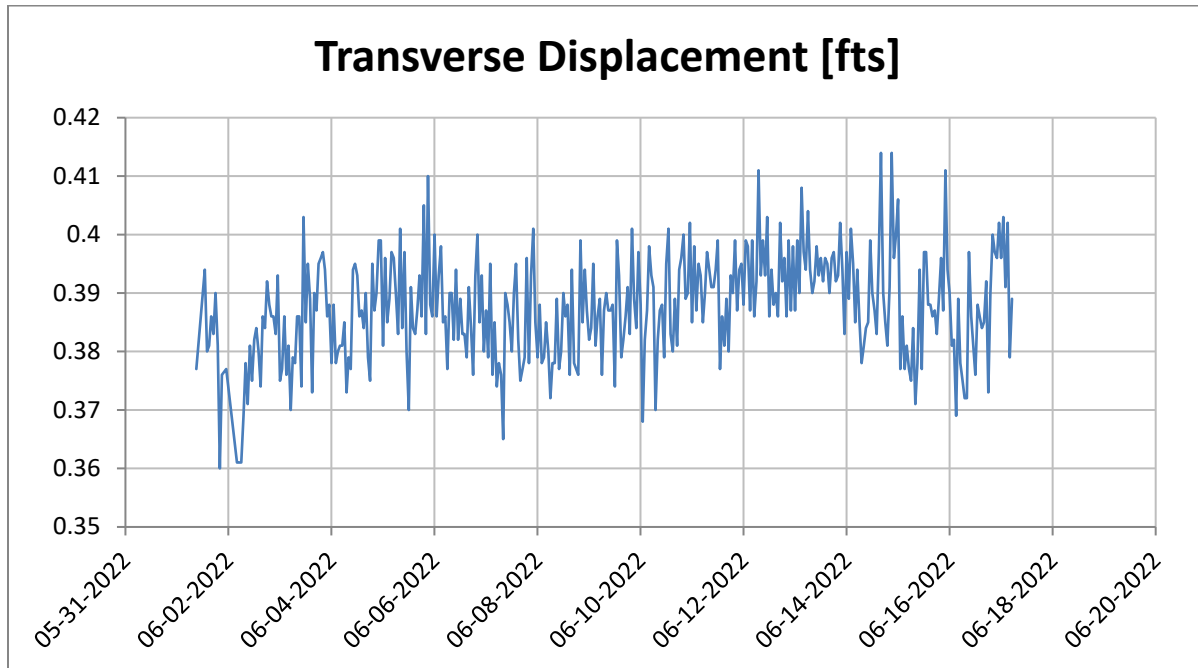
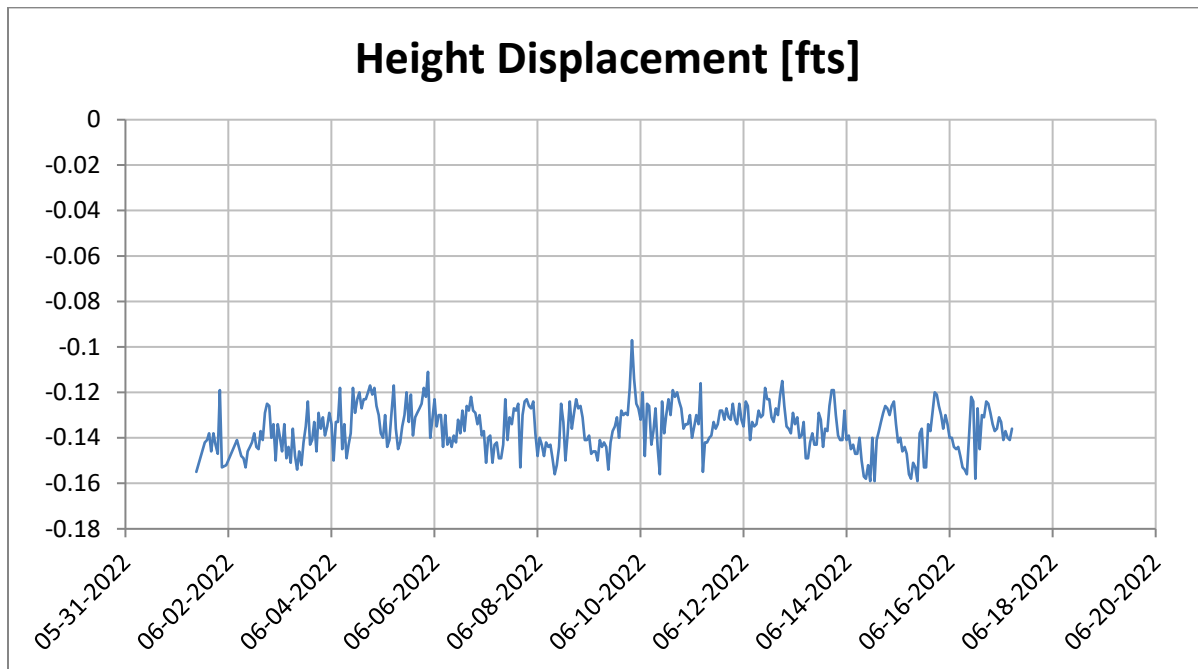
Prism P4

TOE1	22-Apr-22	Prism Removed	Reclamation grading to affect buffer filling activities
P4	17-Jun-22	Prism Removed	Prism removed due to rock deterioration

1. Survey accuracy is ± 0.016 feet.
2. Alarm threshold is ± 0.35 feet.
3. Transverse displacement is in the horizontal direction. Positive direction means closer to the robotic station.
4. Height displacement is in the vertical direction. Positive direction means higher in elevation.
5. Prism abandoned due to rock deterioration.

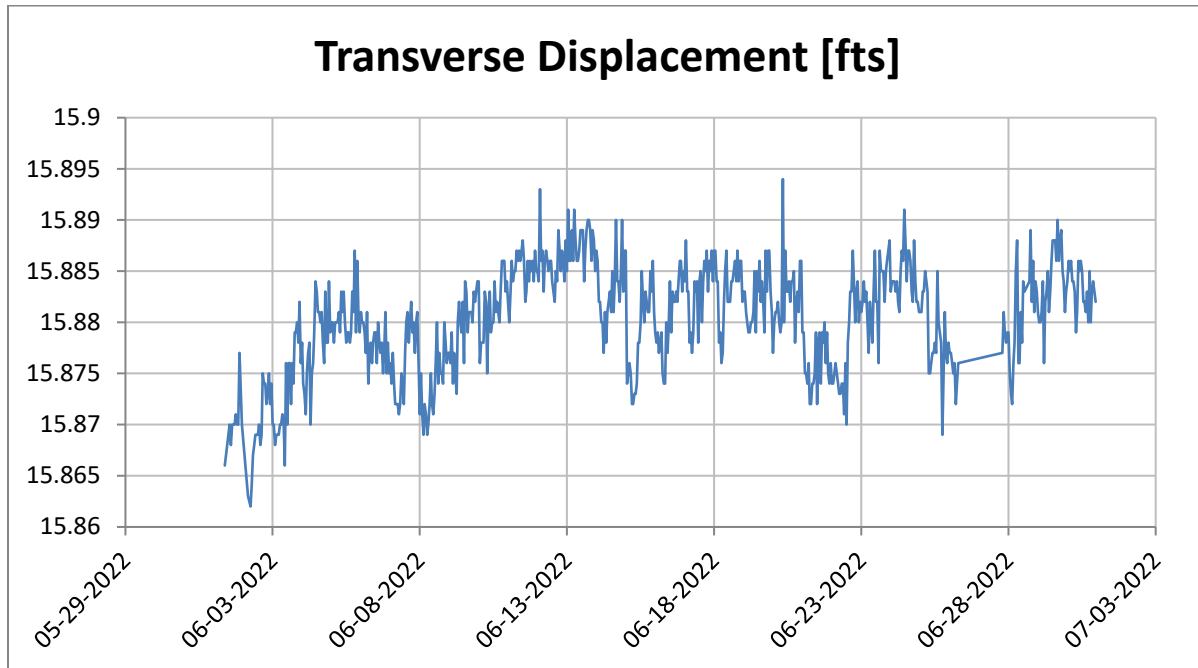
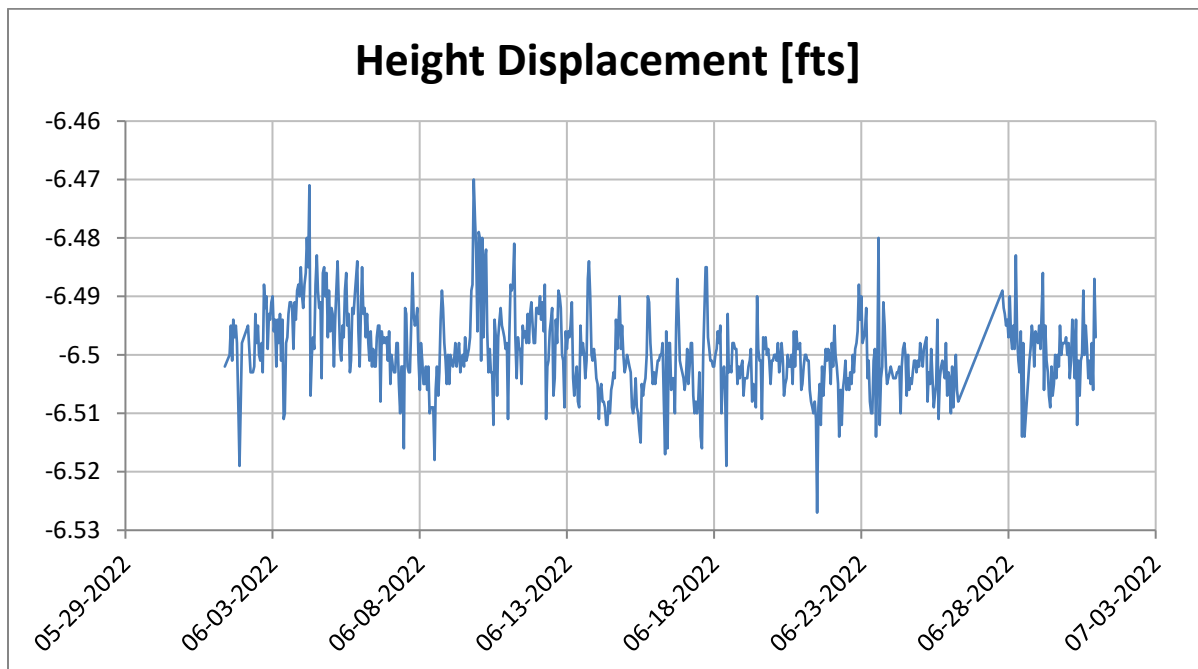
Prism P63

The data show stable conditions with no movement for 15 of 23 prisms with recorded displacements limited to data scatter and not actual movements. Prisms P63, TOE4, and TOE5 are located at the toe of the landslide, and these locations showed slope creep movements at slow velocities. Prisms BR1, BR2, NP66, P69, and TS1 are located above the landslide, and these prisms also recorded slope creep movements at slow velocity. This settlement is likely related to the landslide material consolidating under its own weight. New prisms are placed in areas where slope creep movements are likely to be recorded; therefore, slope creep movements being recorded at more locations is expected to occur. Plots of the transverse and height displacements for each prism are included in Appendix B.

1. Survey accuracy is +/-0.016 feet.
2. Alarm threshold is +/-0.35 feet.
3. Transverse displacement is in the horizontal direction. Positive direction means closer to the robotic station.
4. Height displacement is in the vertical direction. Positive direction means higher in elevation.
5. Prism records slope creep movements with slow velocity.

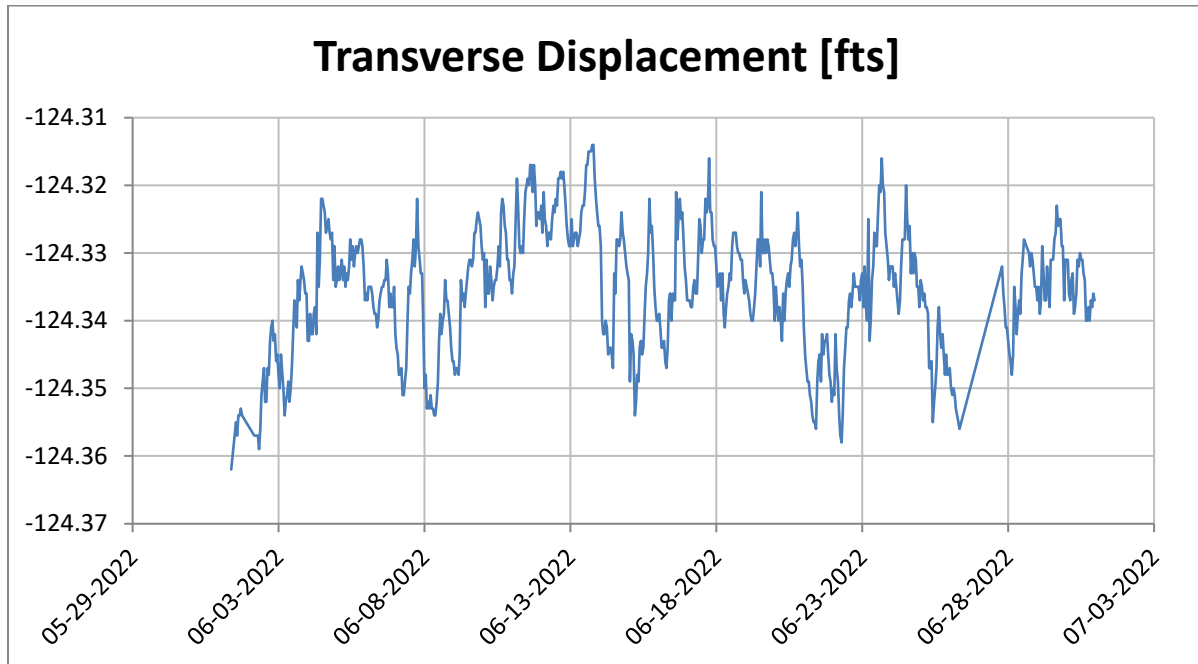
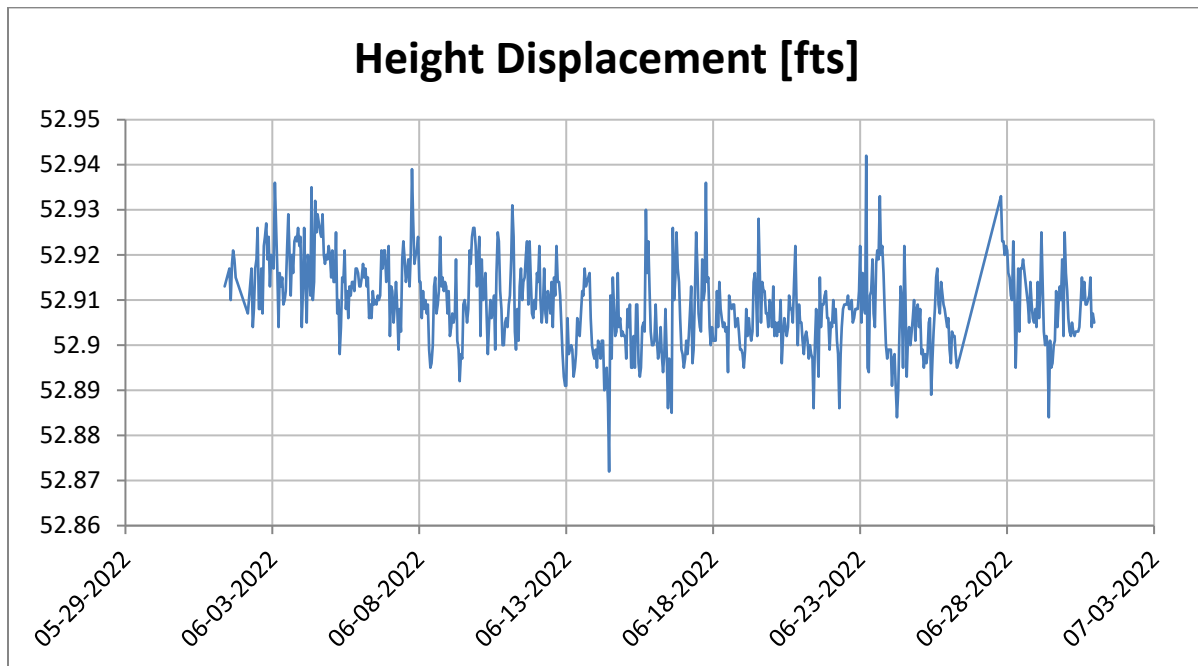
Prism P69

1. Survey accuracy is ± 0.016 feet.
2. Alarm threshold is ± 0.35 feet.
3. Transverse displacement is in the horizontal direction. Positive direction means closer to the robotic station.
4. Height displacement is in the vertical direction. Positive direction means higher in elevation.
5. Prism records slope creep movements with slow velocity.

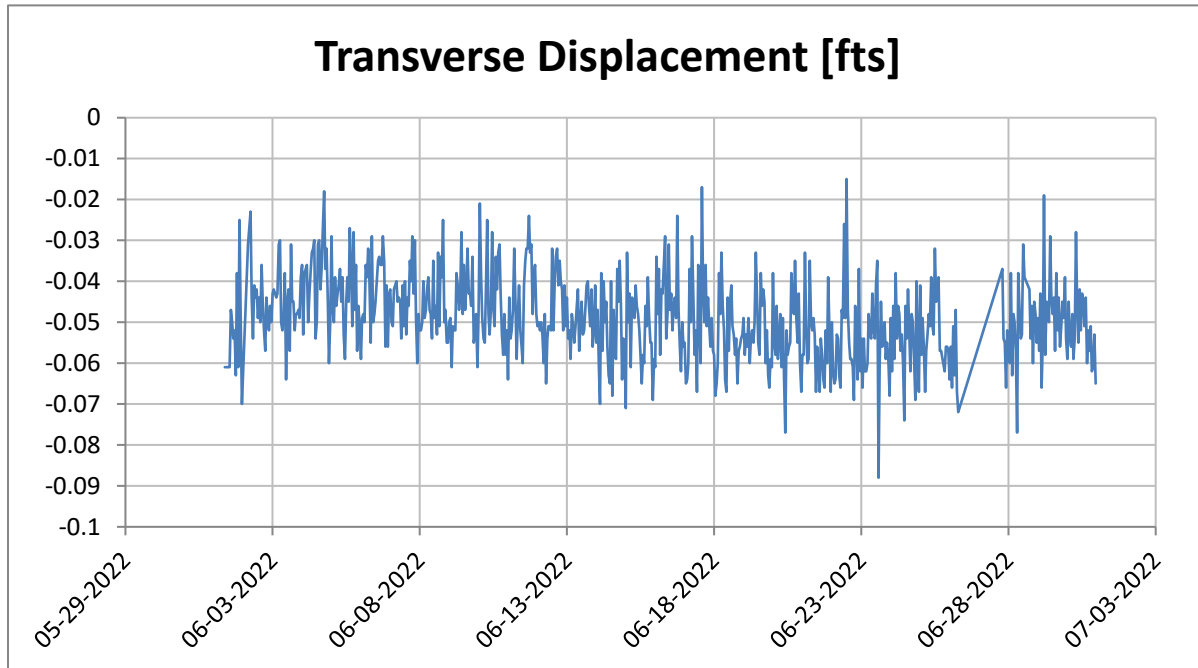
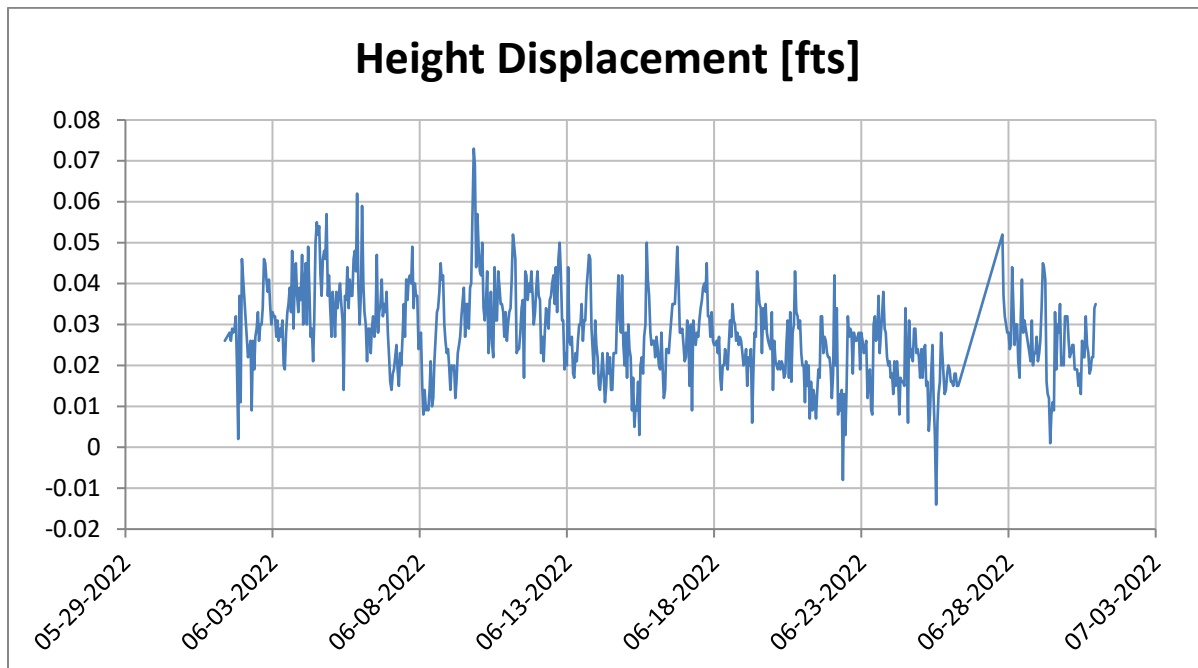
Prism TOE4

1. Survey accuracy is +/-0.016 feet.
2. Alarm threshold is +/-0.35 feet.
3. Transverse displacement is in the horizontal direction. Positive direction means closer to the robotic station.
4. Height displacement is in the vertical direction. Positive direction means higher in elevation.
5. Prism records slope creep movements with slow velocity.

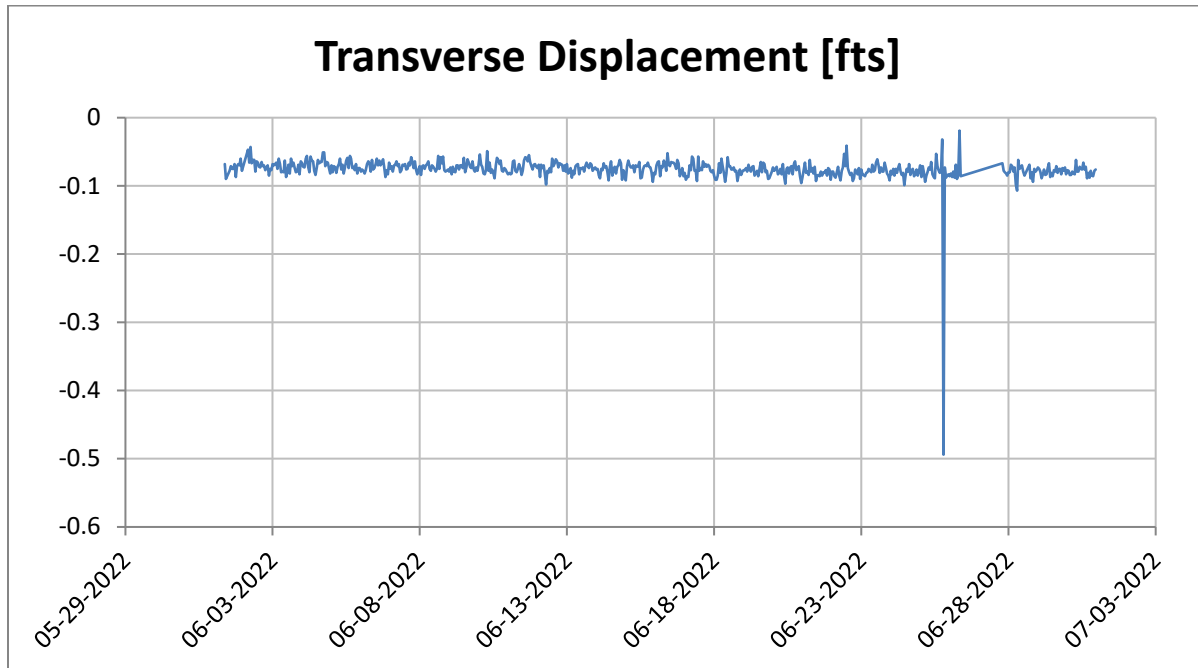
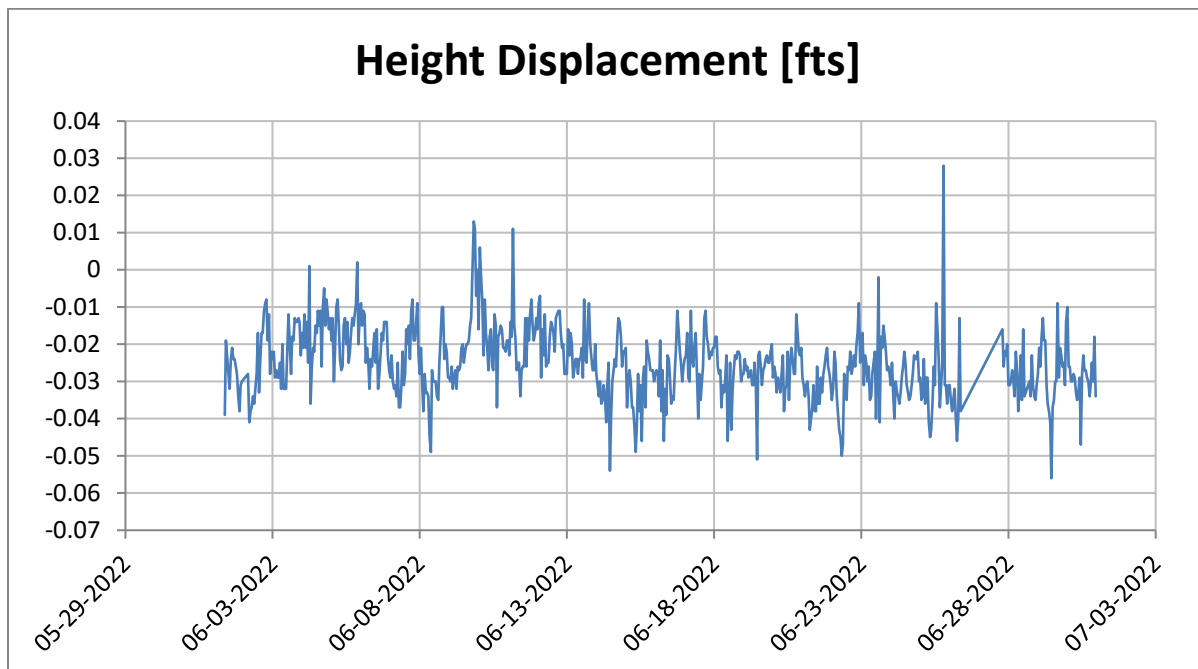
Prism TOE5

1. Survey accuracy is +/-0.016 feet.
2. Alarm threshold is +/-0.35 feet.
3. Transverse displacement is in the horizontal direction. Positive direction means closer to the robotic station.
4. Height displacement is in the vertical direction. Positive direction means higher in elevation.
5. Prism records slope creep movements with slow velocity.

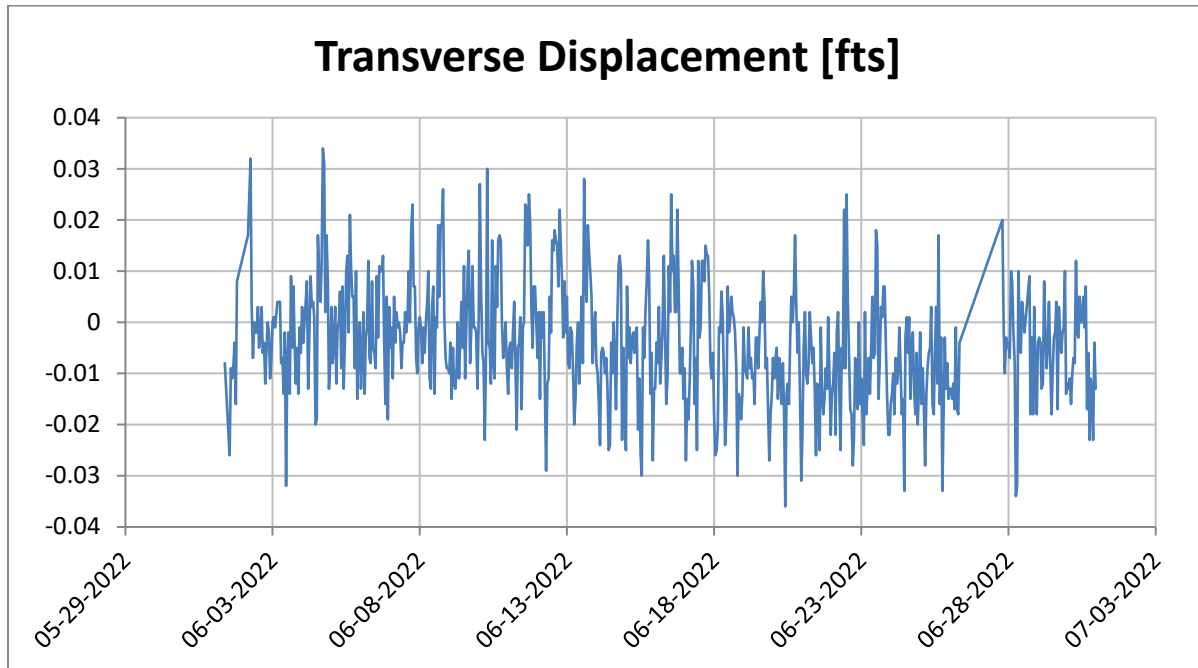
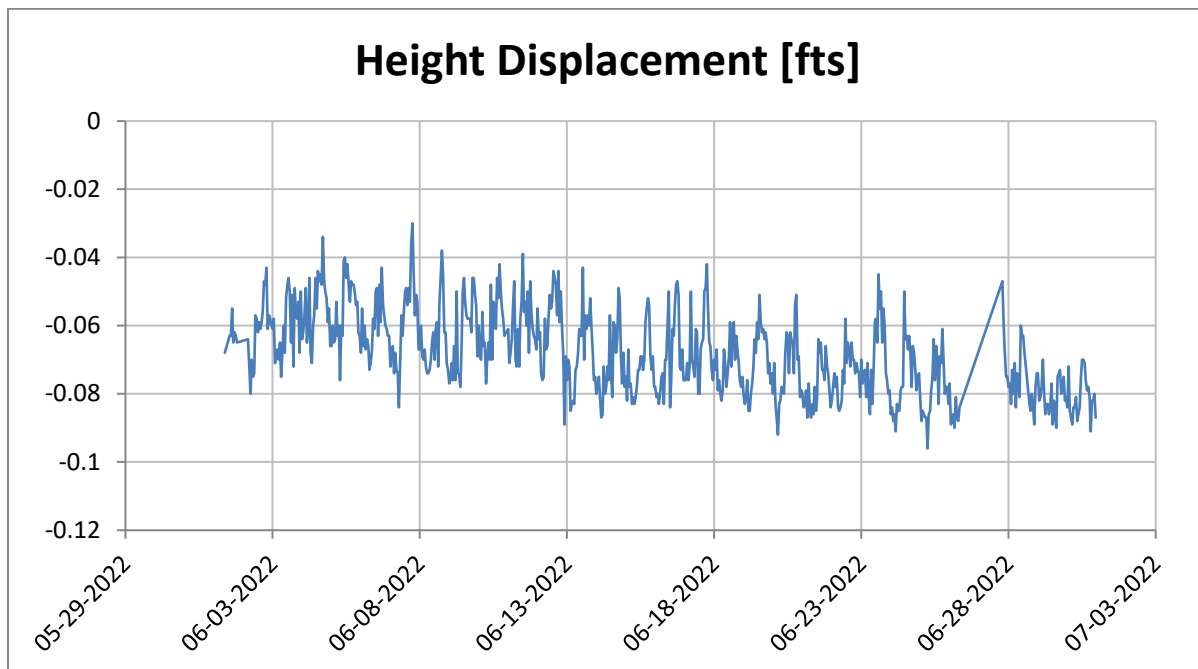
Prism TS1

1. Survey accuracy is ± 0.016 feet.
2. Alarm threshold is ± 0.35 feet.
3. Transverse displacement is in the horizontal direction. Positive direction means closer to the robotic station.
4. Height displacement is in the vertical direction. Positive direction means higher in elevation.
5. Prism records slope creep movements with slow velocity.
