## Lorencito Canyon Mine, C-1996-084, Inspection Report

<b>Permit Number:</b> C-1996-084 <b>Mine Name:</b> Lorencito Canyon Mine <b>Operator:</b> New Elk Coal Company, LLC <b>Operator Address:</b> Mr. Mark Gray 12250 Highway 12 Weston, CO 81091	<b>County:</b> Las Animas <b>Operation Type:</b> Surface <b>Permit Status:</b> Permanent Cessation <b>Ownership:</b> Private
	<b>Operator Representative Present:</b>  Nick Mason
<b>Operator Representative Signature: (Field Issuance Only)</b>

<b>Inspection Start Date:</b> July 27, 2022 <b>Inspection Start Time:</b> 12:00 <b>Inspection End Date:</b> July 27, 2022 <b>Inspection End Time:</b> 14:00	<b>Inspection Type:</b> Coal Partial Inspection <b>Inspection Reason:</b> Normal I&E Program <b>Weather:</b> Cloudy	
<b>Joint Inspection Agency:</b>  None	<b>Joint Inspection Contacts:</b>  None	
<b>Post Inspection Agency:</b>  None	<b>Post Inspection Contacts:</b>  None	
<b>Inspector(s):</b>  Jared Ebert	<b>Inspector's Signature:</b>

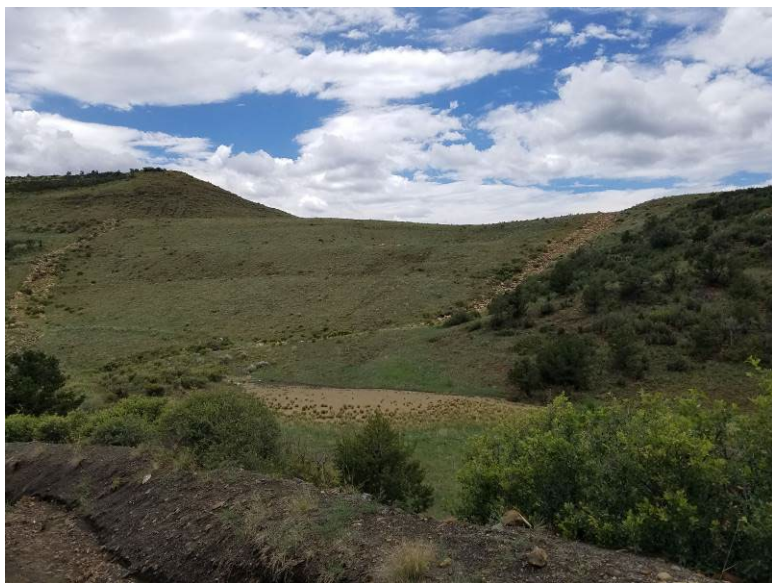
Figure 1. Fill 8

Fills 8, 7, and 9 were observed from their respective receiving ponds. Each of the faces of the fills appeared stable and the vegetation was very green likely due to recent precipitation. No appearances of instability or failures were observed.

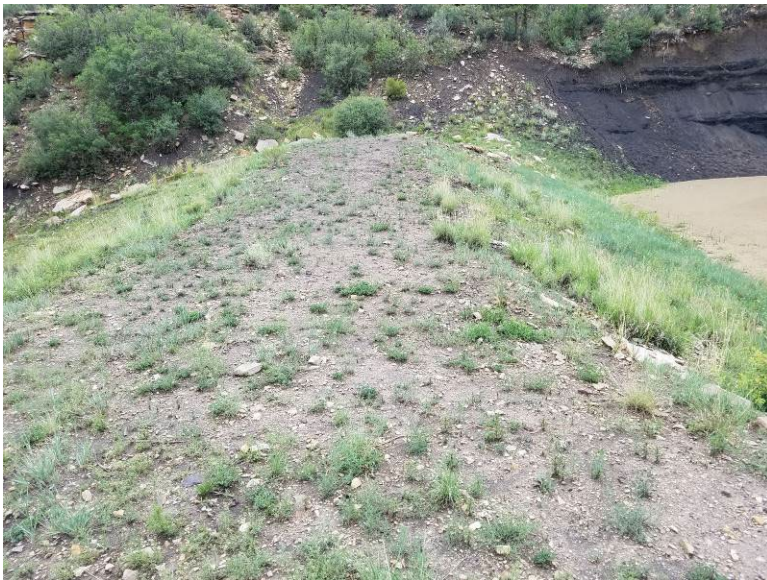
Pond 008 was dripping a small amount of water from the outfall. A pool of water was impounded in Pond 008. The face of the embankment was stable and vegetated. The top of the pond embankment has fairly sparse vegetation, it appears the area is heavily traveled by wildlife. NECC will need to monitor this embankment and possibly reseed the top of the embankment to help establish vegetation for the purposes of long term stability.

Figure 4. Top of Pond 008 embankment.

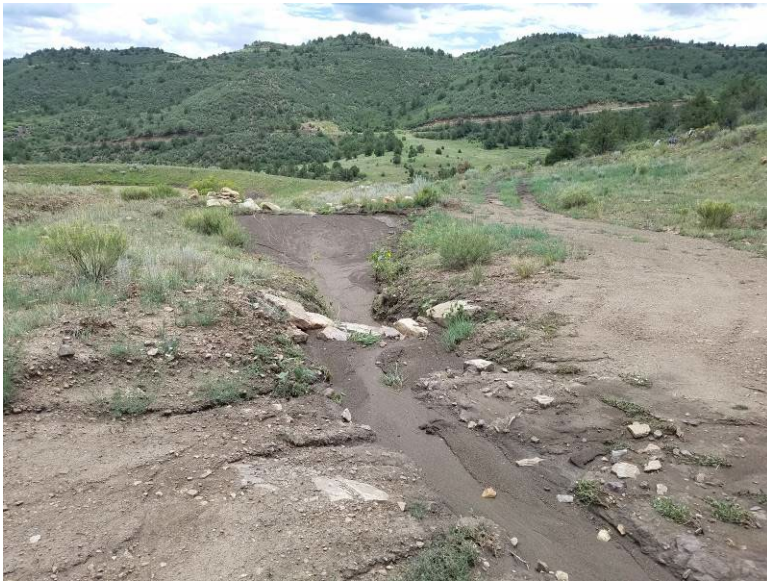
Ditch D8 on the east side of the access road to Pond 006 contains several large check dams. Several of these check dams were full of water and sediment. **This ditch and the adjacent road ditch will likely need to be cleaned out this year so they remain functional.** The reclaimed slope above Pond 006 is eroding and major rills have formed on the face of the reclaimed slope despite the vegetation that has established on the slope. It appears most of this sediment is from the run-off from this slope. NECC is exploring methods to repair and stabilize this slope and several others around the site where erosion has been noted by DRMS staff. Much of the efforts NECC has put toward stabilizing these areas have had mixed success.

*Figure 5. Ditch D8*

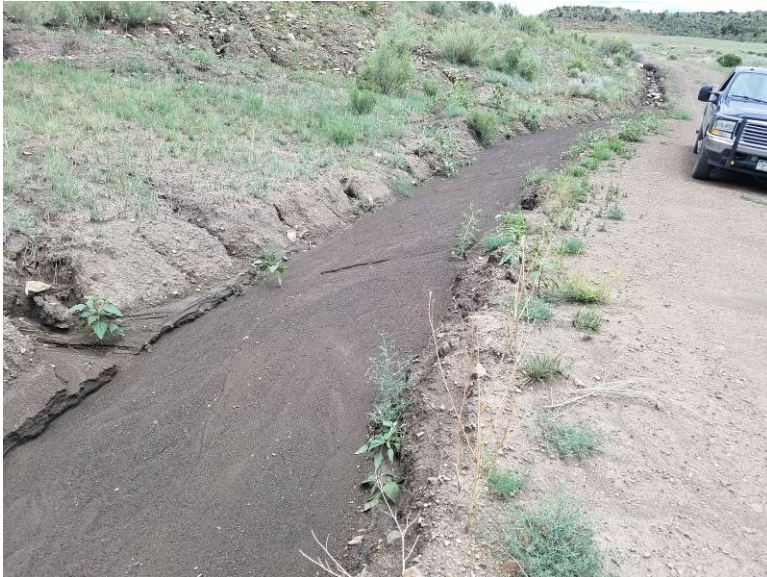
*Figure 6. Ditch adjacent to access road to Pond 006 on northwest side.*
