MINERALS PROGRAM INSPECTION REPORT

MINE NAME: Iron & Wm. Richardson Lode Claims	MINE/PROSPECTING ID#: M-2014-066	MINERAL: Gold and silver	COUNTY: Gilpin
INSPECTION TYPE: Surety Release Inspection	INSPECTOR(S): Brock Bowles, Michael Cunningham	INSP. DATE: July 28, 2022	INSP. TIME: 09:00
OPERATOR: Nevadaville Encore, LLC	OPERATOR REPRESENTATIVE: None	TYPE OF OPERATION: 110d - Designated Limited Impact	
REASON FOR INSPECTION: Surety Release Requested	BOND CALCULATION TYPE: None	BOND AMOUNT: \$14,500.00	
DATE OF COMPLAINT: NA	POST INSP. CONTACTS: None	JOINT INSP. AGENCY: None	
WEATHER: Cloudy	INSPECTOR'S SIGNATURE:

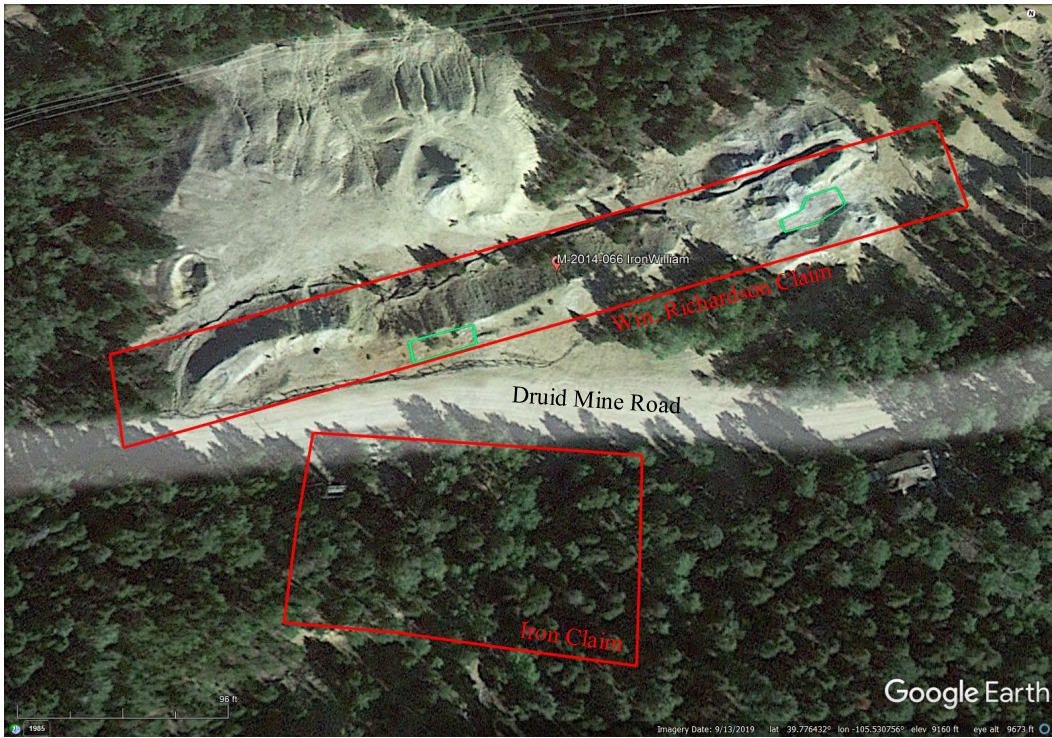
The mine site is a 110d operation permitted to mine gold and silver. The site is comprised of 2 historic mining claims: the Iron claim and the Wm. Richardson claim. Both claims combined equal 1 acre in size. The claims are separated by the Druid Mine Road with the Iron Claim (0.4 acre) on the south side of the road and the Wm. Richards Claim (0.6 acre) on the north (figure 1).

Very little disturbance was created as a result of this mining permit. Only two very small areas were disturbed with a combined disturbance of less than 1000 sq. ft. (figure 1- green areas). The areas that were disturbed were topsoiled and seeded. The vegetation growing on these areas was growing well (photo 4).

Figure 1 – Permit boundaries (red) and disturbed/revegetated areas (green)

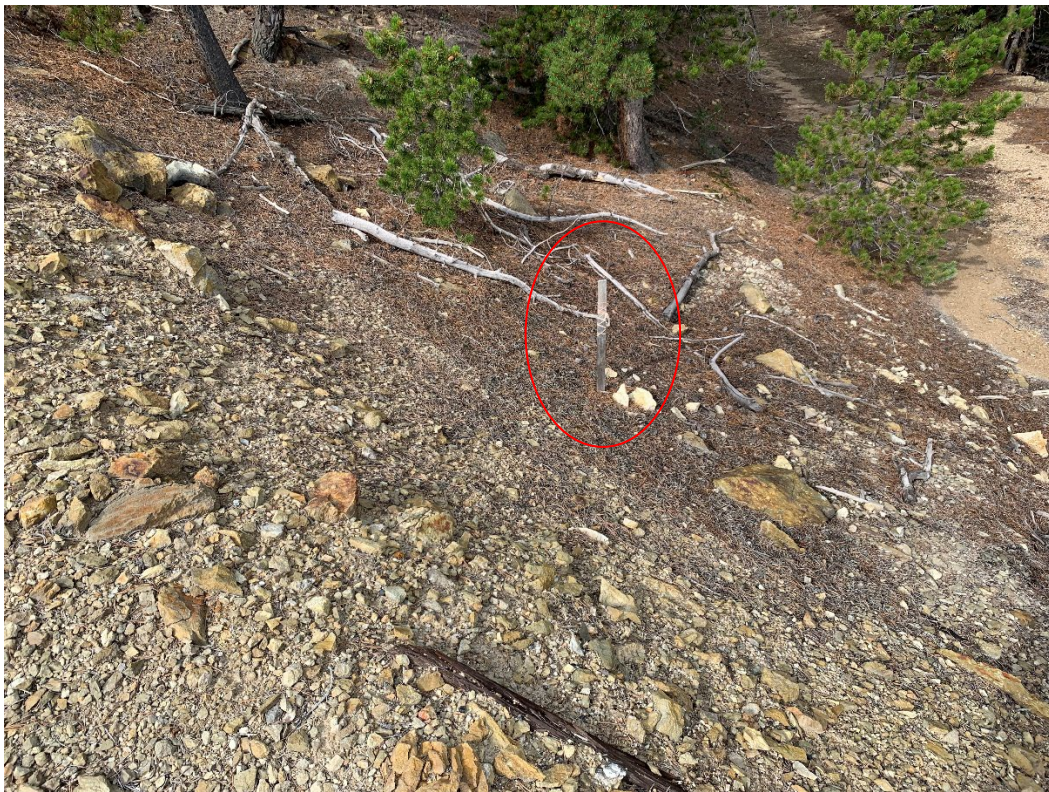
The Wm. Richardson claim was marked with permit boundary markers (photo 2) except the southwest corner marker because the marker would be in the middle of Druid Mine Road. No historic buildings/structures were on this claim. The site is a historic mine tailings dump with only a couple of aspen and pine trees growing on the site prior to the current mining permit, according to the 2014 permit application. The mining plan was to haul the existing ore/tailings to an off-site processing facility. Erosion control structures (wattles and silt fence) were installed around the perimeter of the mined area (photo 3).

Photo 2 – Northwest permit marker

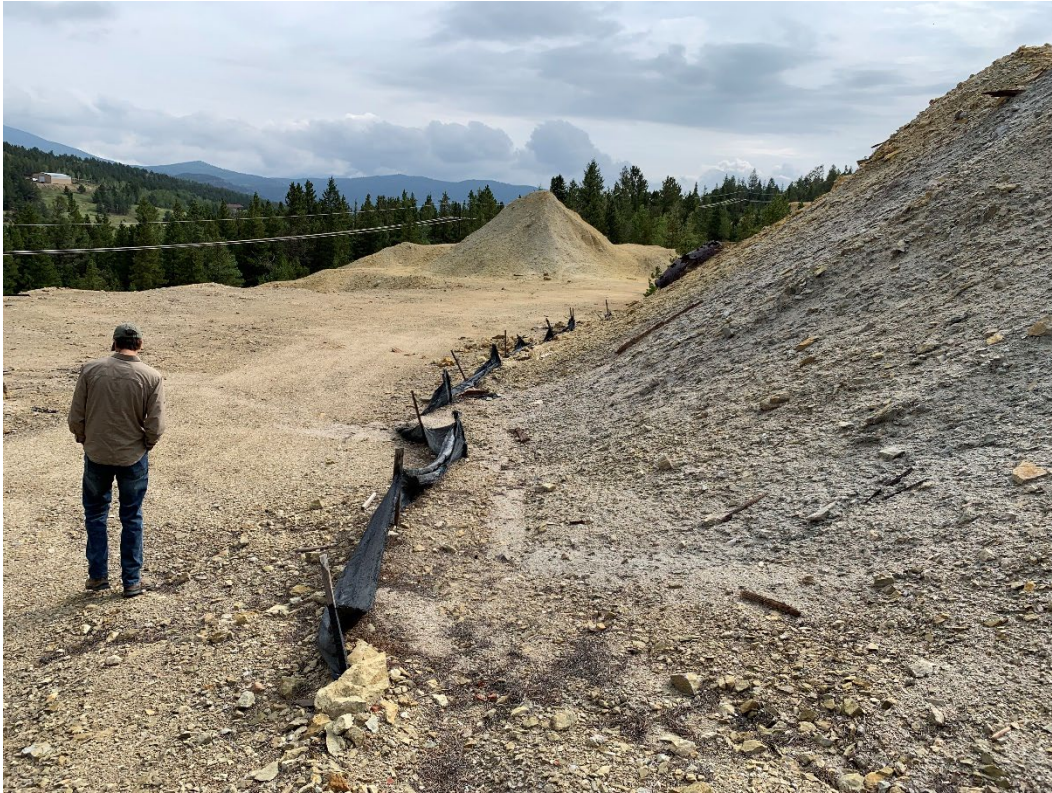
Photo 3 – North permit boundary of Williams claim looking east with erosion control silt fences

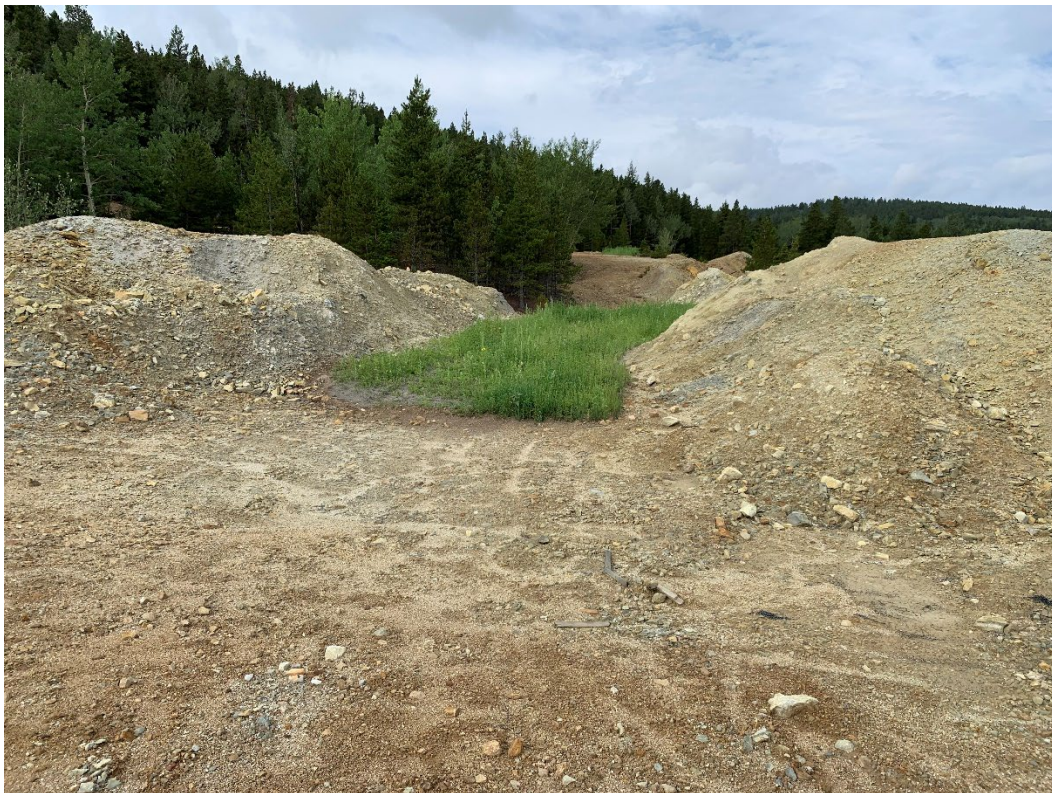
Photo 4 – Vegetation growing on eastern disturbance

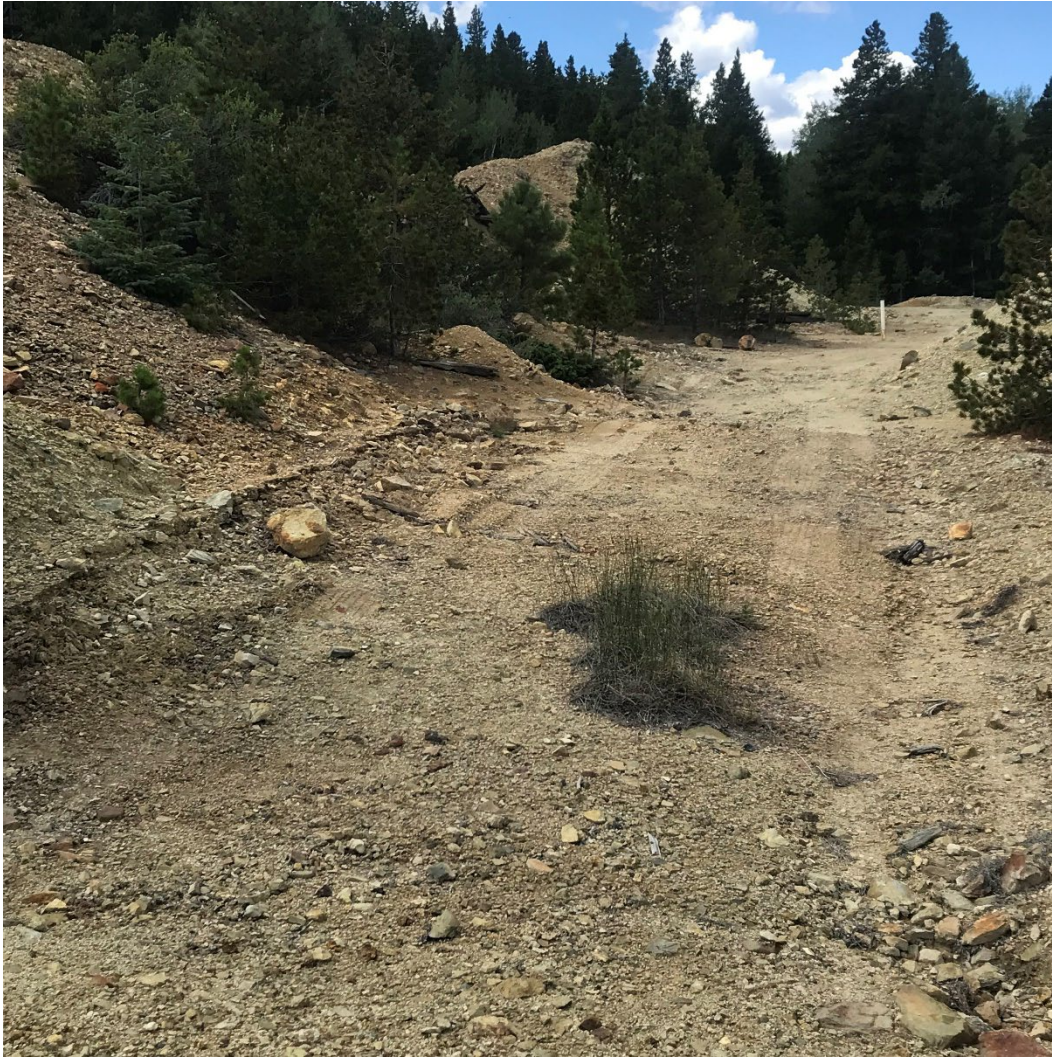
The erosion control structures were removed to clean up the site after the inspection was conducted (photo 5).

Photo 5 – North permit boundary facing west, erosion control structures removed
