MINERALS PROGRAM INSPECTION REPORT
PHONE: (303) 866-3567

MINE NAME: Hancock Gravel Pit	MINE/PROSPECTING ID#: M-1981-279	MINERAL: Sand and gravel	COUNTY: Otero
INSPECTION TYPE: Monitoring	INSPECTOR(S): Patrick Lennberg	INSP. DATE: July 26, 2022	INSP. TIME: 11:30
OPERATOR: All-Rite Paving & Redi-Mix, Inc.	OPERATOR REPRESENTATIVE: Jodi Schreiber	TYPE OF OPERATION: 112c - Construction Regular Operation	
REASON FOR INSPECTION: Normal I&E Program		BOND CALCULATION TYPE: Complete Bond	BOND AMOUNT: \$175,380.00
DATE OF COMPLAINT: NA		POST INSP. CONTACTS: None	JOINT INSP. AGENCY: None
WEATHER: Clear	INSPECTOR'S SIGNATURE:

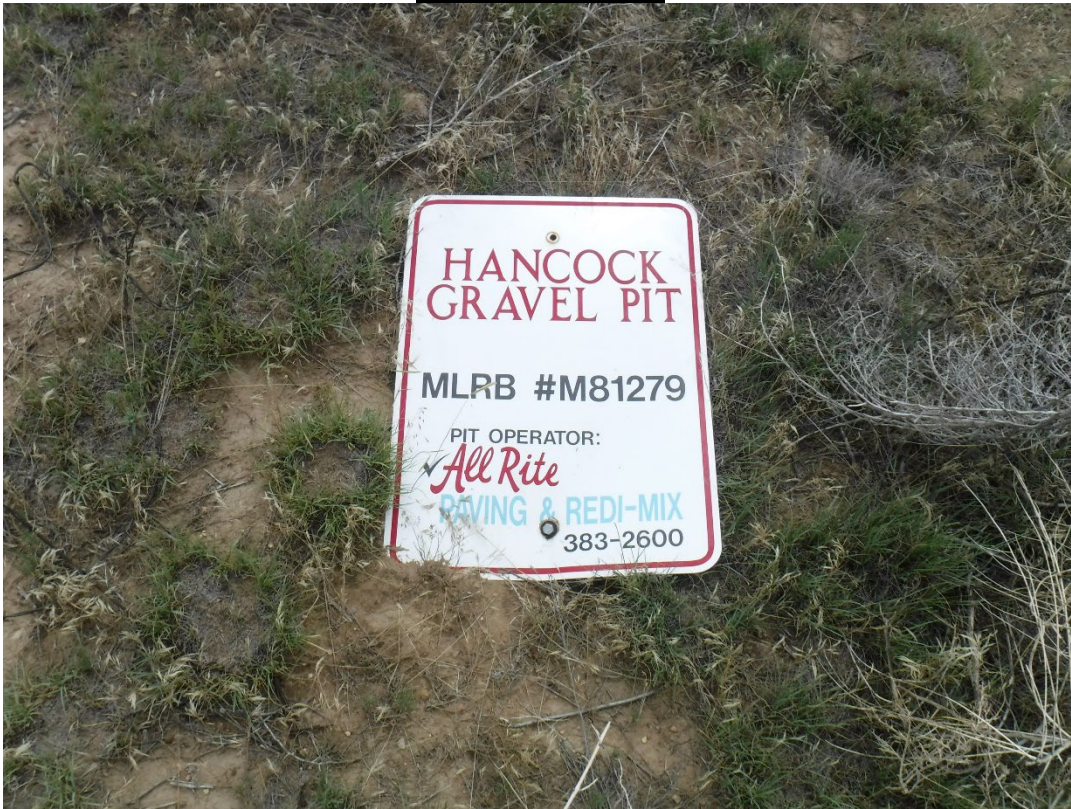
This is a 112c operation permitted for 92 acres to mine sand and gravel for road construction and maintenance. The affected acreage is 92 acres but only 50 acres are to be disturbed at any one time. The mine is located in Otero County. The site is located approximately 4 miles southwest of Rocky Ford, CO. The site can be accessed from the east off of Co Rd 18. The approved post-mining land use is rangeland. A mine sign was posted at the mine entrance pursuant to Rule 3.1.12, although it appears wind may knocked the sign off the post.

Photo 1: Mine sign at the primary mine entrance, recently blown off of post

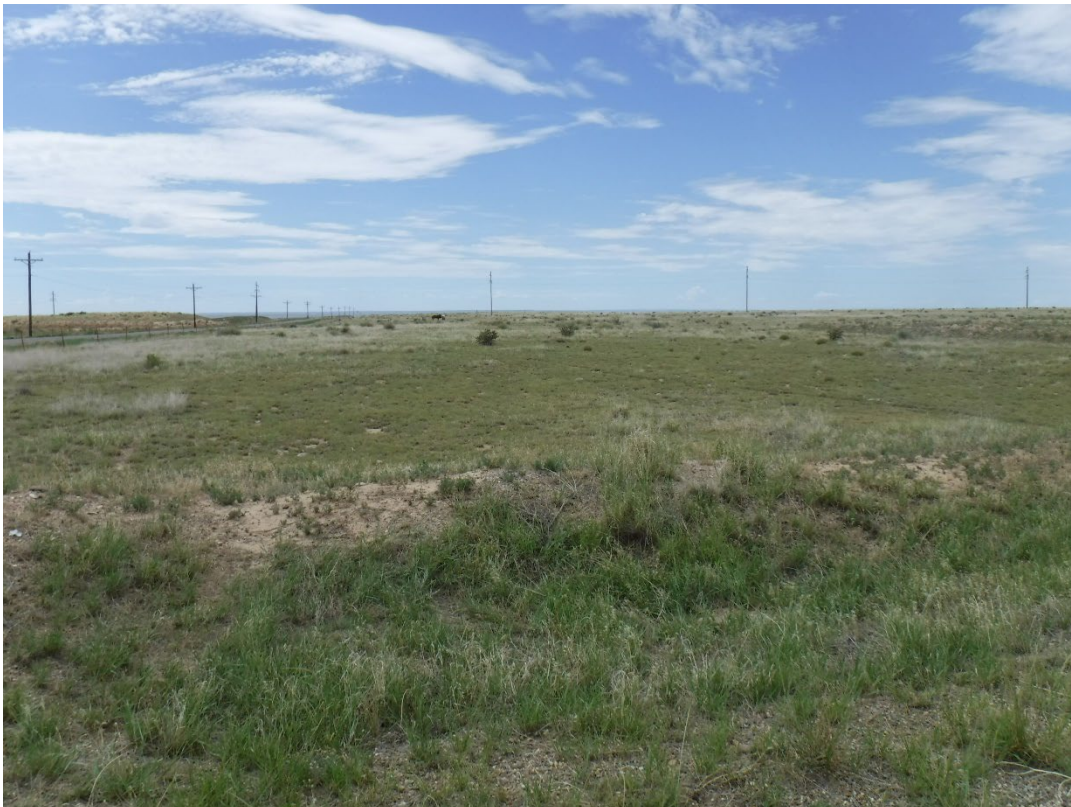
Photo 2: Looking south from entrance at the powerlines along southern permit boundary

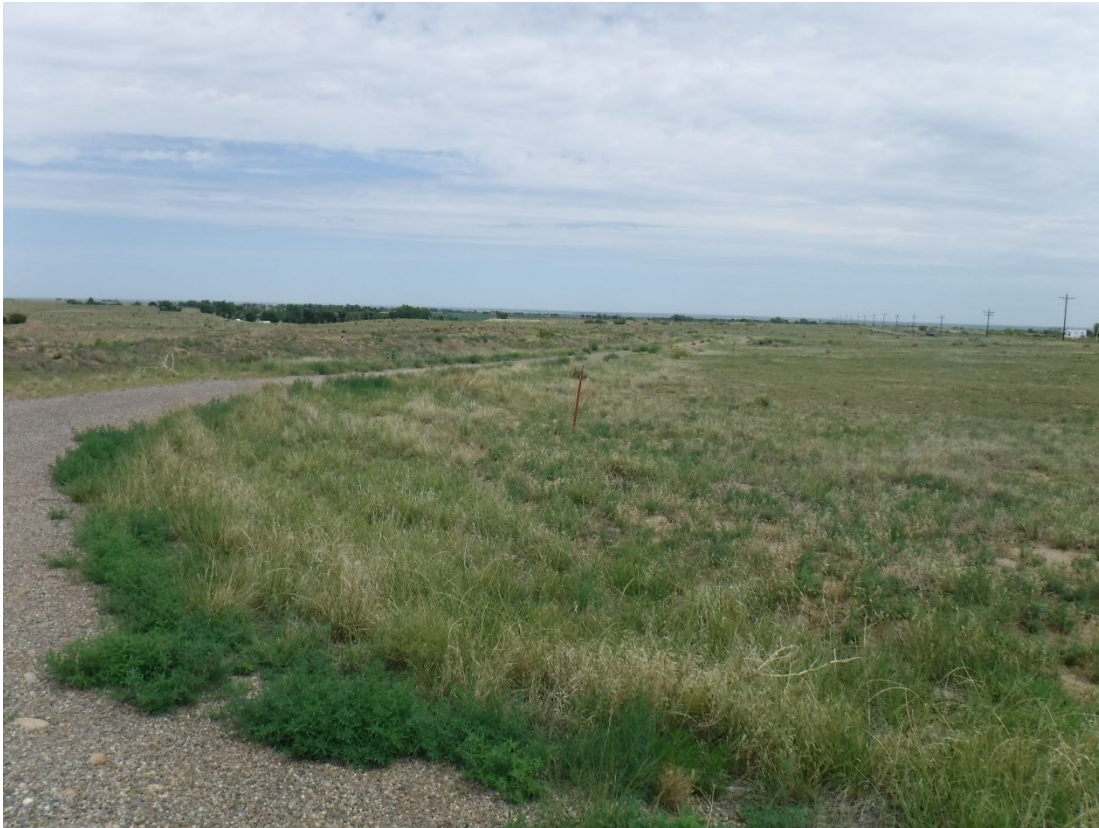
Photo 3: Typical permit boundary marker, red tee-post

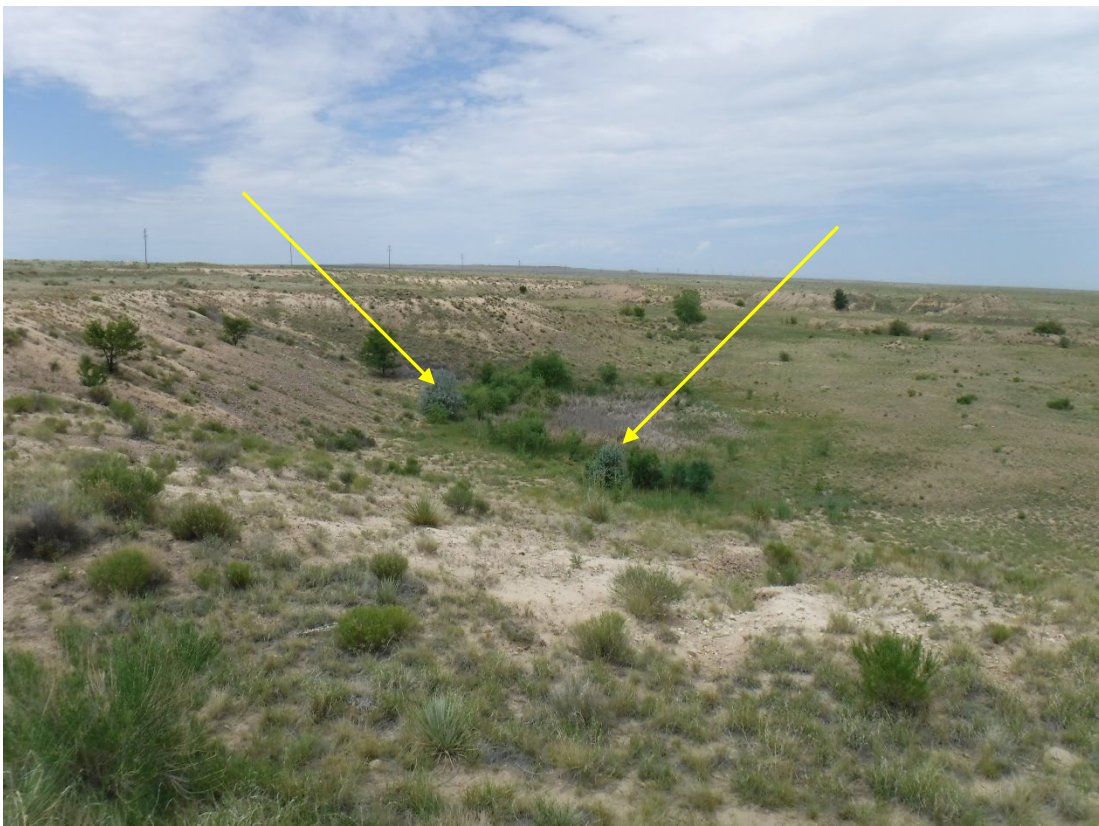
PROBLEM/POSSIBLE VIOLATION: Tamarisk (salt cedar) and Russian Olive trees are present within or have volunteered into the permit area and are becoming established. This is a problem for failure to employ weed control methods for a state listed noxious weed species within the permitted area, and to reduce the spread of weeds to nearby areas as required by Section 3.1.10 (6) of the rule.

Photo 4: Looking south into pit area from northern pit boundary, arrows indicate Russian Olive trees

CORRECTIVE ACTIONS: The operator shall submit photo documentation of the trees removal by the corrective action date.

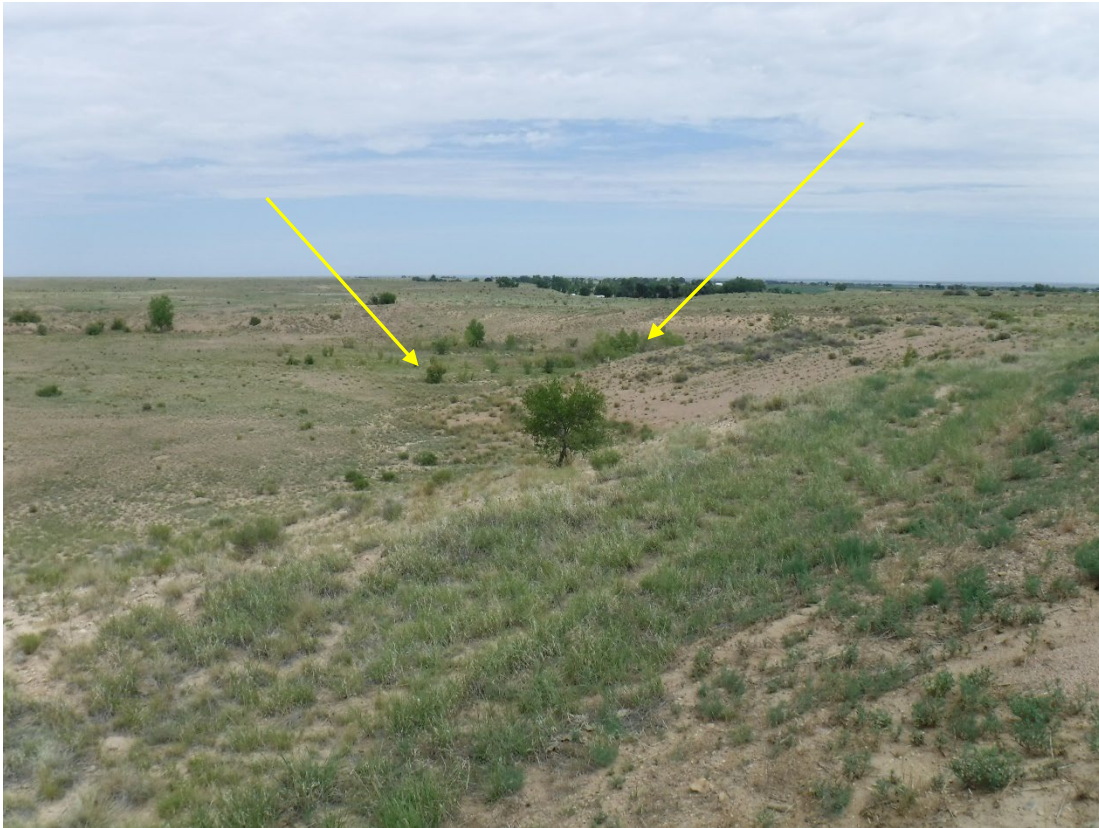
Photo 5: Looking west along the northern pit boundary, arrows indicate Tamarisk trees

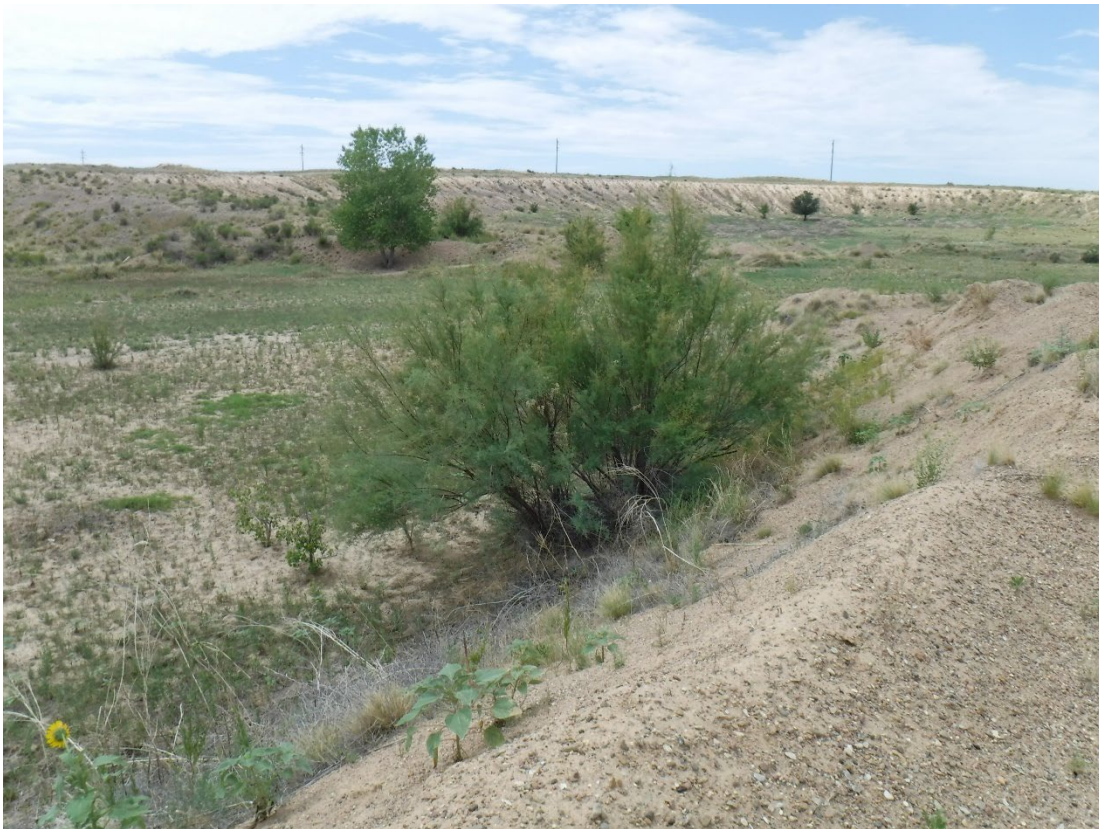
Photo 6: Tamarisk tree

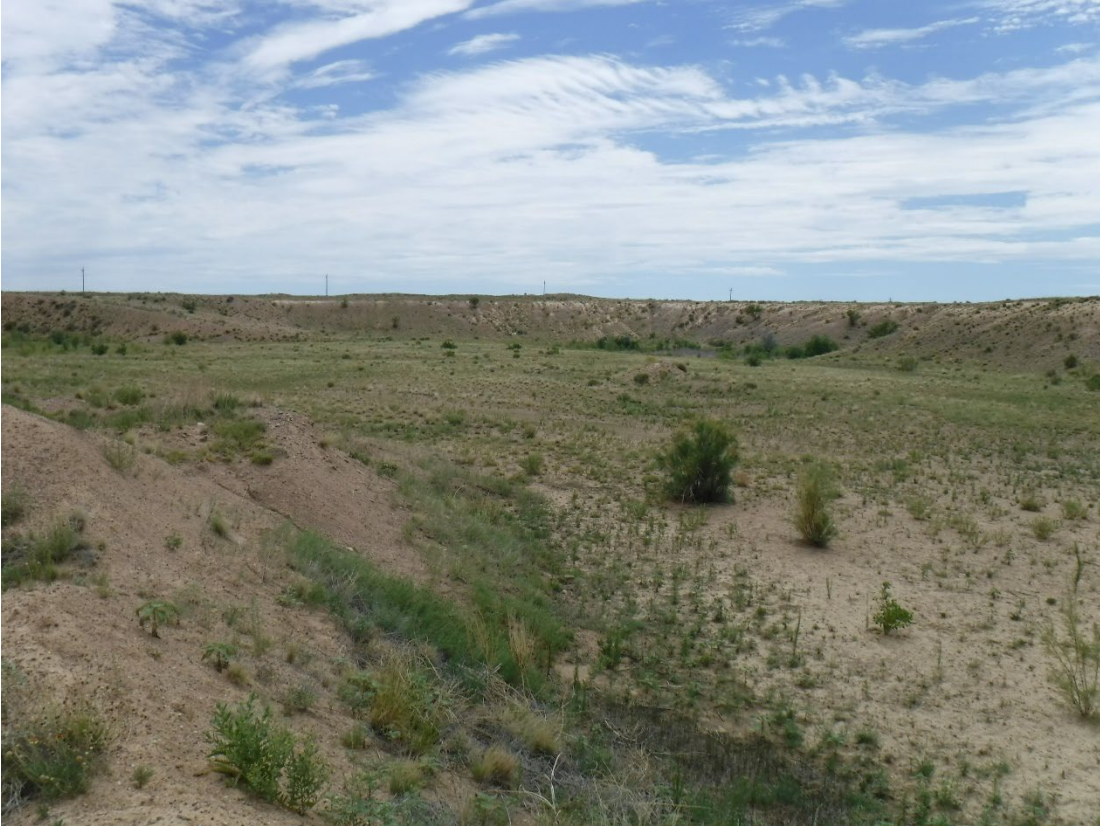
Photo 7: Looking east across the pit floor from the west side of pit

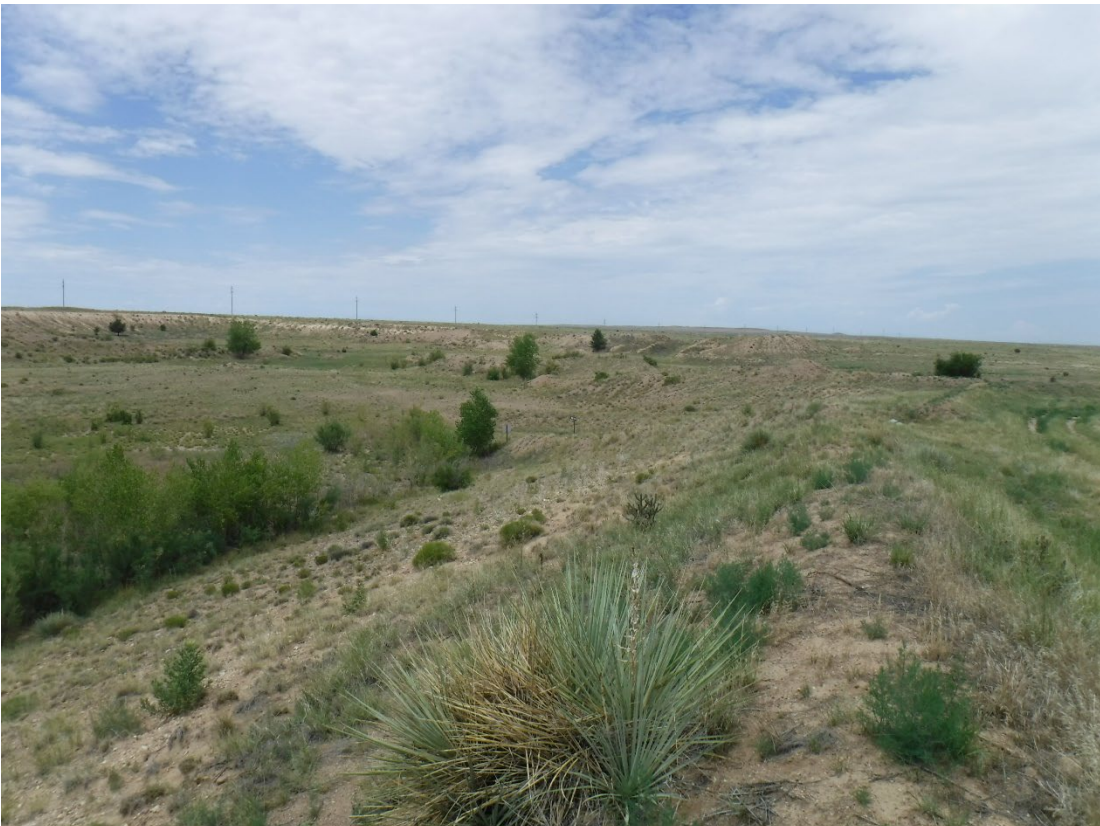
Photo 8: Looking west at the west side of pit area
