MINERALS PROGRAM INSPECTION REPORT

MINE NAME: Stoddard Pit	MINE/PROSPECTING ID#: M-2022-028	MINERAL: Borrow material for	COUNTY: Otero
INSPECTION TYPE: Monitoring	INSPECTOR(S): Patrick Lennberg	INSP. DATE: July 26, 2022	INSP. TIME: 10:00
OPERATOR: Stoddard Construction, LLC	OPERATOR REPRESENTATIVE: John Stoddard	TYPE OF OPERATION: 110c - Construction Limited Impact	
REASON FOR INSPECTION: Normal I&E Program	BOND CALCULATION TYPE: Partial Bond	BOND AMOUNT: No Bond Held	
DATE OF COMPLAINT: NA	POST INSP. CONTACTS: None	JOINT INSP. AGENCY: None	
WEATHER: Clear	INSPECTOR'S SIGNATURE:

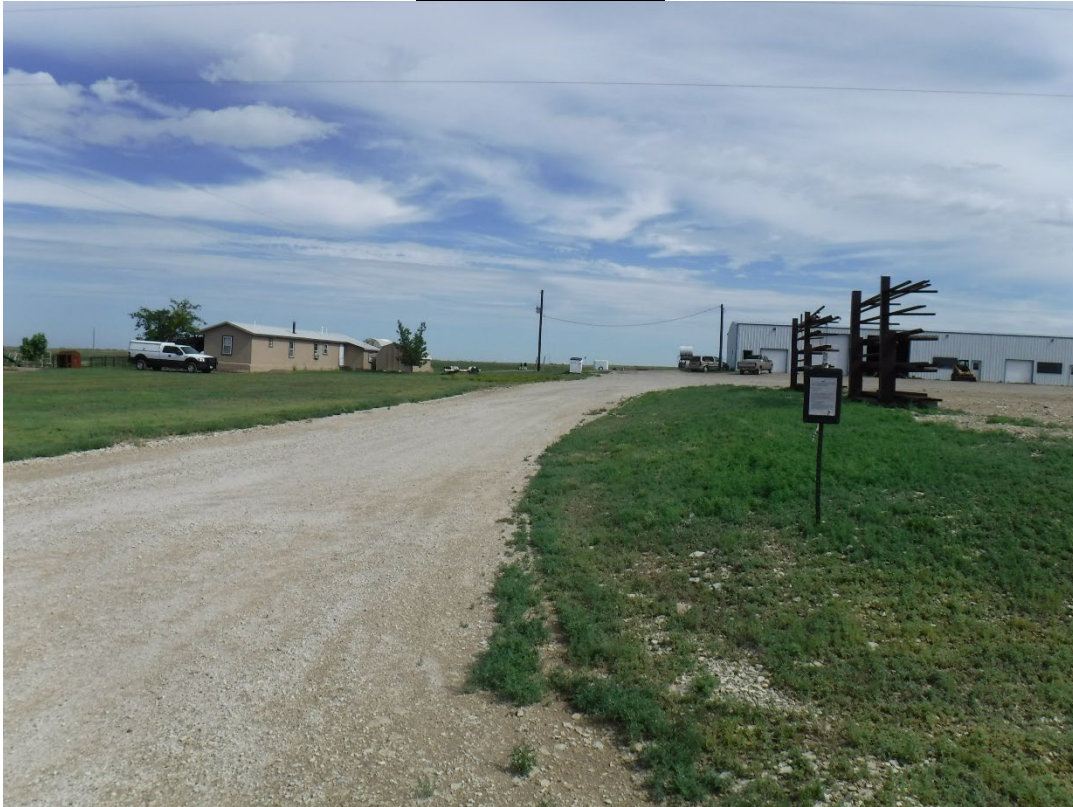
Photo 1: Entrance to Stoddard Construction, note notice sign right of center

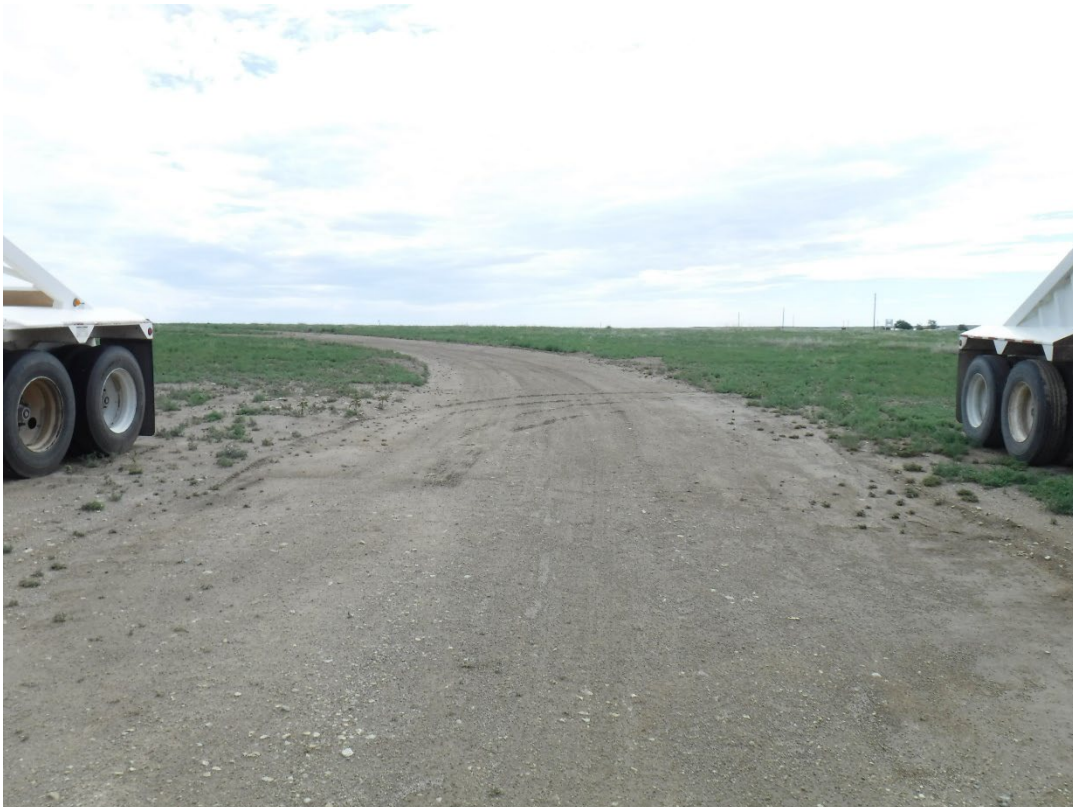
Photo 2: Road entrance from parking lot to mine area

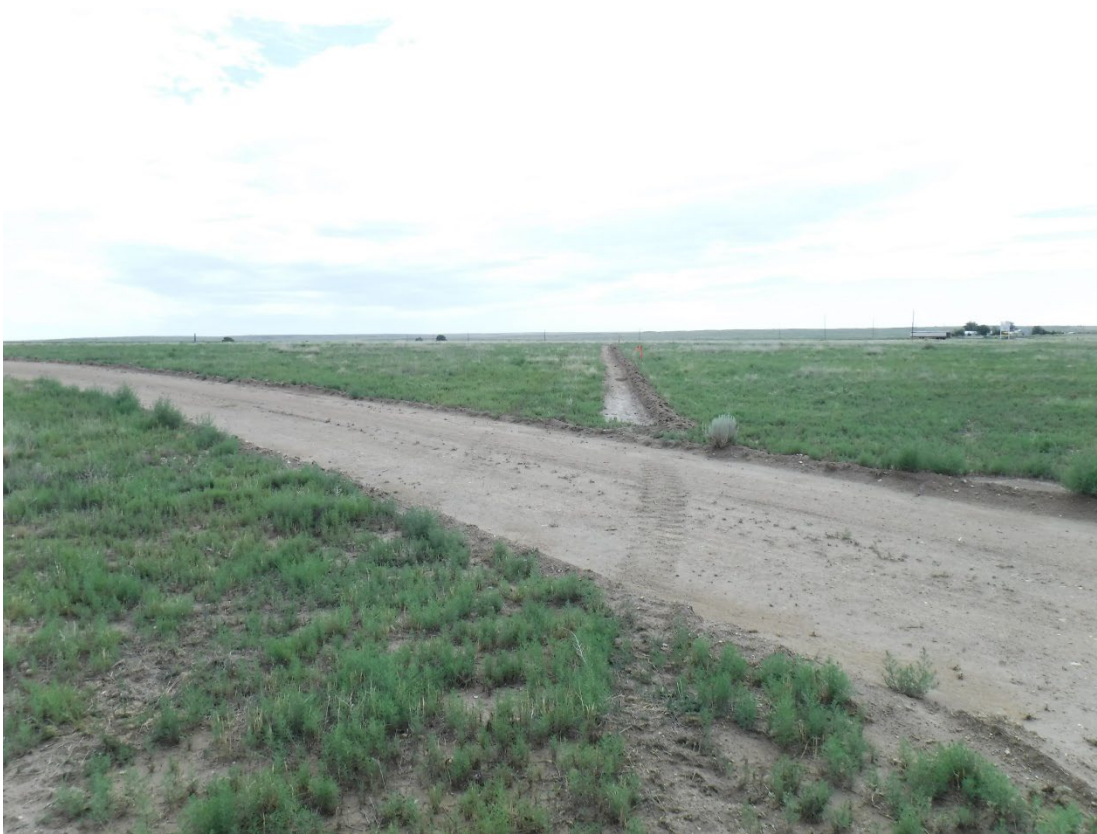
Photo 3: Grubbed in visual marker for permit boundary, south end of permit

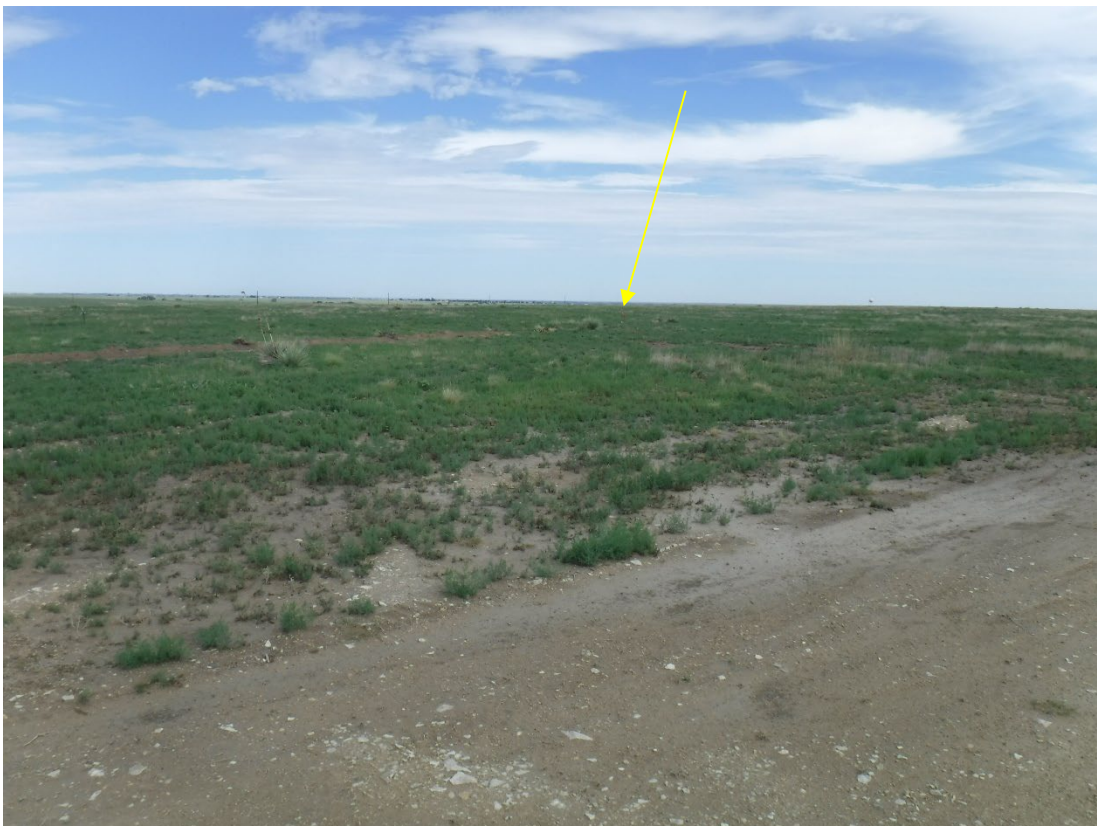
Photo 4: Permit boundary marker (arrow) west side of permit area, looking north

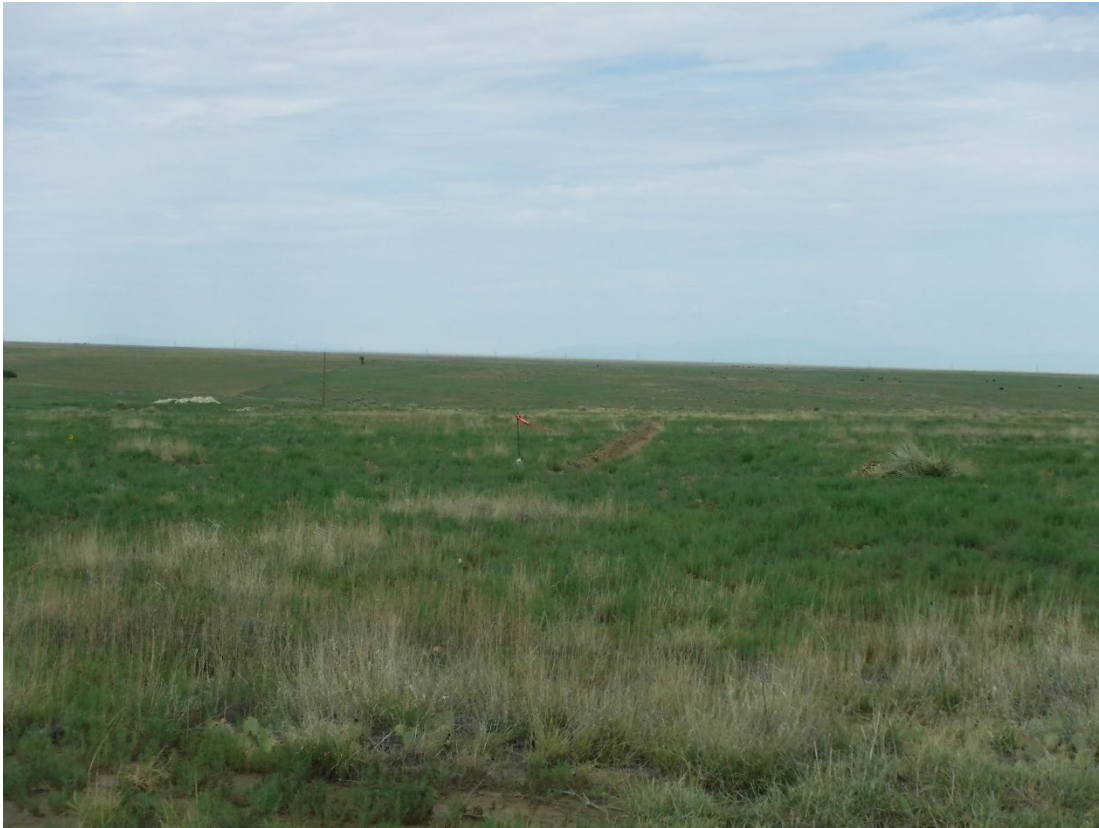
Photo 5: Permit boundary marker from above, looking east

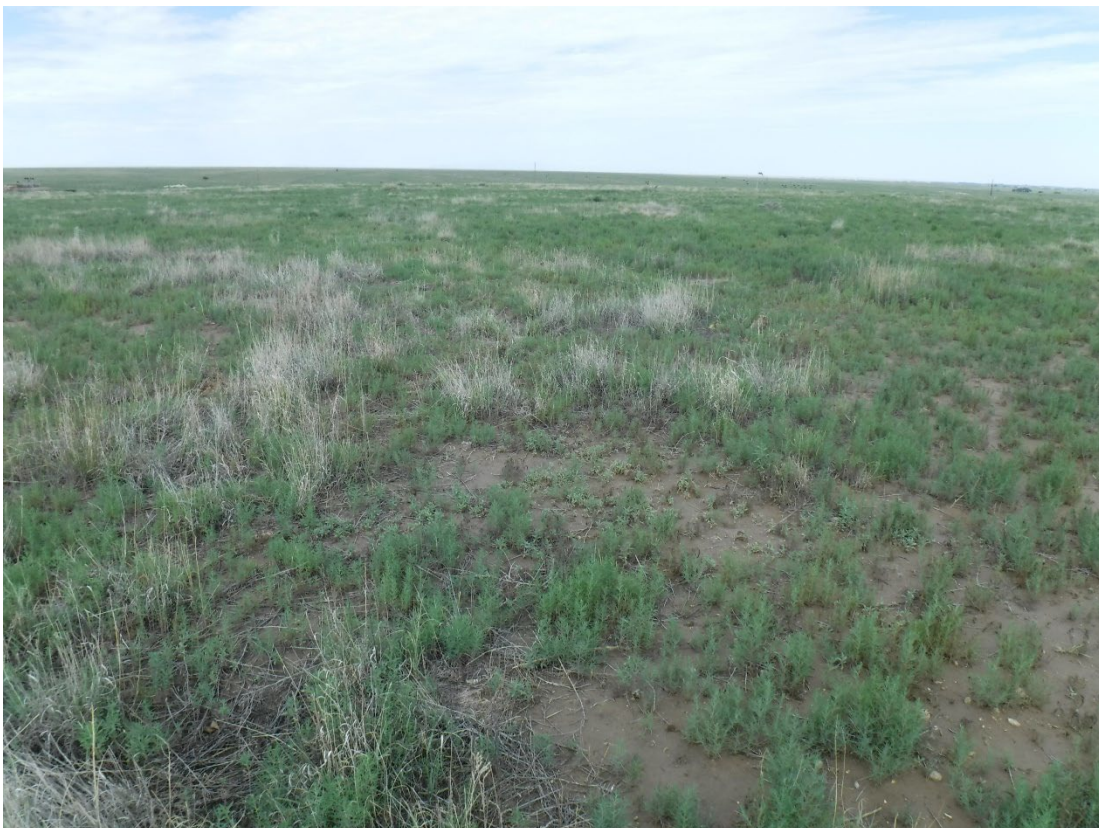
Photo 6: Typical existing vegetation conditions at the site.
