MINERALS PROGRAM INSPECTION REPORT

MINE NAME: Kester Pit	MINE/PROSPECTING ID#: M-2022-014	MINERAL: Gravel, sand and agg	COUNTY: Costilla
INSPECTION TYPE: Preoperation Inspection	INSPECTOR(S): Lucas West	INSP. DATE: August 3, 2022	INSP. TIME: 10:40
OPERATOR: RMS Utilities, Inc.	OPERATOR REPRESENTATIVE: Kaitlyn Gallardo	TYPE OF OPERATION: 110c - Construction Limited Impact	
REASON FOR INSPECTION: Preoperation Inspection	BOND CALCULATION TYPE: Complete Bond	BOND AMOUNT: No Bond Held	
DATE OF COMPLAINT: NA	POST INSP. CONTACTS: None	JOINT INSP. AGENCY: None	
WEATHER: Clear	INSPECTOR'S SIGNATURE:

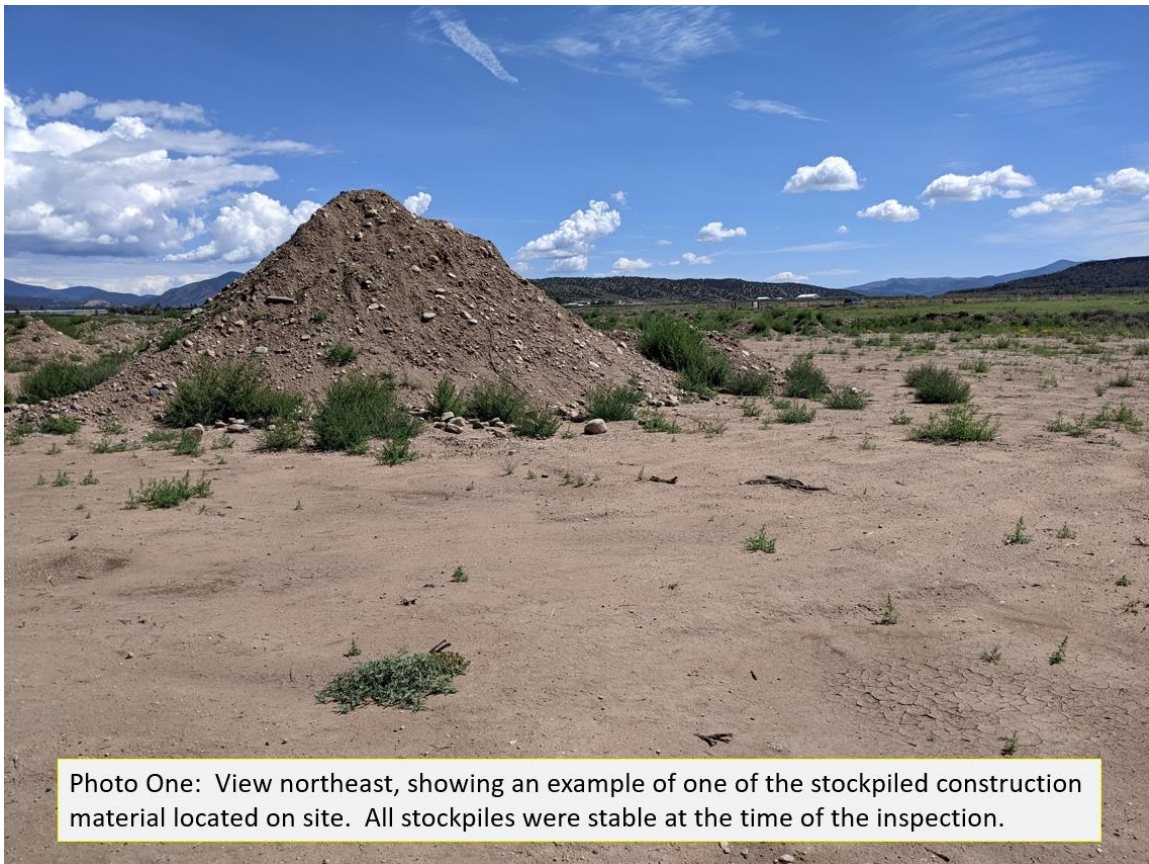
Photo One: View northeast, showing an example of one of the stockpiled construction material located on site. All stockpiles were stable at the time of the inspection.

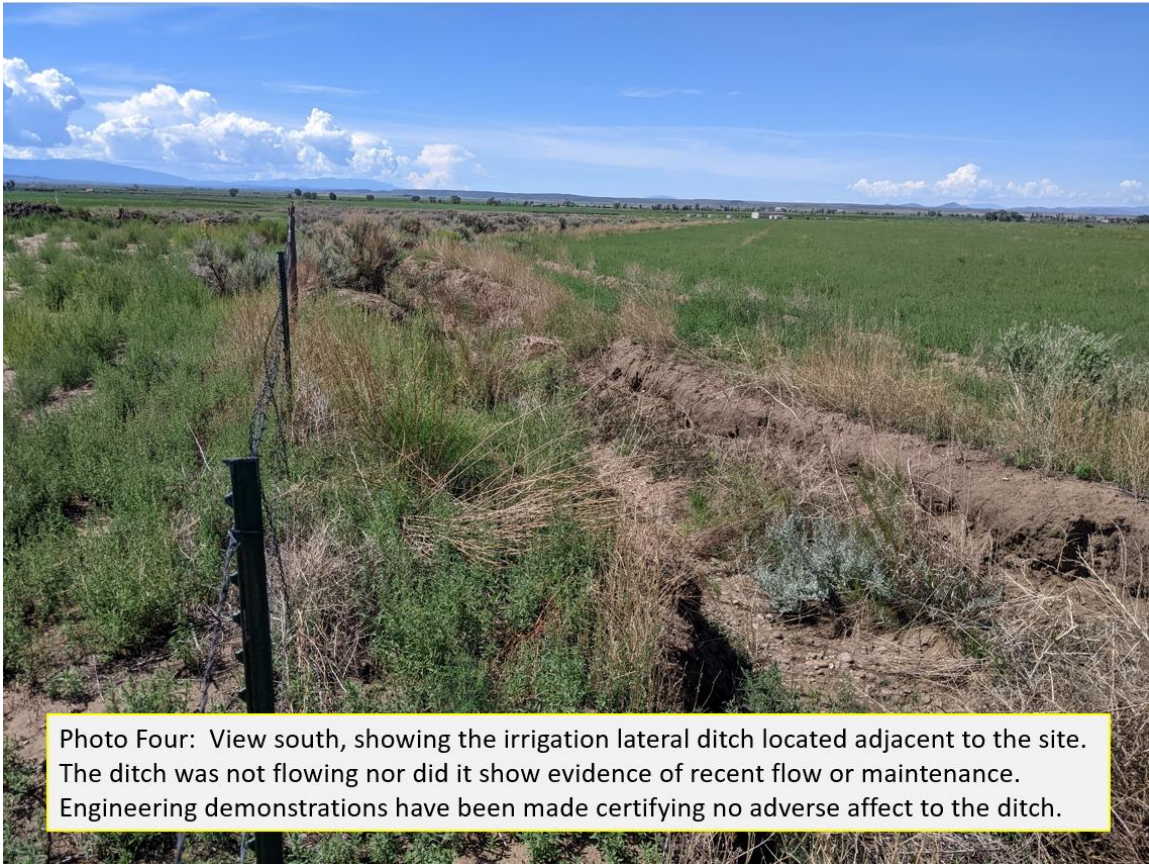
The only notable permanent man-made structures located within 200 feet of the proposed permit area include County Road GG, the fence-lines that border the north and west side of the site, and an irrigation lateral that runs along the west side of the site. The irrigation lateral ditch, shown in Photo Four, was observed and contained no running water at the time of the inspection. The ditch is overgrown with vegetation and shows no signs of recent maintenance. The application details a set back from the property line, which puts the mining extents approximately 20 feet to the east of the ditch. An engineering demonstration has been provided as part of the application materials, certifying that the irrigation ditch will not be impacted by the mining or reclamation activities.

Photo Four: View south, showing the irrigation lateral ditch located adjacent to the site. The ditch was not flowing nor did it show evidence of recent flow or maintenance. Engineering demonstrations have been made certifying no adverse affect to the ditch.
