MINERALS PROGRAM INSPECTION REPORT
PHONE: (303) 866-3567

MINE NAME: Specification Aggregates Quarry	MINE/PROSPECTING ID#: M-1974-004	MINERAL: Granite, gneiss	COUNTY: Jefferson
INSPECTION TYPE: Preoperation Inspection – AM04	INSPECTOR(S): Eric Scott	INSP. DATE: August 5, 2022	INSP. TIME: 09:00
OPERATOR: Martin Marietta Materials, Inc.	OPERATOR REPRESENTATIVE: Phillip Courtney	TYPE OF OPERATION: 112c - Construction Regular Operation	
REASON FOR INSPECTION: Pre-operation Inspection AM04	BOND CALCULATION TYPE: None	BOND AMOUNT: \$1,453,291.00	
DATE OF COMPLAINT: NA	POST INSP. CONTACTS: None	JOINT INSP. AGENCY: None	
WEATHER: Clear	INSPECTOR'S SIGNATURE:

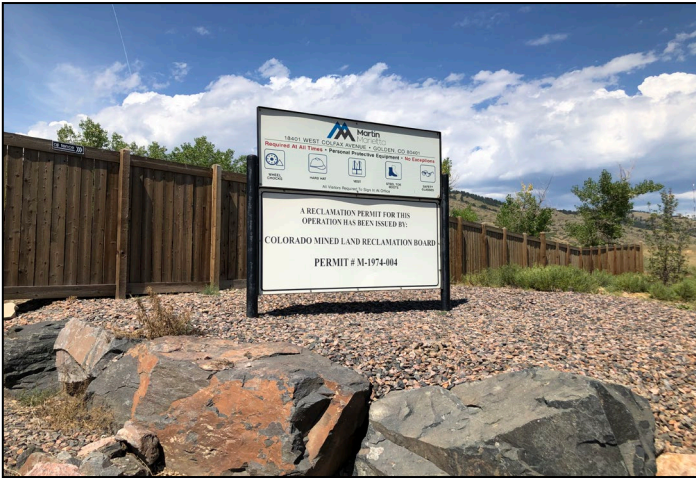
This was a pre-operation inspection of the Specification Aggregate Quarry, a 112c construction materials operation operated by Martin Marietta (MM), conducted as part of the AM04 application review process. This inspection was conducted by Eric Scott of DRMS who was accompanied on-site by Phillip Courtney of MM. The site is located on the west side of Hwy 40 approximately 3 miles south of Golden CO and approximately ¼ mile north of Interstate 70. The site identification sign, and notice of amendment applied for were present at the site entrance (photos 1-2).

Photo 1 – Site identification sign at site entrance

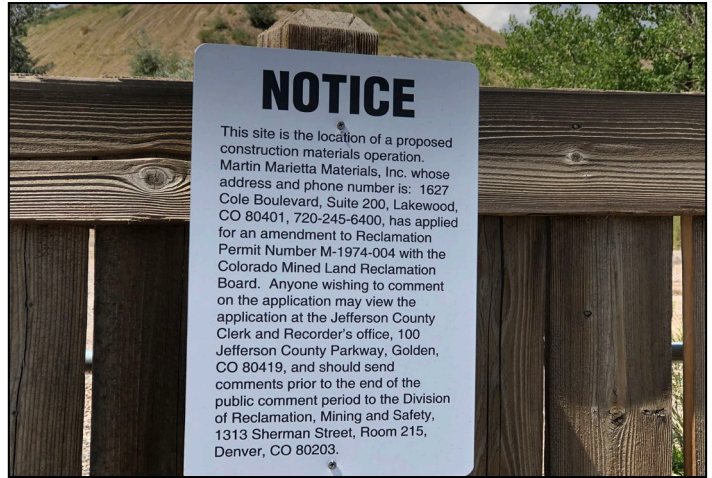
Photo 2 – Notice of amendment applied for sign at site entrance

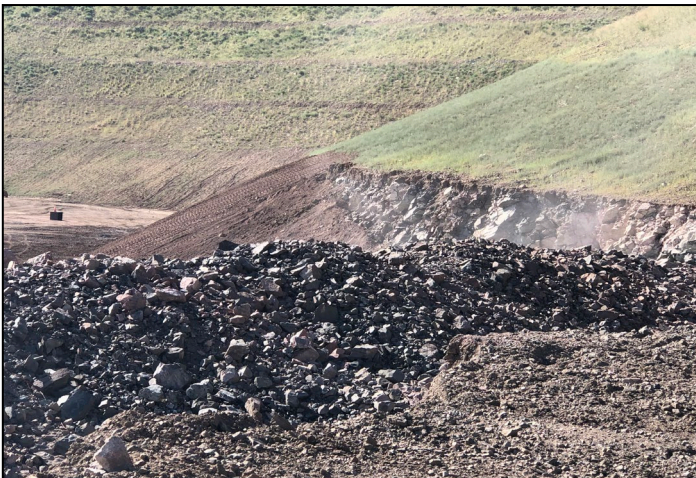
During the inspection DRMS noted that the site, on the whole, appeared to be very well managed as was in compliance with the approved mining and reclamation plans. The material extraction areas in the south area of the existing pit are maintained well, and there are also excellent concurrent reclamation activities completed and underway in the south area of the pit (photos 3-4).

Photo 3 – Concurrent reclamation at material removal area

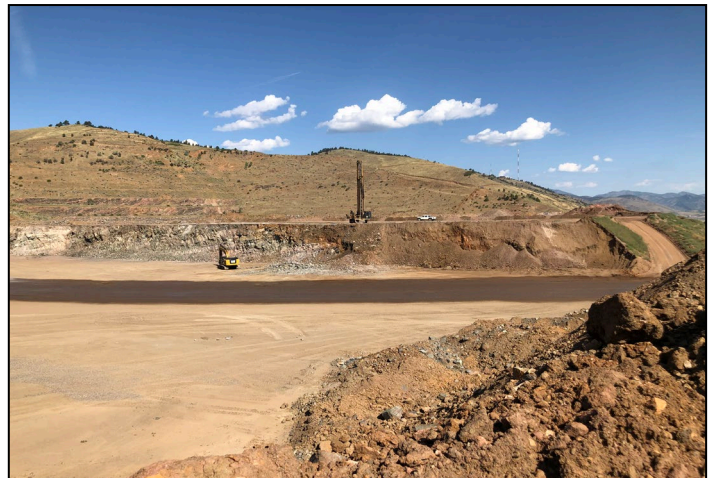
Photo 4 – Drilling for next blast in material removal area

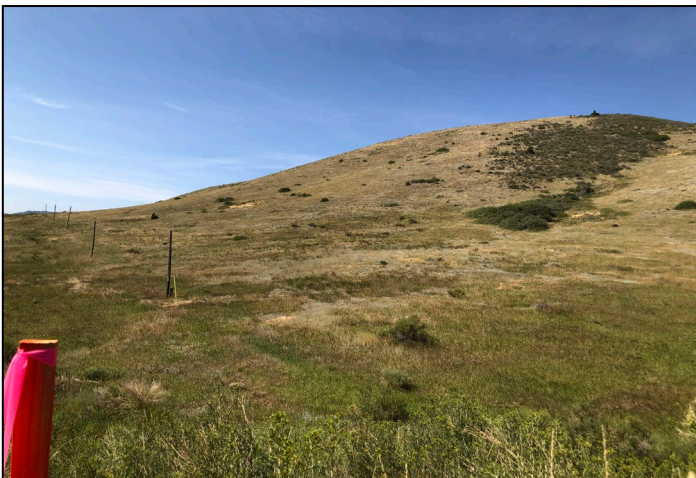
DRMS and MM then drove and hiked around the perimeter of the proposed amendment area. DRMS noted that the new permit boundary was marked, and that all on-site observations agreed with the information provided in the AM04 application (photos 5-9). Mr. Courtney stated that more permanent permit boundary and buffer area markers will be placed when the amendment is approved and finalized.

Photo 5 – looking SSW into AM04 area from SE permit corner

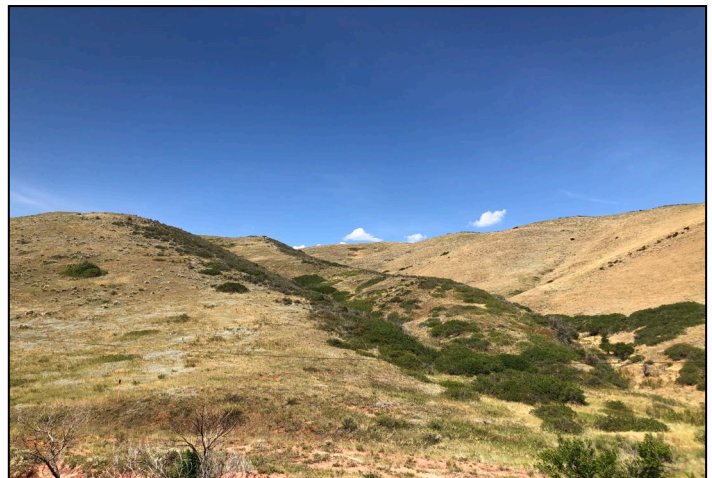
Photo 6 – Looking W into AM04 area from area SE of existing permit

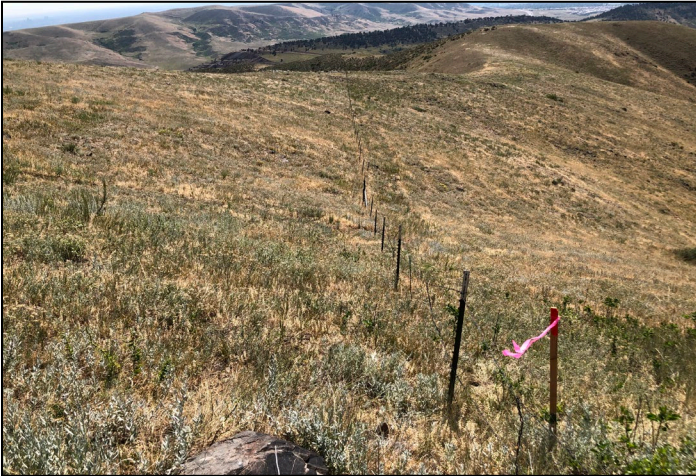
Photo 7 – NW corner of AM04 area looking east into AM04 area.

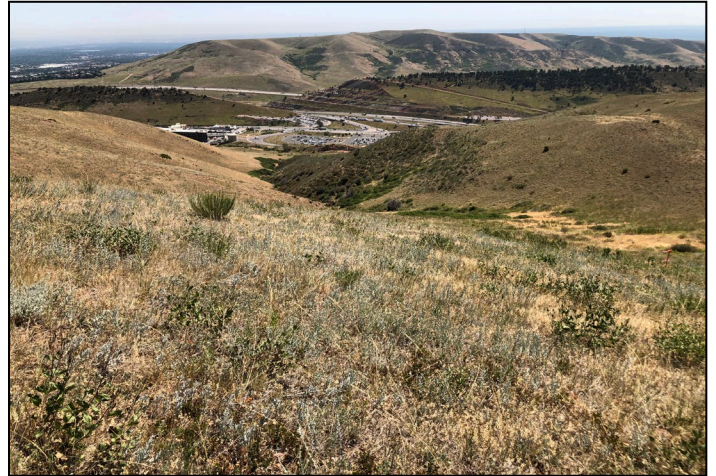
Photo 8 – Top of AM04 area looking east/down into valley shown in Photo 6

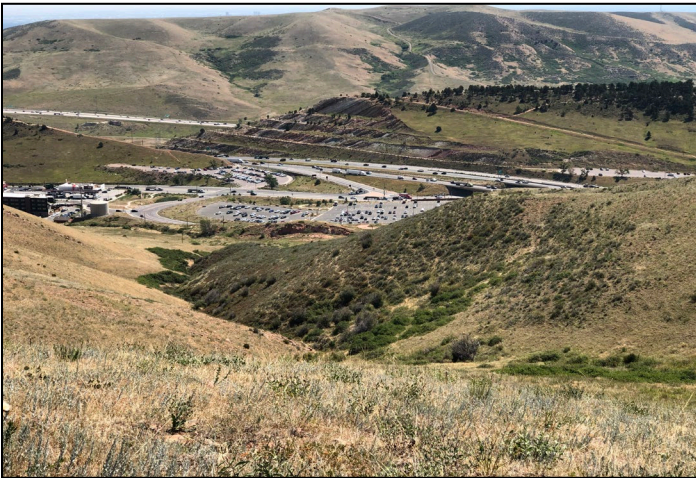
Photo 9 – AM04 area from center looking east
