MINERALS PROGRAM INSPECTION REPORT
PHONE: (303) 866-3567

MINE NAME: North Road Pit	MINE/PROSPECTING ID#: M-2014-009	MINERAL: Gravel and sand	COUNTY: Delta
INSPECTION TYPE: Monitoring	INSPECTOR(S): Robert Zuber, P.E.	INSP. DATE: July 20, 2022	INSP. TIME: 12:50
OPERATOR: Delta County	OPERATOR REPRESENTATIVE: Tim McCracken and others	TYPE OF OPERATION: 112c - Construction Regular Operation	
REASON FOR INSPECTION: Normal I&E Program		BOND CALCULATION TYPE: None	
DATE OF COMPLAINT: NA		BOND AMOUNT: \$0.00	
POST INSP. CONTACTS: None		JOINT INSP. AGENCY: None	
WEATHER: Clear	INSPECTOR'S SIGNATURE:

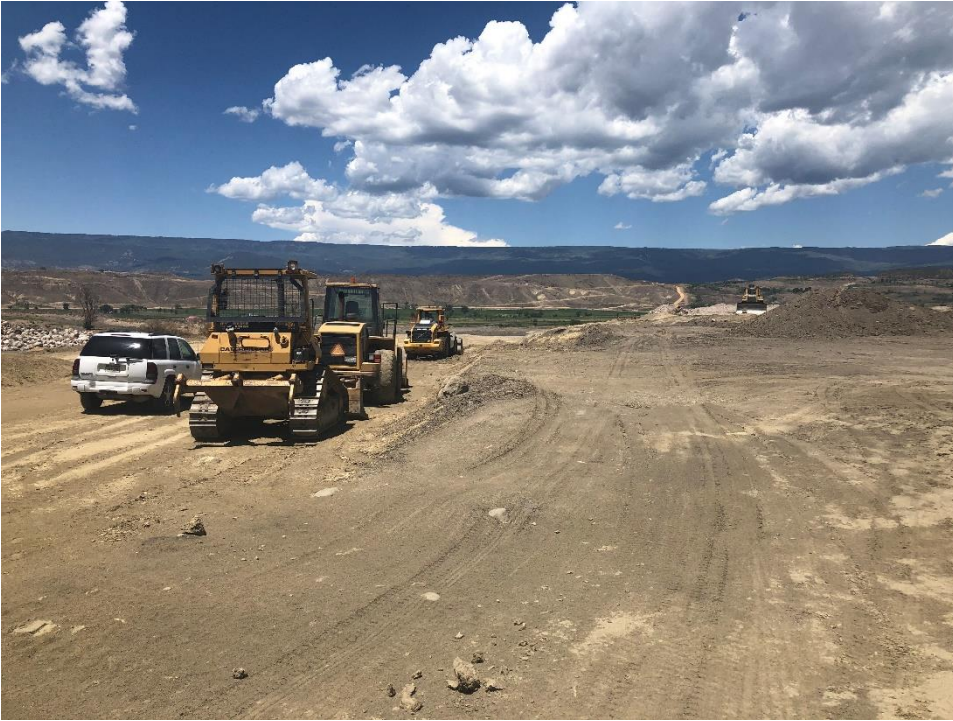
Equipment and material storage

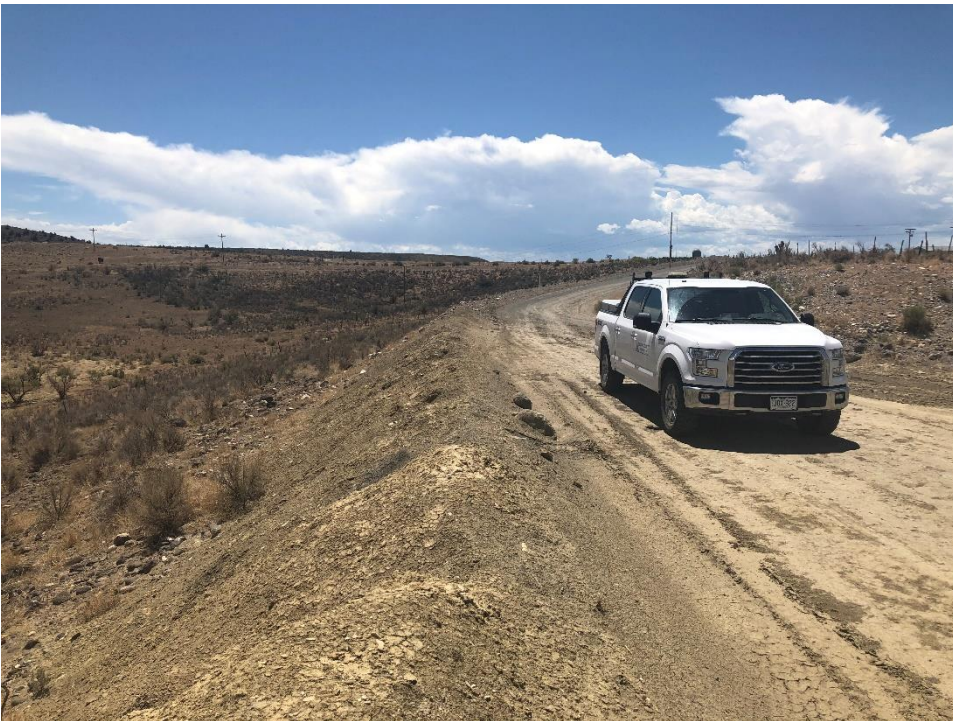
East side of site

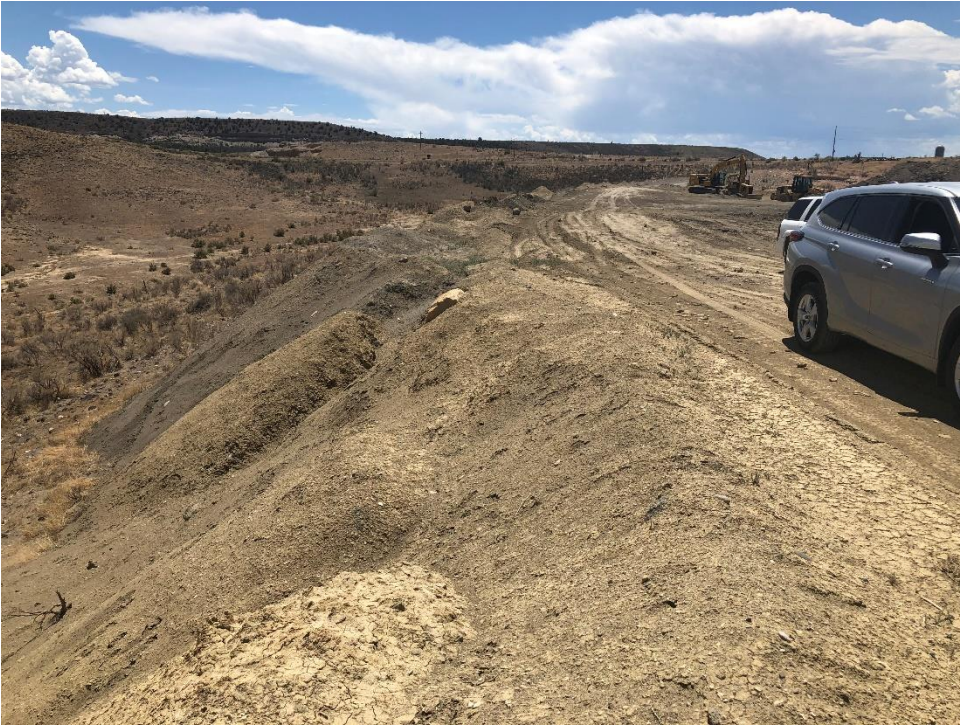
There were no signs that stormwater runoff or snowmelt runoff from the site are causing pollutant loading to the adjacent land. The toe of the unstable hillside, discussed above, is approximately 150 feet from the permit boundary. However, in at least two locations the berm around the site should be repaired to reduce sediment loading onto the undisturbed part of the site. This will ultimately reduce the area in need of reclamation. The culvert and sediment sump on the north side appears to be functioning well; the Division recommends periodic sediment removal from the sump to maintain functionality.

Berm in need of repair

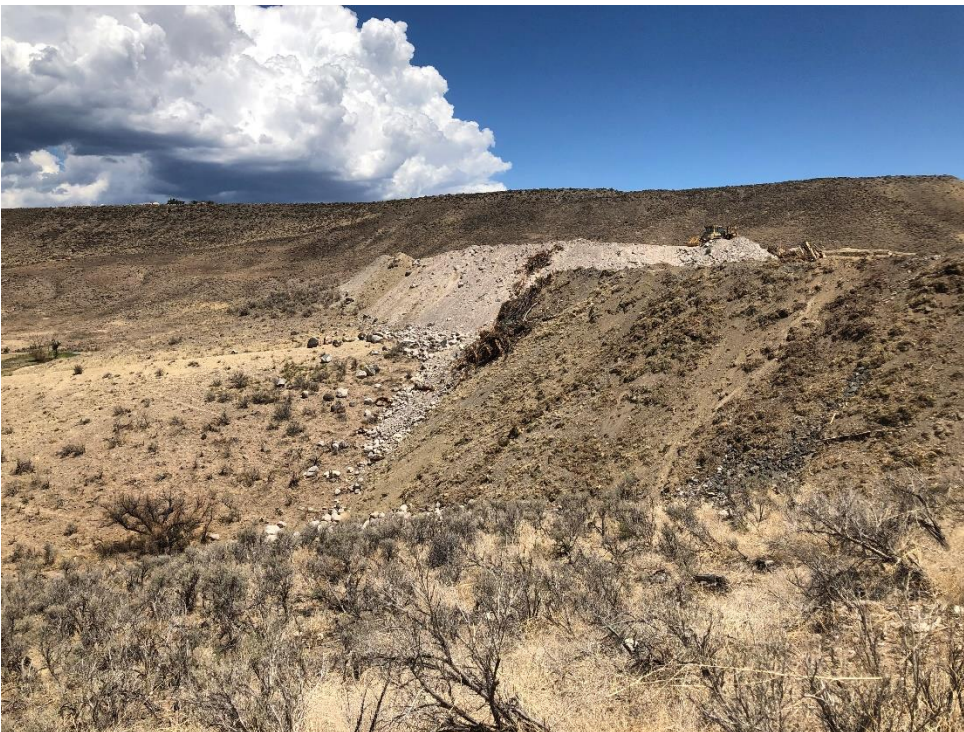
PROBLEM/POSSIBLE VIOLATION: Problem: The current reclamation plan needs to be updated and clarified pursuant to C.R.S. 34-32.5-116 (1). In particular, the County must provide sufficient information to describe reclamation of the unstable slope at the northeast portion of the permit area.

At the northeast area of the site, below the area where material and equipment are stored, the north-facing slope is unstable (erosion is present and large boulders have fallen from the top). The County must submit a

Slope at northeast corner where a revised reclamation plan is needed

CORRECTIVE ACTIONS: The County shall submit a Technical Revision, with the required \$216 revision fee, to update and clarify the current approved reclamation plan to reflect existing and proposed activities by the corrective action date.

Technical Revision updating the Reclamation Plan for the permit (both text and map) indicating that this area needs to be graded, topsoiled, and seeded. Also, the County should identify a plan for the large boulders (e.g., protection of the toe of the slope).
