MINERALS PROGRAM INSPECTION REPORT
PHONE: (303) 866-3567

SIGNATURE DATE: August 9, 2022

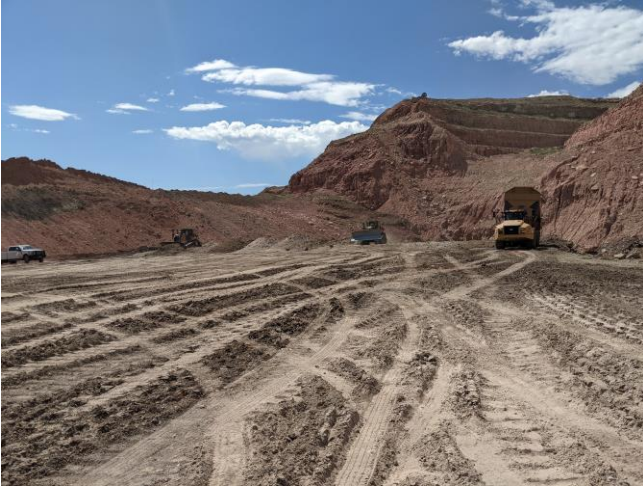
Backfill and grading along buttress.
