**MINERALS PROGRAM INSPECTION REPORT**  
**PHONE: (303) 866-3567**

<b>MINE NAME:</b> Ross Pit	<b>MINE/PROSPECTING ID#:</b> M-1990-134	<b>MINERAL:</b> Gravel	<b>COUNTY:</b> Moffat
<b>INSPECTION TYPE:</b> Monitoring	<b>INSPECTOR(S):</b> Zach Trujillo	<b>INSP. DATE:</b> July 27, 2022	<b>INSP. TIME:</b> 08:30
<b>OPERATOR:</b> James H & Kathleen H Ross	<b>OPERATOR REPRESENTATIVE:</b> Bud Bower	<b>TYPE OF OPERATION:</b> 110c - Construction Limited Impact	
<b>REASON FOR INSPECTION:</b> Normal I&E Program	<b>BOND CALCULATION TYPE:</b> None	<b>BOND AMOUNT:</b> \$20,545.00	
<b>DATE OF COMPLAINT:</b> NA	<b>POST INSP. CONTACTS:</b> None	<b>JOINT INSP. AGENCY:</b> None	
<b>WEATHER:</b> Clear	<b>INSPECTOR'S SIGNATURE:</b>

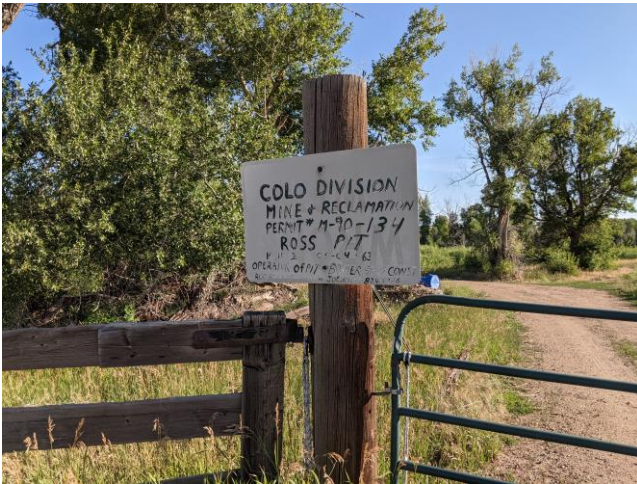
The mine sign is located at the entrance of the permit boundary at the gate. Boundary markers were observed in addition to fence lines delineating the boundary. A dead tree has been placed over the access road to ensure trespassers or unwanted machinery from access the reclamation.

Mine id sign.

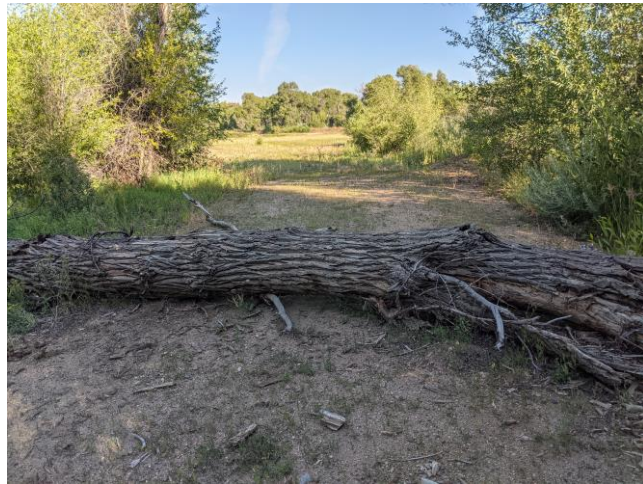
Tree at access road.

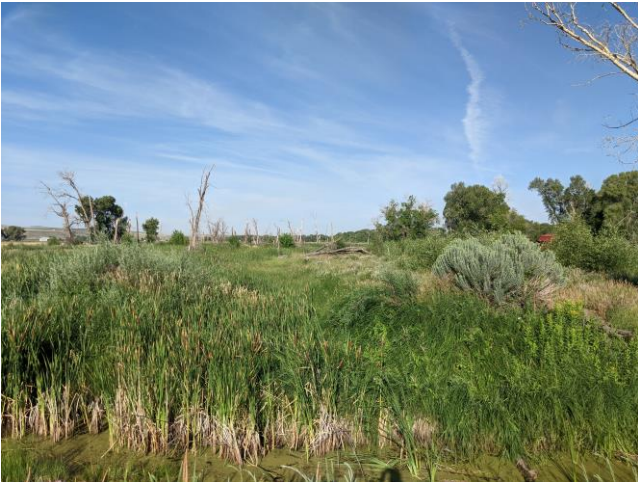
Area 4.

The site has been fully reclaimed with no remaining equipment left on site. Excavated areas were below the groundwater table and as such, ponds have been formed. Vegetation along ponds in 'Areas 1', '3' and '4' are very well established and no issues were noted. The portion of the pit named 'Area 2' of the mine showed vegetation however a little more sparse potentially due to saturation from fluctuating seasonal groundwater levels. In some of the lower spots, cat tails have begun to grown in 'Area 2'. While 'Area 2' shows establishment of vegetation, it could benefit from an additional growing season prior to full bond release.

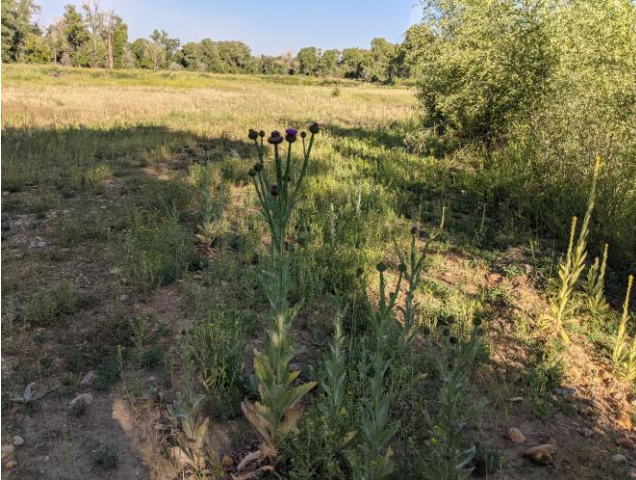
During the inspection two patches of thistles were observed, both within 'Area 2'. The first patch was small and sparse located near the downed tree along the access road. The second patch was larger and more concentrated and was long the northern perimeter of the permit boundary. The operator stated that a crew would chop and treat the two patches of thistle.

Small thistle patch.

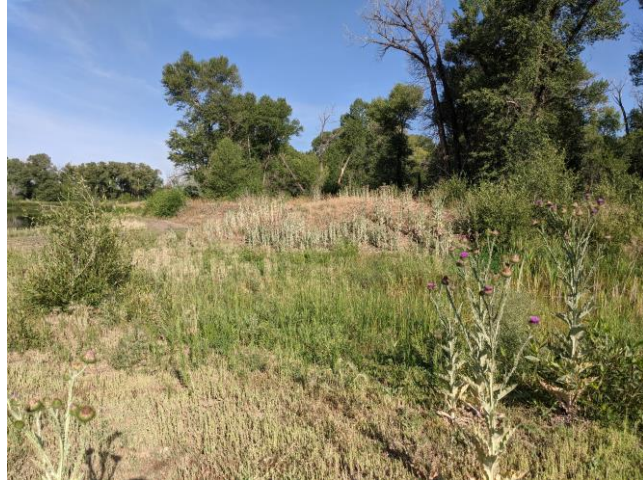
Larger thistle patch.
